The EC135 Drive Train Analysis and Improvement of the Fatigue Strength

ECD-0159-07-PUB

Key words: EC135, Fatigue strength, Drive train, Main gear box

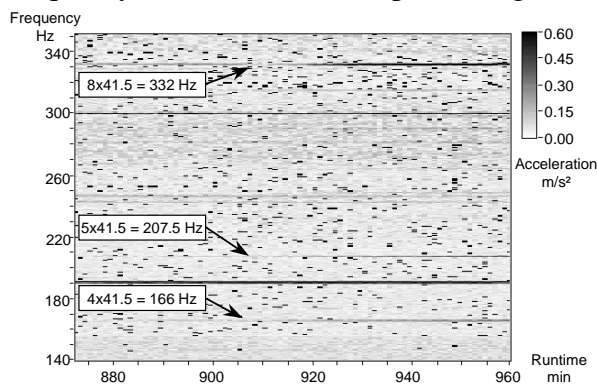
Figure 5: Low Frequency Amplitude Spectrum

- Figure 5 shows the low frequency spectrum with the significant increase of the 8th harmonic of the rotating frequency of the fenestron output shaft 41.5 Hz. Also for the 4th harmonic an amplitude increase can be detected.
- In the envelope spectrum of Figure 6 the shaft frequency and the trend of its 2nd harmonic also point at an anomaly of this component.
- Figure 7 depicts the pronounced increase of the acceleration values of the rotation frequency of the fenestron output shaft gained from the demodulated envelope.

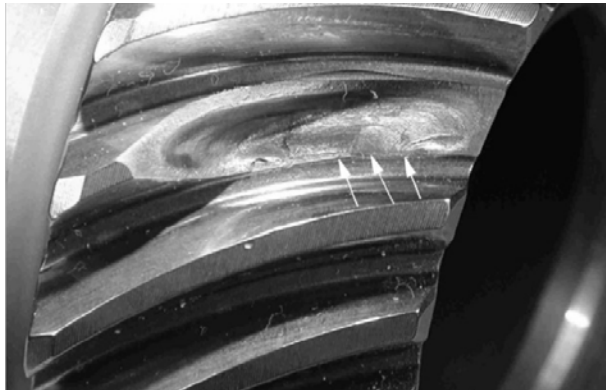
Figure 9: Failure of an Output Bevel Gear

In 2003 a fracture of one tooth of the output shaft was detected in service after 2400 flight hours of the transmission. As this is a completely unexpected damage the investigation aimed at finding an exceptional influence to explain the premature damage. The historic information available for the affected gear box contained an occurrence of a freewheel slippage with subsequent hard engagement. This incident happened after approximately 5 flight hours of the gear box.

Using the information of the HUMS test – loads and damage development time until crack detectability – a crack propagation model was tuned to deliver the same behaviour than observed in the test. Applying this model with the usage load spectrum for the output gear yielded in a damage development time well in accordance with the time interval between the freewheel incident and the detection of the crack in the gear.

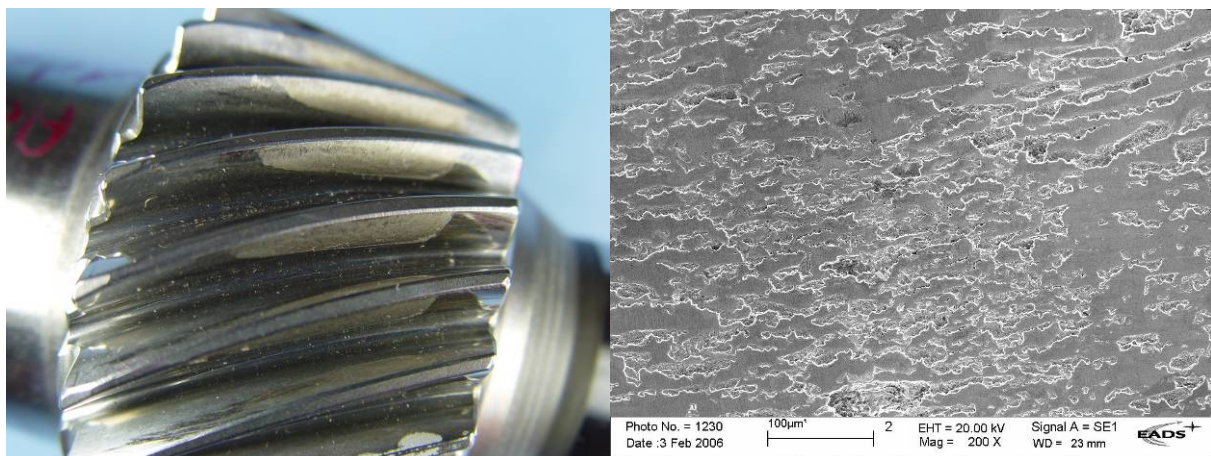
*Figure 10: Micro Pitting of an Input Stage Bevel Gear at TBO inspection.
Overview and 200x magnified View of the Area.*

Micro pitting is influenced by the film thickness of the lubricant in the gear contact. The film thickness is mainly influenced by the load, by the bulk temperature of the teeth and by the lubricant.

Numerous calculations performed at Eurocopter and the gear box manufacturer ZFL showed, that the capacity to sustain micro pitting might be limited for the existing gear box for the used operating and ambient conditions. Nevertheless the observed micro pitting did not fit with the calculation and the experience obtained in numerous other applications. After further investigations some measurements of the oil pressure in various flight conditions have been performed. It was shown, that in some special flight condition the oil pressure can drop for some fractions of seconds below the limit and such conditions do increase the risk of micro pitting. As precautionary action the flight envelope was tightened to reduce such flight conditions and the amount of oil was increased by 2 litres to ensure correct lubrication of all gear stages inside EC135 MGB.

In 2006 Eurocopter planned to present a further upgrade version of the EC135, so called EC135 P2+/T2+ with again increased MTOW and AEO TOP rating. To maintain this, it was decided to replace the standard lubricant according to MIL-PRF-23699 by a special gear box lubricant.

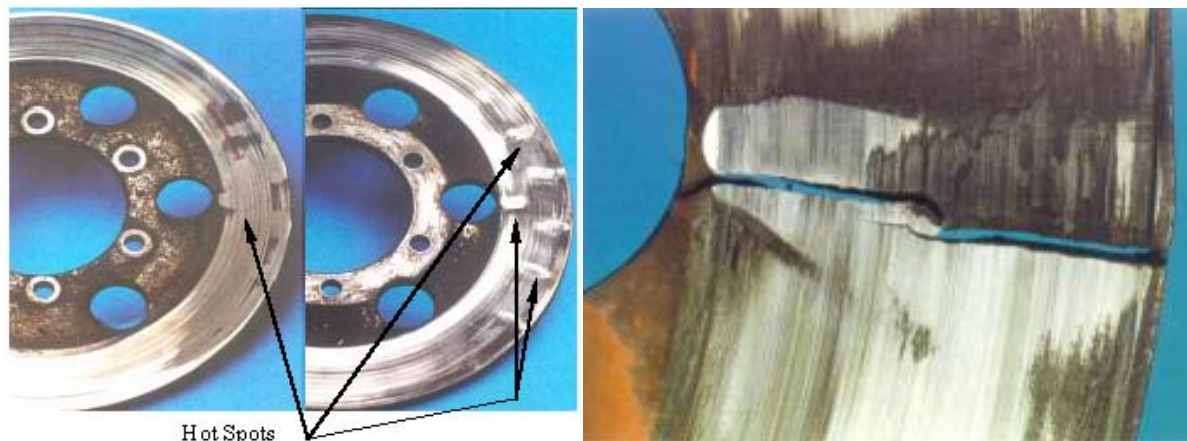
The customers of EC 135 often complained a rattling behaviour of the rotor brake system. This was caused by some tolerances which were selected too high and was aggravated in some cases by deformation of the rotor brake disc. In some cases hot spots were observed on the disc and in very few cases cracks appeared in the disc as seen in Figure 13. Eurocopter did deeper investigations on this phenomenon to avoid such kind of hot spots, while the usage of the rotor brake was not recommended for some time.

Figure 13: Front and Rear Side of a Brake Disc with Hot Spots and a Detail of a cracked Rotor Disc in the Hot Spot Area.

The investigation showed slight pad sediments arise on the peaks of the brake disc if the disc faces are not flat enough. This results in brake discs with different friction coefficient areas. By activating the brake system with such a disc, stick-slip-effects do amplify the clattering phenomenon. Different local temperatures on the brake disc caused by different local brake forces may lead to a bake process of the sediments on the disc.

During excessive brake usage hot-spots may have an adverse influence on the disc stress behaviour. Cracks may be initiated as seen in Figure 13 with a disc crack which ends in a weight reduction bore. Non-uniform heat transfer distribution leads to temperature peaks, causing material mutations and embrittlements. Local cracks arise during the cooling down phase.

New manufactured brake discs with very high tolerance requirements (flat and parallel faces) were introduced to avoid possible starting points of such hot spot areas and thus disc cracks. In parallel the weight reduction holes were deleted to allow a more uniform radial heat transfer distribution across the disc circumference. As third the disc adapter was also changed from an assembly consisting of two parts to an integrated, not assembled part. By these three means, all complaints of the customers stopped and the unlimited use of the rotor brake system is possible. Actually Eurocopter collects all in service feedback to demonstrate the performance of the system.

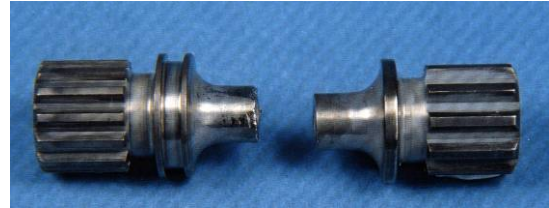
The fan drive shaft connects the MGB with the fan as shown in Figure 14 a). The fan cools the oil of the MGB and the engine 1 or 2 depending on the installed side. As for all accessory drives for EC135 the drive shaft is designed as a mechanical fuse: In case of seizure or sudden stoppage of the fan, the shaft will shear and the fan will be decoupled from the MGB to prevent the MGB from further damage. On the other side, due to this design the shaft has a very small diameter which may also shear unintendedly (see an example in Figure 14 b)). This happened several times during the early serial phase of the EC135. Also rather heavy wear and seizing in the splined connection was found.

b) A failed Fan Drive Shaft

The transmitted load is limited by the fan and is much too low to create the failure, so the stress due to misalignments was investigated. Depending on the type of misalignment - radial or angular displacement - additional dynamic stresses are created inside the shaft, coming from the bending moment (for radial displacement) or from the shear forces (for angular displacement), see Figure 15. As the rotational speed of the shaft is 12.665 RPM the applied load cycles reach a very high number in a short period of flight time.

As the stress is very sensitive to the displacement, the fan drive shaft was improved by increasing the length of the thin section and using a lubrication chamber (improving the lubrication situation) at the spline connections. This prevents the wear and seizing in the splines thus allowing the given play in the connection to accommodate the inevitable amount of misalignments without creating excessive forces inside the shaft. The shaft of new design is now in use for several years and no further case of breakage of such a new shaft occurred.

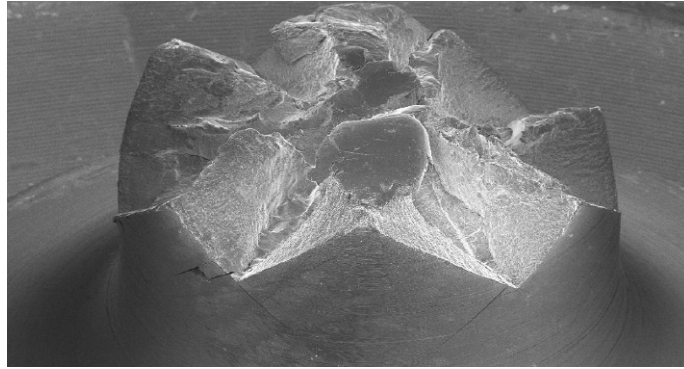
Investigations of failed fan drives showed, that both kinds of displacement can be found and also cases of mixture of both types. In Figure 16 to 18 examples of the two basic and one intermediate failure modes are shown.

Figure 16: Failure Mode of Radial Displacement

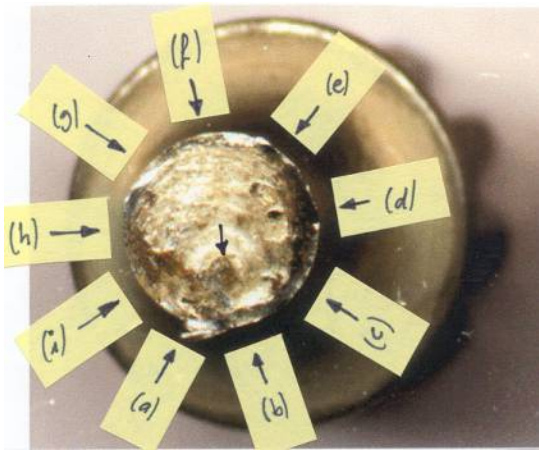
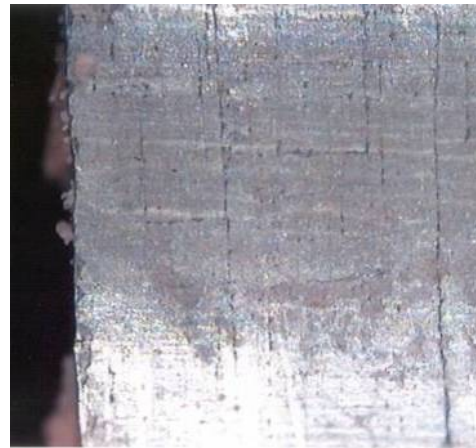
a) Fracture Surface

b) Side view with Secondary Cracks

Figure 17: Failure Mode of Angular Displacement

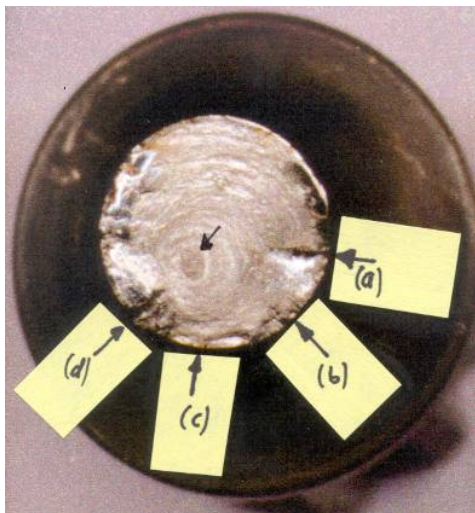
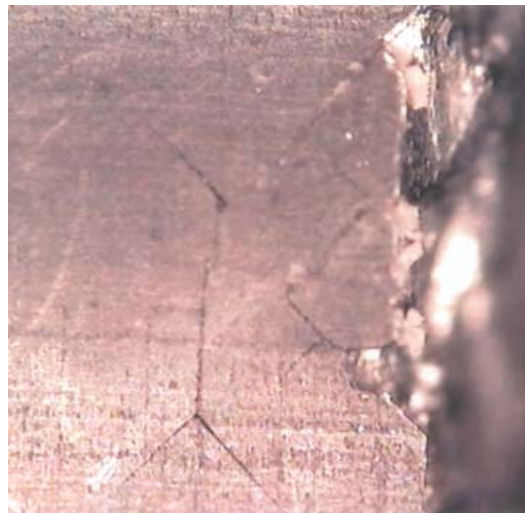
a) Fracture Surface

b) Side view with Secondary Cracks

Figure 18: Intermediate Failure Mode
