EH101: LIGHTNING PROTECTION OF COMPOSITE MATERIALS:
RESULTS OF PRELIMINARY TESTS ON CFC PANELS

L.Luini, G.Meschi
Costruzioni Aeronautiche G.Agusta
Cascina Costa, Italy

A.Bertazzi
CESI
Milano, Italy

September 8-11, 1987
ARLES, FRANCE

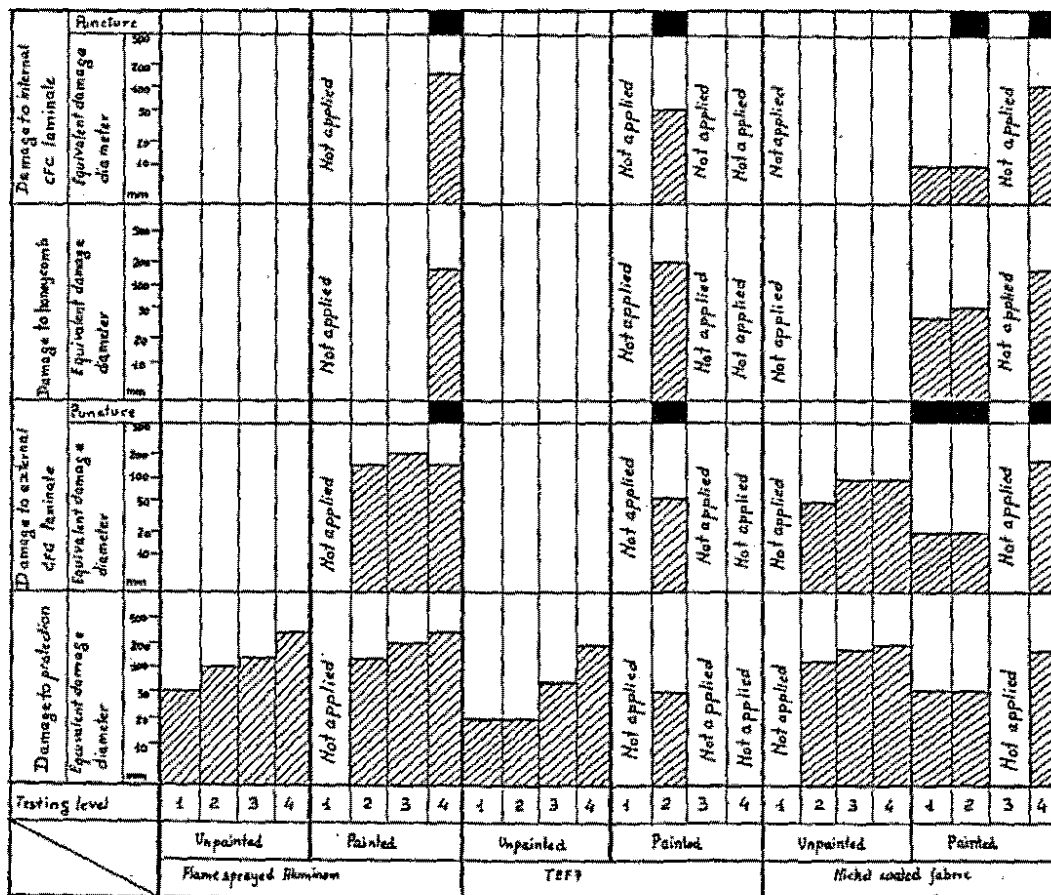
In the figure the extension of the damage to the protection layers, to the external laminate (the laminate to which the arc has been applied), to the honeycomb and to the internal laminate are shown for the various protection layer and current levels . The extension of damages is expressed as dimension of an equivalent circular damaged surface having an area equal to the actual one.

-for the unpainted panels all the adopted protection layers assure the absence of puncture of the laminate. Furthermore only in the case of nickel coated fabric a delamination has been detected in external laminate, but its extension does not exceed 80 cm^2 , in the worst case.

The damage to protection layers, never exceeding an area of 320 cm^2 , consists in burning of the flame sprayed aluminum layer, burning of the resin layer which cover the aluminized fabric, or strap of the nickel fabric.

-for the painted samples a dramatic decrease in protective effectiveness is shown. Infact, the area of damage to the protection layers is reduced or unchanged but the deepness of the damage is largely increased by the presence of the paint. In particular panels protected with flame sprayed aluminum are not punctured up to the third test current level, but a delamination involving two or three layers and having an area of about 320 cm^2 has been recorded. At the highest current level the puncture has been recorded of both internal and external laminates, with a damage to the honeycomb extending for an area of about 300 cm^2 . Fig. 6 shows the effects of a 200 kA pulse: puncture of the sample, delamination and tufting of the laminates, burning of the honeycomb.

Fig. 5. Results of arc impact tests on sandwich laminates.

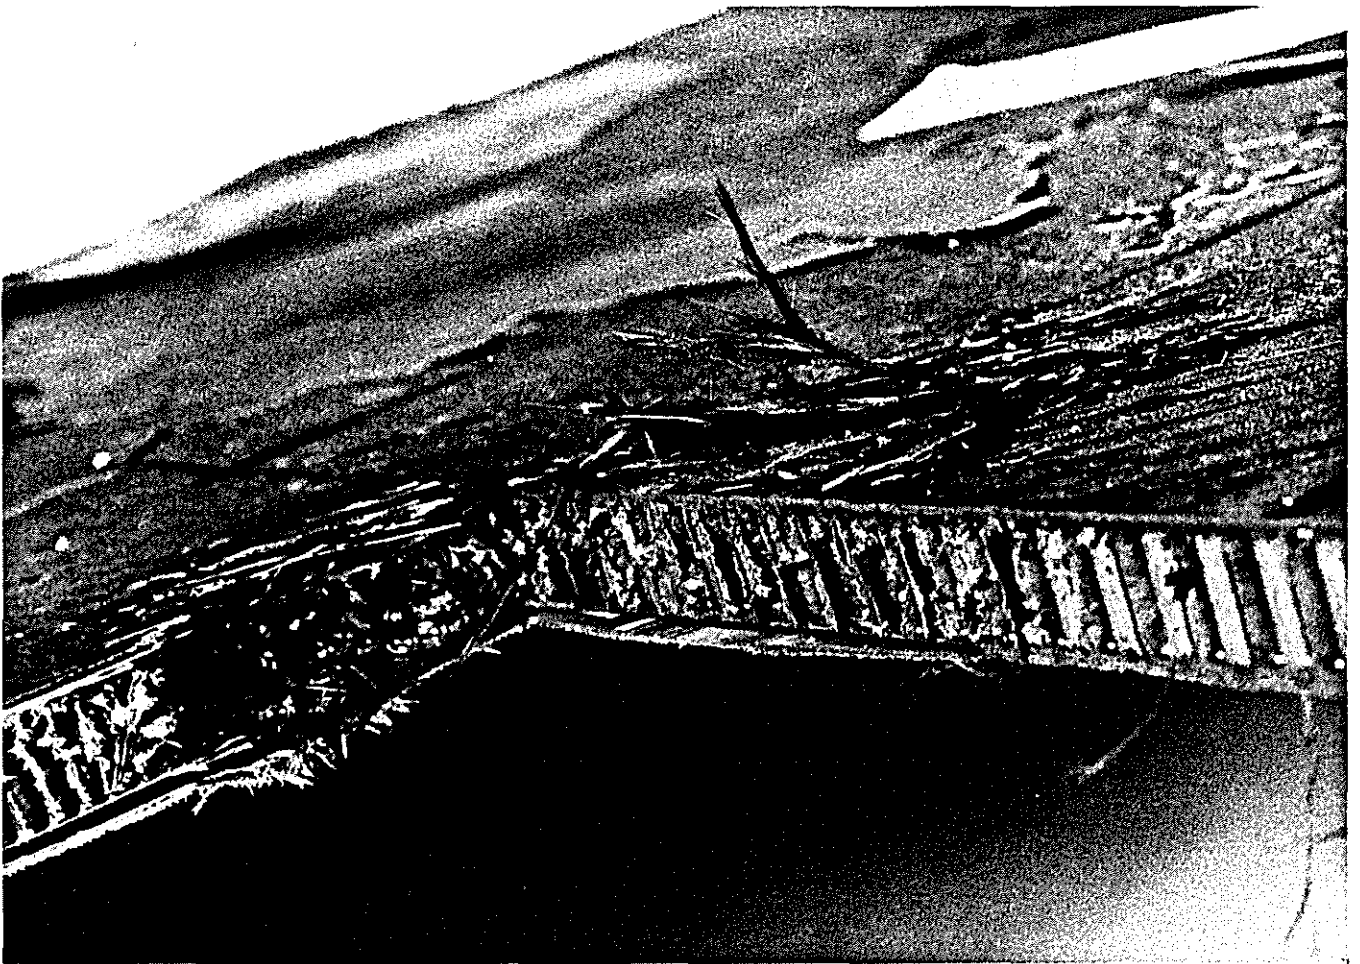
Fig. 6. Arc impact tests. Damage caused by a 200 kA strike to a painted sandwich panel protected with flame sprayed aluminum.

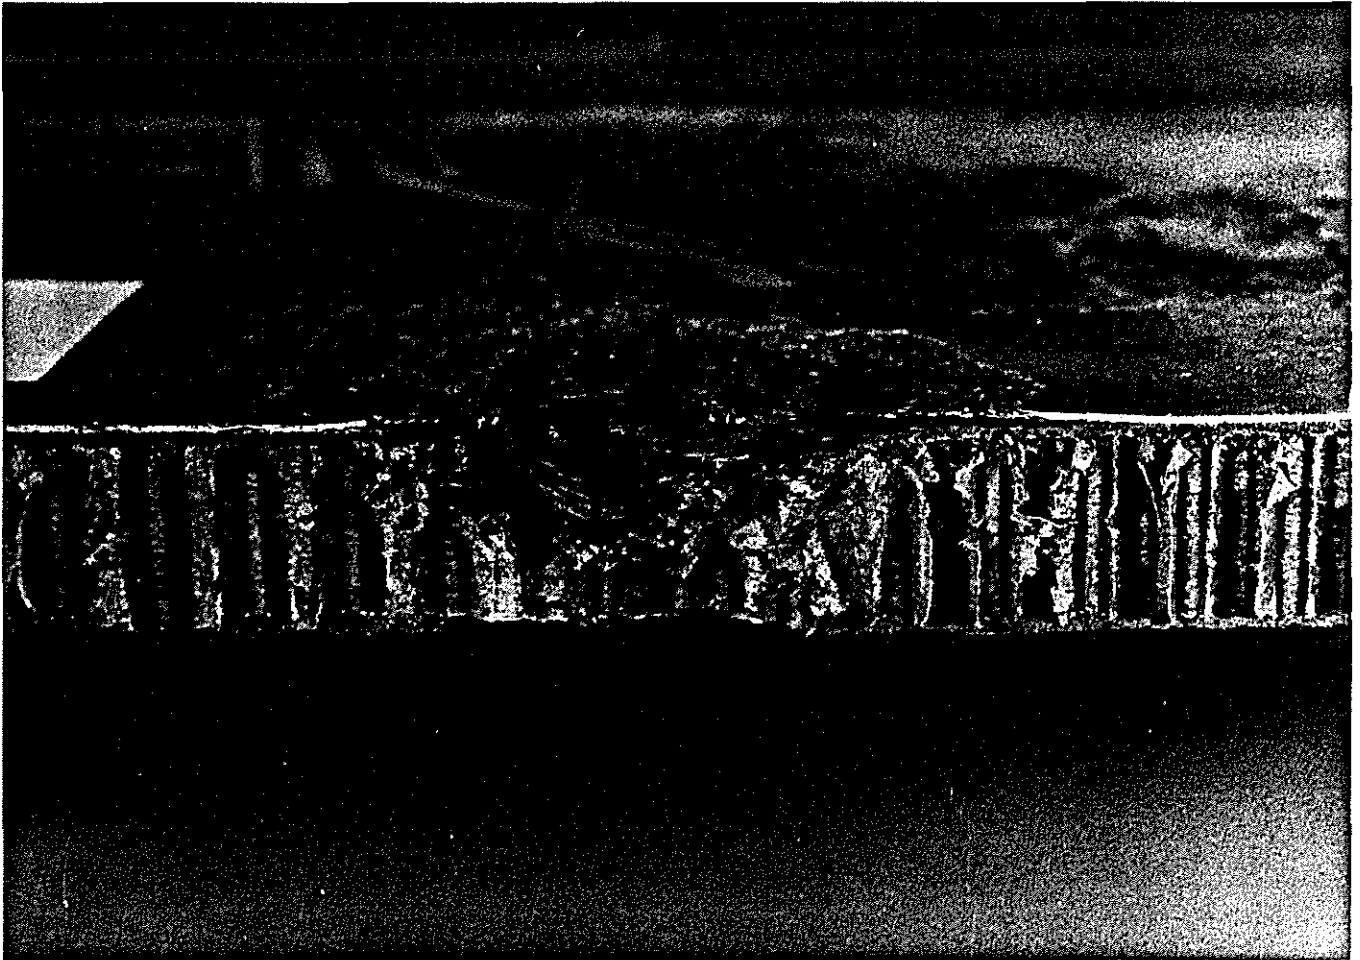
Panels protected with aluminized fabric are punctured at the second test level. Fig. 7 shows the effects of a 105 kA pulse.

Fig. 7. Arc impact tests. Damage caused by a 105 kA strike to a painted sandwich panel protected with TEF 7.

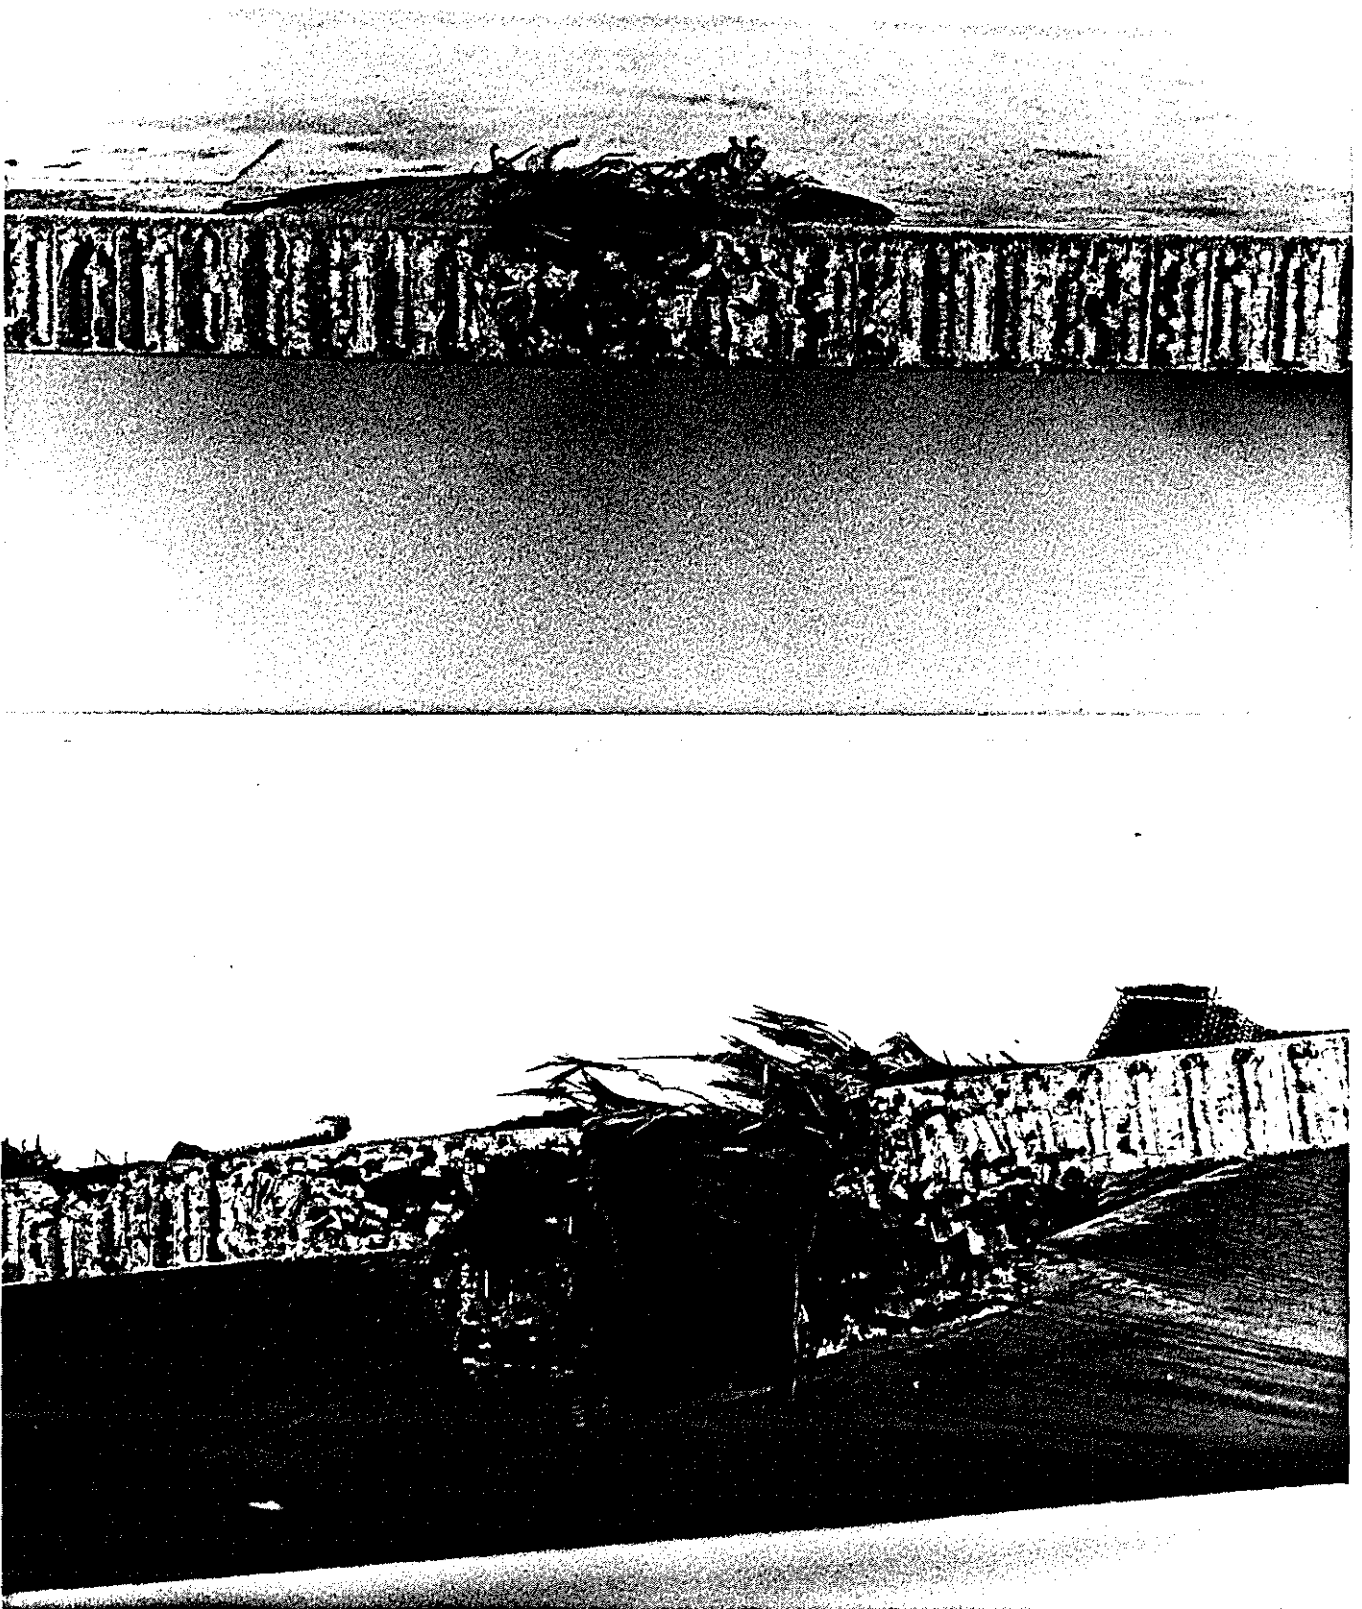
External laminate of the panels protected with nickel coated fabrics is punctured at the first current level. At the second current level the panel is completely punctured. The further increase of the test current causes only an increase in the area of the damage to the honeycomb. Fig. 8a, 8b show the effect of a 53 kA and of a 186 kA pulse.

Fig. 8. Arc impact tests. Damage caused by a 53 kA (a) and by a 186 kA (b) strike to a painted sandwich panel protected with nickel coated fabric.

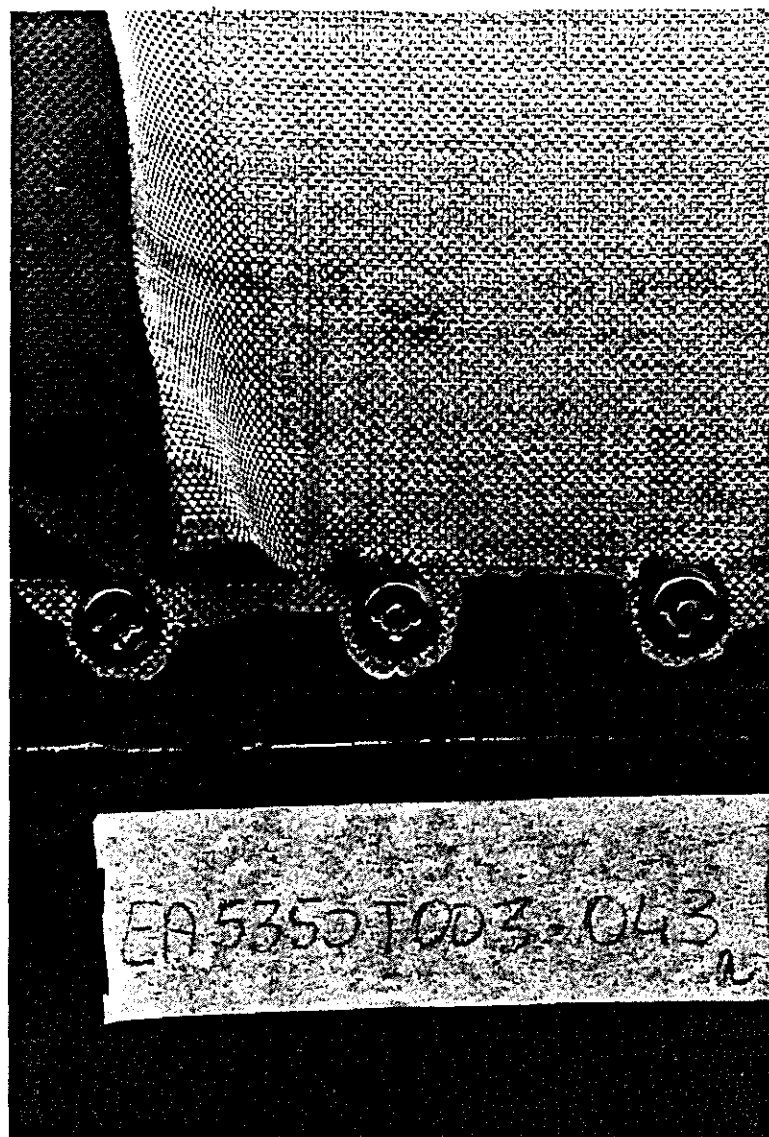
-For the rivetted joints the maximum damage to the laminate consists in a local delamination of the first layer in a very narrow zone around each head of the rivets with local tufting. This damages is larger in case of painted panels. The typical damage to the protection layer consists in cut of the fabric between the rivets, this damage is larger in the case of nickel coated protection layer. In fig. 10 an example of damage to this type of joint is given.

-In all the tested joints the fourth level of test current causes sparks at the joint. In glued panels, in some cases, these sparks cause a local burning to the last layer of the laminate.

-In all the cases no signs of reduction in the structural strength of the joint has been recorded.

Fig.10. Joint analysis tests. Damage caused by the conduction of a 200 kA strike to a painted jointed panel protected with nickel coated fabric and jointed to a aluminium sheet with ten titanium blind rivets. The paint has been removed by the current.
