# High Speed Gears Overheating due to Lubrication

## 2. CASE 1 – MGB INPUT MODULE

## 3. CASE 2 – Nose Gearbox

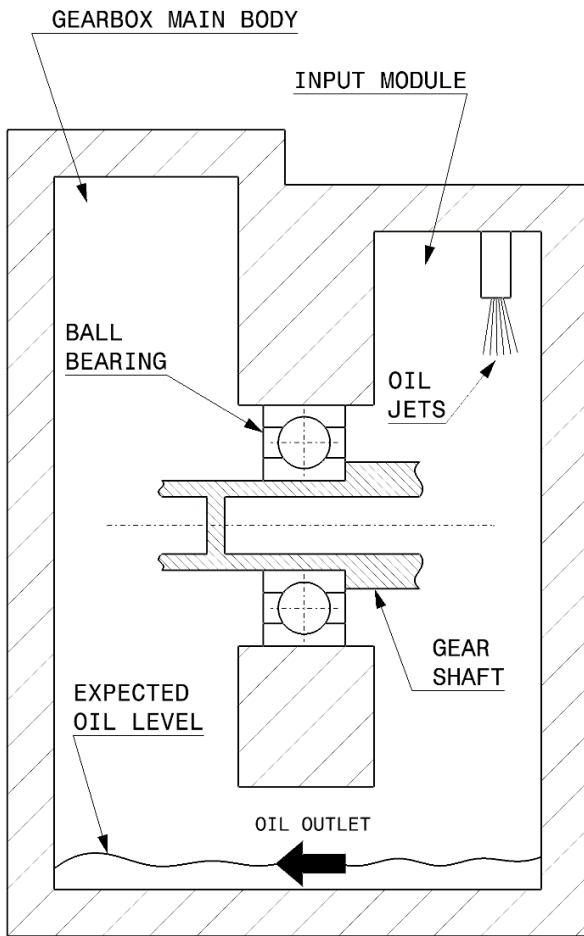
Figure 1: Case 1, a schematic of the system

peripheral speeds reach the highest values. A simple gearbox schematic, as shown in figure 1, is ideal to explain the phenomena that caused the issue.

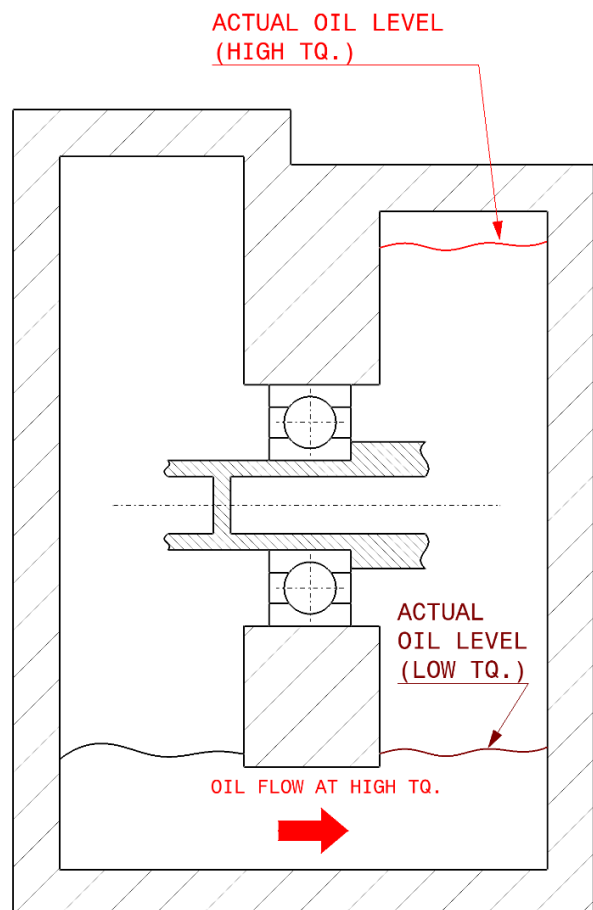
Figure 2: Case 1, measured oil levels

Based on this first evidence, a more thorough testing activity was carried out; since the bearing temperature appeared very high only in one of the two input stages the attention was focused on that specific area. The stage was provided with dedicated means to evaluate oil level inside its case; a normal operating stage would show low oil level inside, whereas the presence of a significant oil level would highlight some oil outflow issue. Running the test with such equipment revealed an even more puzzling behavior: the oil level trapped within the input stage was initially higher than expected, but still quite low; however, it suddenly raised when torque was increased, up to filling the whole housing, as shown in figure 2:

This observation readily accounts for both general and localized bearing overheating; however, its underlying cause is not immediately evident. The

gearbox does not incorporate any torque-dependent lubrication mechanisms or features, making a torque-related variation in oil level difficult to justify. A focused examination of the gearbox design allows to take some steps forward in understanding the causes of the issue. The first critical observation is that the entire input module oil outlet flow must pass through a relatively wide opening located at the bottom, as shown in figure 1. According to the original design intent, air pressure equalization between the input stage compartment and the rest of the main gearbox should have been ensured by airflow through the bearings and/or the upper portion of the oil outlet, which is expected to be only partially occupied by the oil stream. Unexpectedly, tests results indicate that the oil level fully occupies the outlet duct cross-section, thereby obstructing air passage through this route. Based on these findings, it can be inferred that air pressure balance is also not ensured by flow through the bearings. As a consequence, the following phenomena are believed to be occurring within the gearbox:

- 1) when the oil level reaches the oil outlet opening upper wall air pressure balance is lost;
- 2) in this condition, air pressure in the first stage case and in the rest of the MGB are no longer balanced.
- 3) an MGB temperature increase (such as that generated by torque increase) causes an air expansion within the MGB main body.
- 4) due to the limited flow capacity of the gearbox breathers, thermal expansion of the air results in a pressure increase within the input module.
- 5) this translates into a backpressure effect which forces oil back through the input module oil outlet opening and into the module, rather than allowing it to exit as intended.
- 6) oil accumulates within the input module, significantly increasing power losses and operating temperatures

Although not all aspects of this sequence of events could be conclusively verified, this was selected as the only plausible explanation for a torque-transient-dependent oil level within the input module.

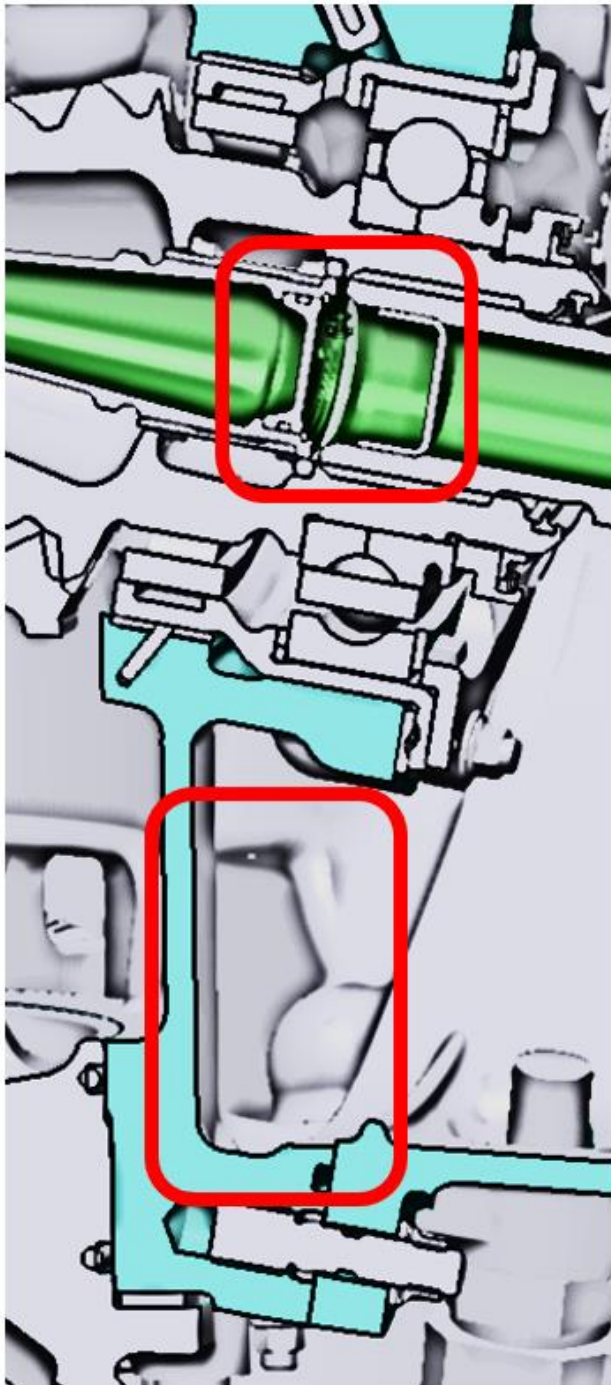
Figure 4: Case 1, the real components

For the sake of clarity, figure 4 provides a detailed view of the area so far described highlighting the plugs that had to be drilled and the outlet area.

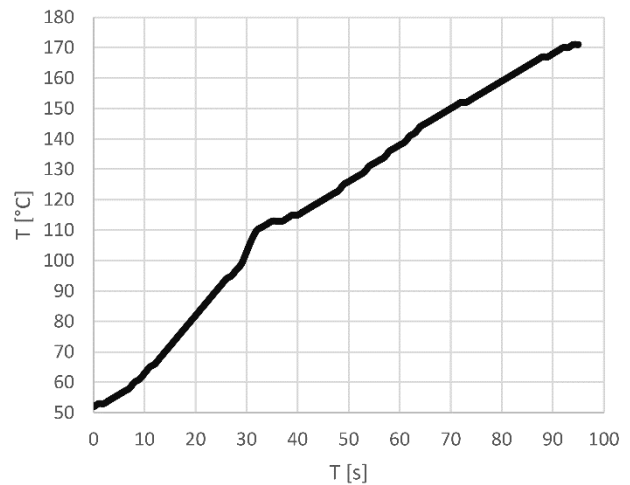
Figure 5: sharp increase in bearing temperature

The issue appeared in terms of pinion bearings overheating. More specifically, temperature on bearings increased very steeply, exceeding  $170^{\circ}\text{C}$  in less than two minutes with no signs of stabilization. This is shown in figure 5, which reports the thermal behavior during a test run at idle speed ( $\approx 80\%$  of nominal rpm) with no power flow through the gearbox. Operating at full speed and full power would have resulted in significantly higher temperatures. Under such

conditions, use of the input stage must be avoided to prevent component damage. Consequently, dedicated investigations and testing across multiple configurations are required.

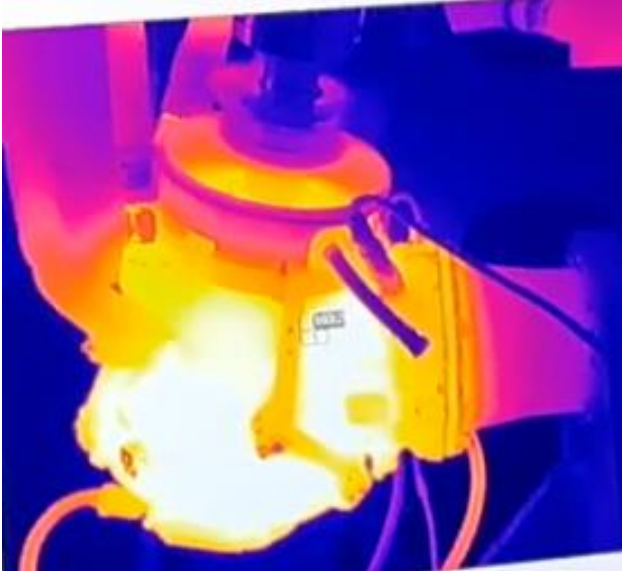
Figure 6: Case 2 thermal imaging showing generalized overheating

In a second phase of the investigation, temperature distribution maps provided by thermo-imaging were also employed, as shown in figure 6. Based on these and other data, it was generally concluded that the issue was associated with the restricted clearance between the gear baffle and the upper section of the input stage housing, as shown in figure 7. According to this initial hypothesis, oil would find obstructions in going past the gear baffle during its path towards the sump. This led to the proposal of increasing the gap

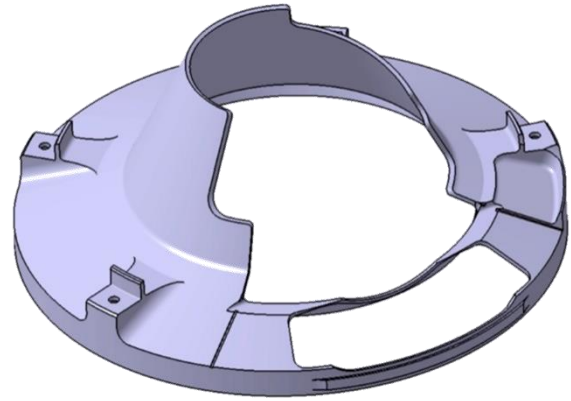
Figure 8: Case 2 improved baffle, full gear protection

between the baffle and the housing, introducing holes in the gear web and even considering the addition of external oil drainage ducts. A revised baffle design (shown in figure 8), providing an improved shielding of the whole gear, was 3D printed and (unsuccessfully) tested.

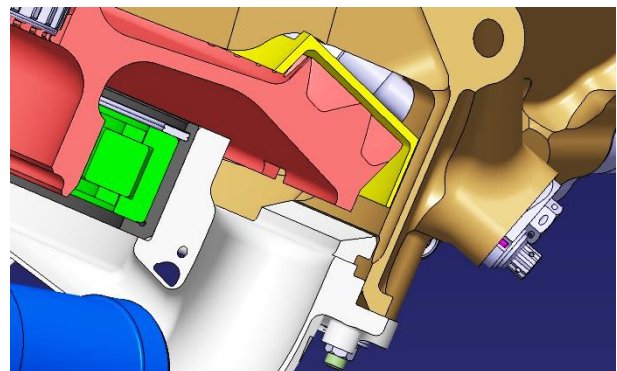
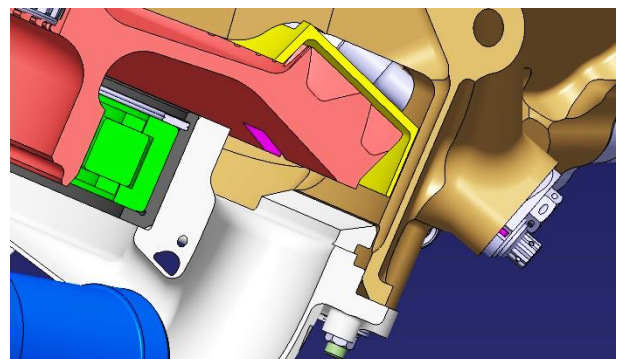
Several parts were modified and tested, and none provided a sizable advantage except for a small modification at the bottom of the gear profile shape as shown in figures 9 and 10. Starting from this observation, the idea of an unexpected root cause started to take shape. The issue was likely not attributable to windage generated by the gear teeth or to oil being obstructed from passing beyond the gear, but rather to the fact that the back of the gear (even if axis-symmetric) would induce a windage pattern that ultimately impeded the oil from reaching the duct that leads oil to the scavenge pump.

Figure 9: Case 2, the gear prior to modification

Figure 10: Case 2, the gear after modification
