# EXPERIENCE OF VIRTUAL SIMULATION OF AIRCRAFT ACCIDENTS RELATED TO STRENGTH PROBLEMS

Yuri Aleksandrin, Vladimir Grigoryev, [vgrigoryev@mi-helicopter.ru](mailto:vgrigoryev@mi-helicopter.ru),  
Mil Moscow Helicopter Plant (Russia)

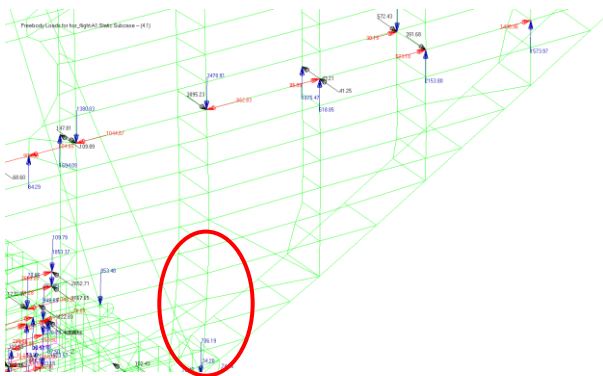
A task of residual strength investigation of heavy Mi-26 helicopter was performed. The structure got an in-service damage of one of main frames (Figure 2 - 3). The stress state changing due to this damage and load paths redistributions were analyzed. The conclusion was given about possibility of single safe flight of the aircraft to a place of repairing; requirements to flight condition (weather, aircraft configuration, maneuvers limitation) were developed.

Figure 2. Load distribution in damaged area.

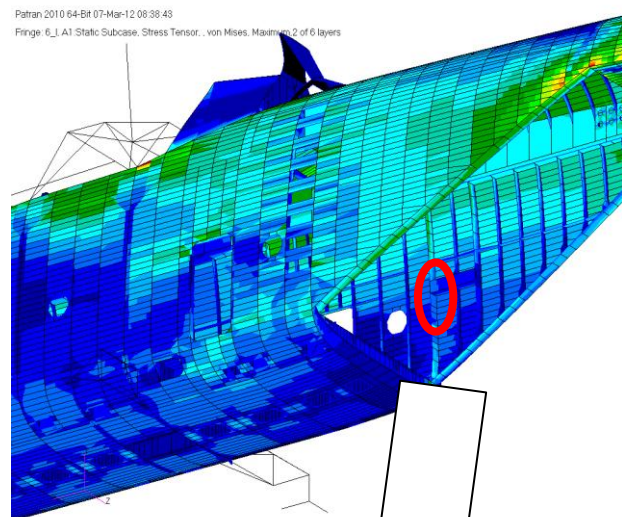
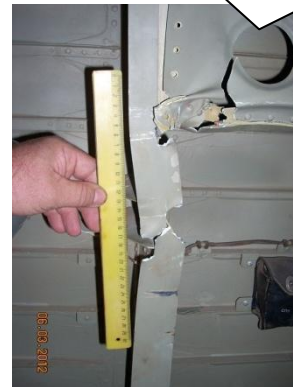
Figure 3. Stress-strain state of structure received in-service damage

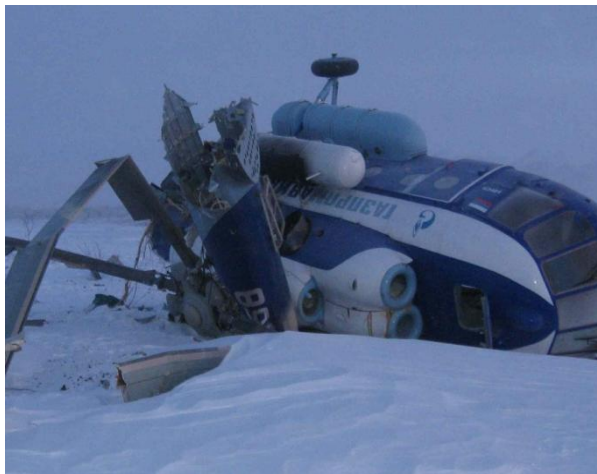
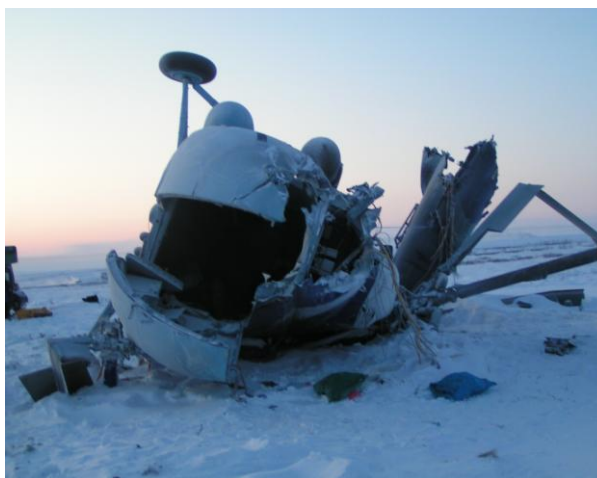
Flight accident at Vorkuta, (19.12.2009) was investigated. Residual strength and damage dimension estimations were performed; loading during the crush landing was simulated. Pictures of destroyed structure are given in Figure 4.

Figure 4. Views of aircraft structure at site of FA.

The main goal of the work was estimation of possibility of structure repairing for returning to service. Analysis results showed what such repair is possible under conditions when NDI results in areas, localized by means of simulation (Figure 6), are positive, and leveling results are positive too.

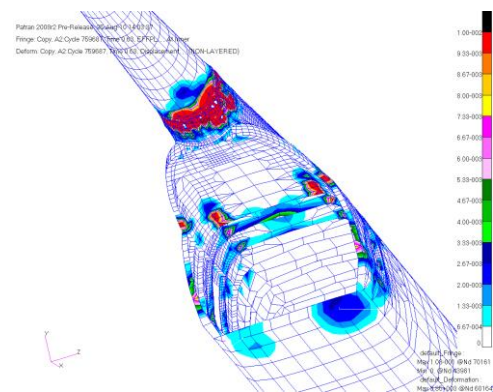
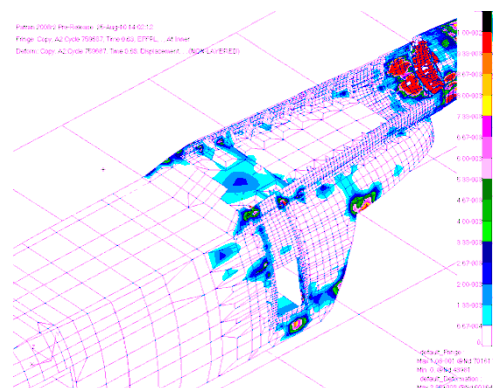
Figure 6. Plastic strain distribution

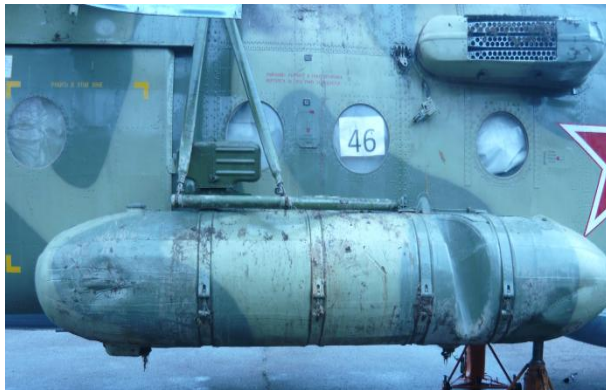
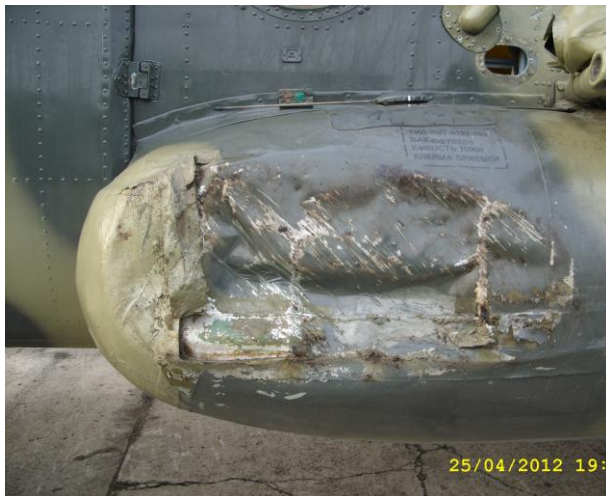
It can be see very close agreement between simulations and real FA pictures.

Figure 11. Deformed state of tank structures after real rollovers

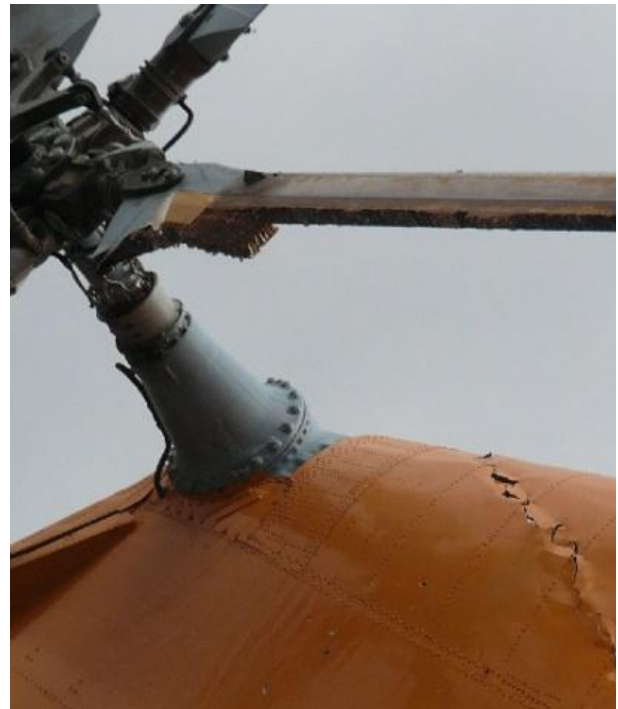
Figure 12. Damaged tail rotor blade and fin.

It was discovered what main cause of structure damage was tail rotor disbalance, forced with detachment of part of tail rotor blade. The followed process can be characterized as having short overload (release of elastic energy), excitation of

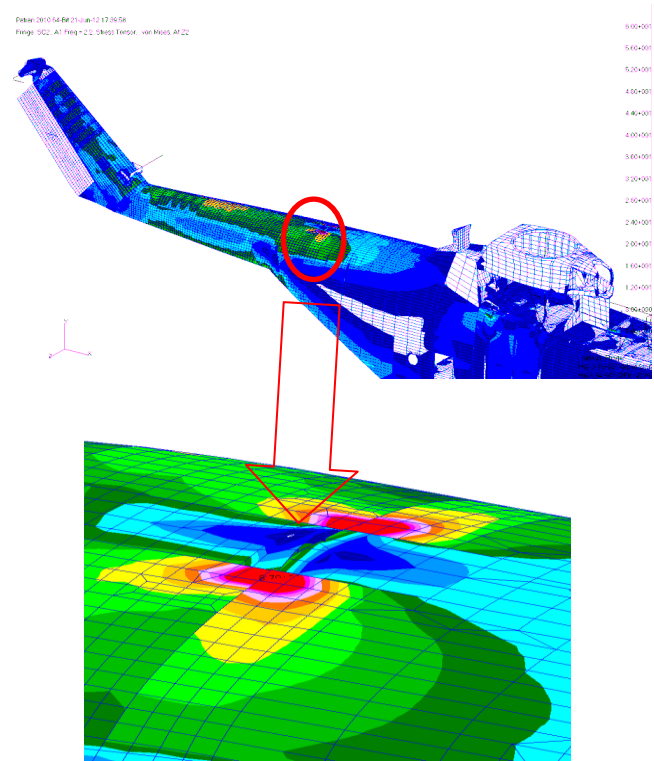
Fractography analysis shows, what fatigue damages were present in the skin at the area of frame #33. Fatigue crack growth to a state of critical length was taken place due to coincidence the number of adverse factors:

- Bad quality of repairing
- Insufficient material properties of structure skin (skin material - Al-Li allow 01420);
- Unacceptable quality of structure inspection in service. The crack, having length about critical, should be once and again detected during walk-around inspections.

It was pointed out, what during regular inspection (in on-ground position) the crack has open state; it should alleviate crack detection.

Figure 17. Stress and deformed state of cracked structure.
