OLD AIRCRAFT, NEW FAILURES

Miss Bernice Robinson BEng (Hons) MSc DIC AMIMEchE

Key words: Aging aircraft, failure mechanisms

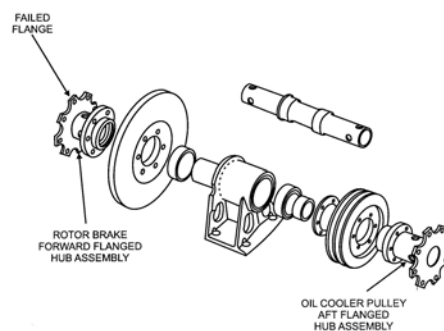
The accident occurred shortly after take-off when the helicopter lost its yaw control and the initial on-site examination of the aircraft identified that there had been a failure of the forward flange assembly of shaft section 2. This flange assembly connected the Tail Rotor Drive Shaft (TRDS) section 1 from the Main Rotor Gearbox (MRGB) to the rotor brake on the TRDS section 2, Figure 2. Its roles in the system were to transmit drive via the TRDS to the intermediate gearbox and when rotor brake was applied, to carry the retardation loads from the brake to the MRGB.

Figure 2: Schematic view of Shaft Section 2 showing assembly detail and location of the failed Hub.

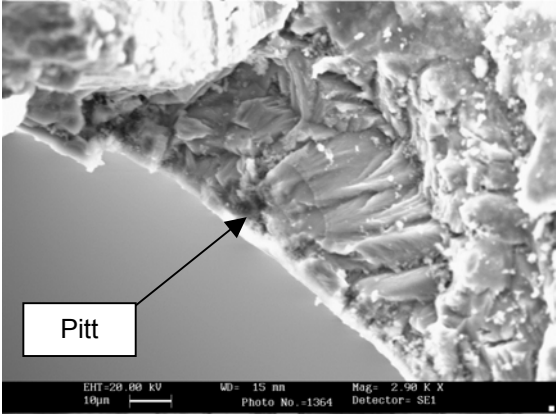
The examination of the fracture surfaces on the flange section of the Hub showed that the fracture paths had generally followed the radius of the flange/hub change of section and their overall appearance indicated a slow growing failure mechanism with the cracks having been in existence for some time prior to final failure. Examination under magnification revealed that the fractures were associated with the pitting noted on the anodised face and that there was evidence of secondary cracking. Features also were identified which were consistent with multiple crack initiation sites around the radius of the flange/hub. Using a Scanning Electron Microscope (SEM), SCC was identified as the prominent crack propagation mechanism that originated at the pitting (Figure 4), with small areas of fatigue interspersed.

Figure 4: SEM view showing crack initiation and propagation from corrosion pit

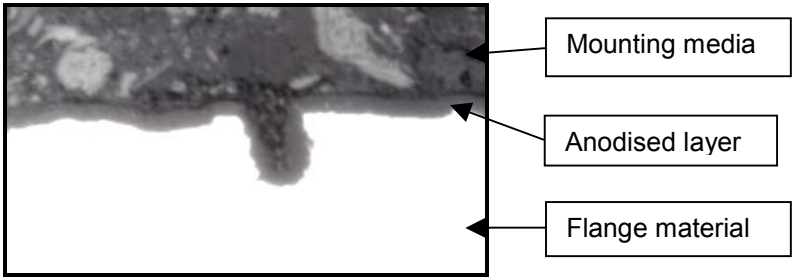
Sections were taken through the hub and flange, polished and etched which revealed the forging structure and anodising. Thus revealing that the corrosion pits had been present before the final stages of manufacture, as the anodised layer was present within the corrosion pits (Figure 5). The etched microstructure also showed that the grain structure was highly orientated across the flange thickness at 45° from the vertical (left, Figure 6) and that the corrosion pitting was associated with the exposed end grain structure, as the deeper pits followed the same 45° path (right, Figure 6).

Figure 5: Micrograph showing the anodising layer inside one of the corrosion pits.

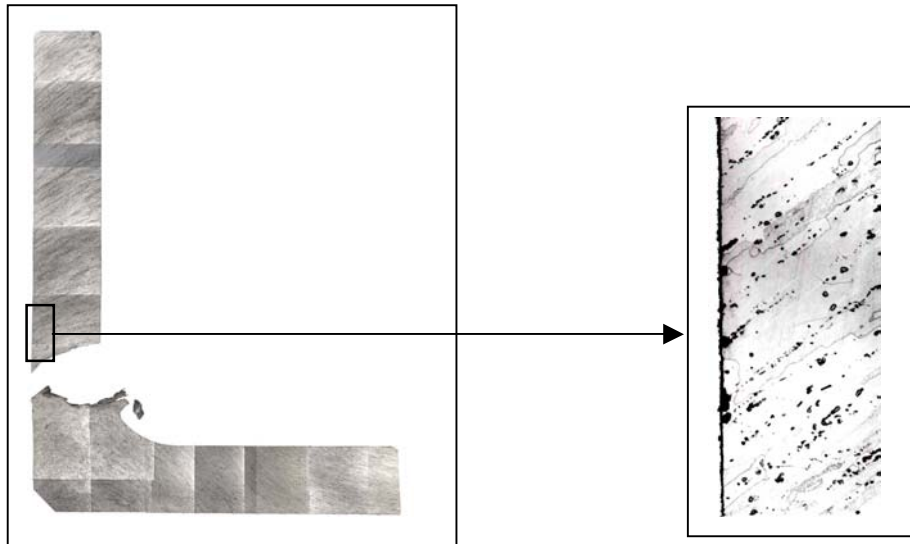
Figure 6: Micro-section of failed hub showing (on left) highly orientated grain structure from forging and (on right) corrosion pits orientated along grain structure.

Comparisons were then made to Hubs both from the same batch as the failed one and to those from other batches. It was found that other components from the same batch displayed similar pitting and grain structure orientation, thus it was likely that they would have a similar susceptibility to SCC. Hubs from the previous batches, were found to have some pitting but not to the same extent as the newer Hubs. The most marked difference was however the lack of the highly orientated grain structure that had been noted on the newer Hubs. It was discovered during the investigation that the machining of the forgings for the latest batch of hubs had been conducted off-axis, thus resulting in the highly orientated grain structure in the flange section of the hub that had significantly increased the components susceptibility to the SCC failure mechanism. The manufacturing faults had occurred because instructions on exactly how to machine the component had not been implicitly stated on the old hand produced part drawings and some of the technical expertise of forging master skills had deteriorated since the 1950s when the part was first manufactured.

It was determined that the flange had failed due to a combination of factors and that it would not have occurred if any of the individual factors were missing, these factors being the

susceptible alloy, the orientated grain structure, the pitting and the axial loading. Therefore if one or ideally more of the factors could be removed, then the rest of the helicopter fleet should not suffer a similar failure. It was not practical to change the component material to a more SCC resistant alloy as there was only a limited length of time for the fleet to remain in service. But it was possible to examine all of the aircraft within the fleet to ensure that the components were correctly shimmed, to establish that no other hubs had cracked and it was recommended that where possible hubs manufactured before the 1996 batch should be used.
