TWENTYFIFTH EUROPEAN ROTOCRAFT FORUM

Paper n° M9

**DAMAGE RECOGNITION IN GEAR BOXES FOR
HEALTH AND USAGE MONITORING**

S.Emmerling
EUROCOPTER DEUTSCHLAND GmbH, München, Germany

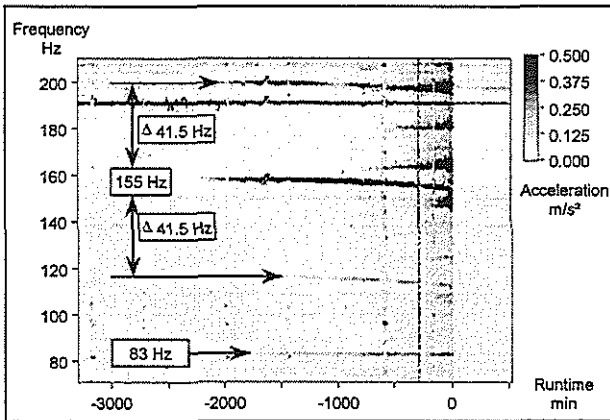
Figure 8: Low Frequency Amplitude Spectrum of Step 0 in Table 2

The low frequency spectrum in Figure 8 shows shaft rotation frequencies and their harmonics as well as modulation phenomena as damage symptoms. The amplitudes of the second harmonic of the fenestron output shaft frequency at 83 Hz increase with the progressing damage. However, the level remains relatively low. More obvious is a modulation which is excited with the shaft frequency. It is marked by the modulation carrier with 155 Hz and two side bands spaced at 41.5 Hz above and below the carrier frequency.

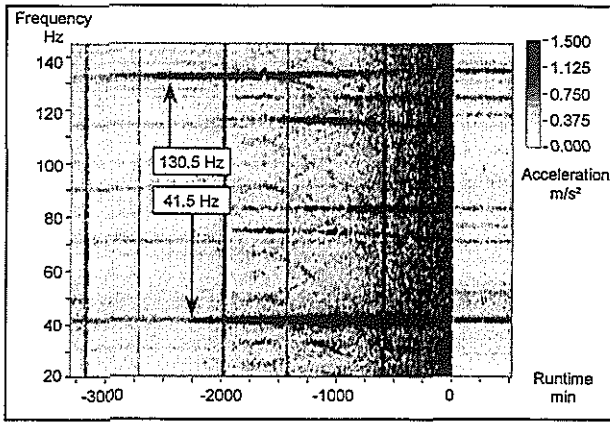
Figure 12: Envelope Spectrum of Step 0 in Table 2

The observation of the envelope spectrum in Figure 12 allows the best way to localize the damage. The increasing amplitude values at 130.5 Hz beginning at -2500 min clearly identify the shock sequence of the outer bearing race. At about 250 minutes later also the rotation frequency of the fenestron output shaft at 41.5 Hz shows higher amplitudes. If the spectrum is analyzed up to 1200 Hz the higher harmonics of the shock sequence frequency and the shaft frequency can be observed to increase at -2500 min and -2250 min respectively.

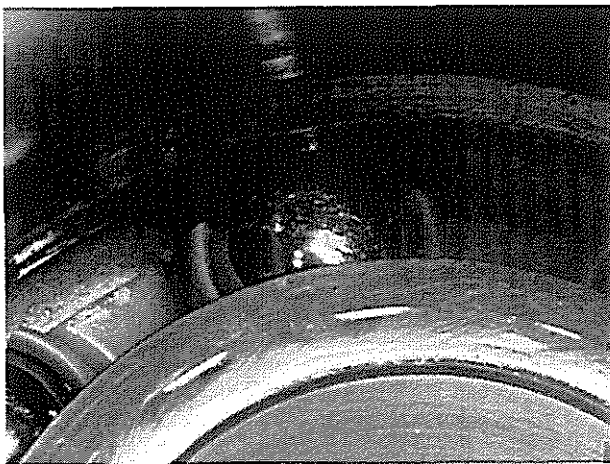
Figure 14: Damaged Bearing No 13

Test step 0 was a test run started for the purpose of a fatigue qualification test but was used for the setup and calibration of the monitoring system. The input load applied during this run is slightly above the theoretically maximum torque to be expected in service but is not sufficient for creating damages to the gears. During this run the emerging damage of a bearing (No. 13 of Figure 4) of the fenestron output shaft was detected by the vibration monitoring system.

The disassembly inspection of the transmission showed slight pitting damages on the balls and the races of the bearing no 13 (Figure 14).

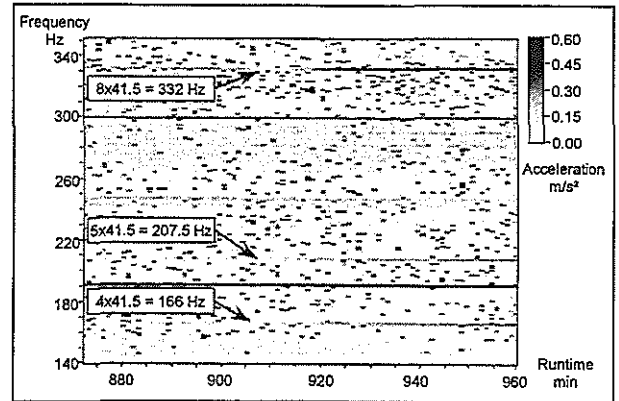
Figure 15: Low Frequency Amplitude Spectrum of Step 1 in Table 2

- Figure 15 shows the low frequency spectrum with the significant increase of the 8th harmonic of the rotating frequency of the fenestron output shaft 41.5 Hz. Also for the 4th harmonic an amplitude increase can be detected.
- In the envelope spectrum of Figure 16 the shaft frequency and the trend of its 2nd harmonic also point at an anomaly of this component.
- Figure 17 depicts the pronounced increase of the acceleration values of the rotation frequency of the fenestron output shaft gained from the demodulated envelope.

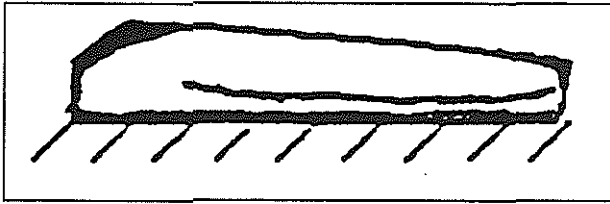
Figure 18: Sketch of Crack in the Output Bevel Gear

Three individual characteristics identified the damage at the fenestron output bevel gear (No. 4 of Figure 3):

The design of the output shaft made it possible to remove it easily from the transmission and to perform a visual inspection of the gear on site. Here no signs of a damage could be noticed. Only the dye penetrant investigation made the cracks visible in five of the 23 teeth of the gear. A sketch of one of the cracks is given in Figure 18.

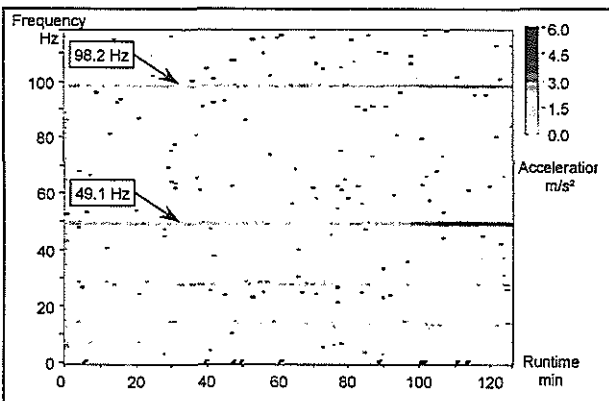
Figure 19: Envelope Spectrum of Step 7 in Table 2

As already experienced in the previous runs where damage recognitions were performed the assessment of the envelope spectrum shows the most significant features of damages. The envelope spectrum of step 7 shown in Figure 19 reveals the damage of the input bevel pinion with the emerging of the 1st and 2nd harmonic of the input shaft frequency at 49.1 Hz and 98.2 Hz. The higher harmonics which are not shown in this figure experience the same increase of their amplitudes.

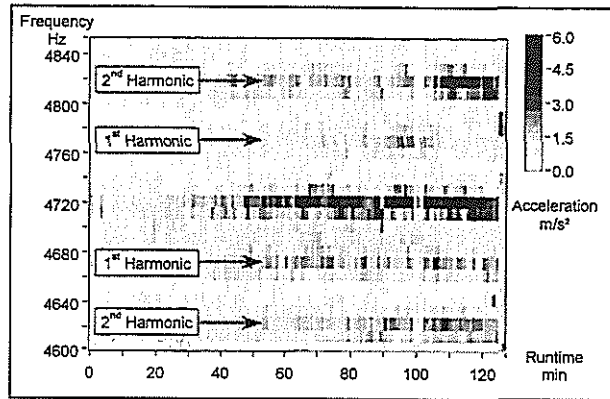
Figure 20: High Frequency Spectrum of Step 7 in Table 2

The high frequency spectrum in Figure 20 shows the increase of a modulation carrier frequency at 4720 Hz with side bands of the 1st and 2nd harmonic of 49.1 Hz related to the input shaft frequency. The second harmonics are more pronounced than the first side bands. Although the damage leads to an increase of amplitudes in the envelope spectrum after minute 90 (see Figure 19) the modulation carrier of 4270 Hz can be recognized from minute 50 on.

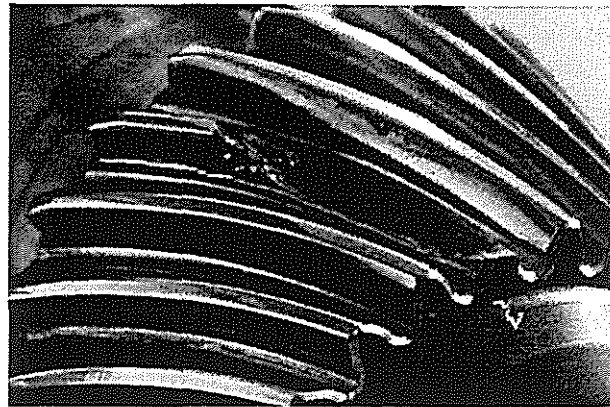
Figure 21: Tooth of the Input Bevel Pinion Failed in Step 7

In spite of increasing loads during the runs 2 through 6 no further damages could be created. To gain more measurements with damages for validating the diagnosis method two gears were artificially damaged. At three teeth evenly spaced around the circumference of the input bevel pinion No. 1 of Figure 3 and the output spur gear No. 7 of Figure 3 a groove was grinded at the tooth root radius. This area is the most loaded region of a tooth and was regarded as optimal for initiating a crack.

During this run a higher risk was taken to have the chance to observe the increasing crack of a gear tooth until the final fracture. Eventually one tooth of the predamaged input bevel gear broke off as shown in Figure 21.
