„Safe in the Sky“ Continuing Airworthiness Process at Eurocopter Deutschland

Eurocopter Deutschland GmbH, 81663 Munich, Germany

By means of a practical example, describing the rupture of a balance weight of a flight control lever of the tail rotor on an EC145 helicopter, the different process steps are shown and explained in detail. These steps start with the incident, along the occurrence reporting by the operator to the OEM, further to the different analysis and investigation steps which are subsequently leading to the definition of protective and corrective measures and finally to an information to all operators in order to accomplish actions for the affected helicopter fleet.

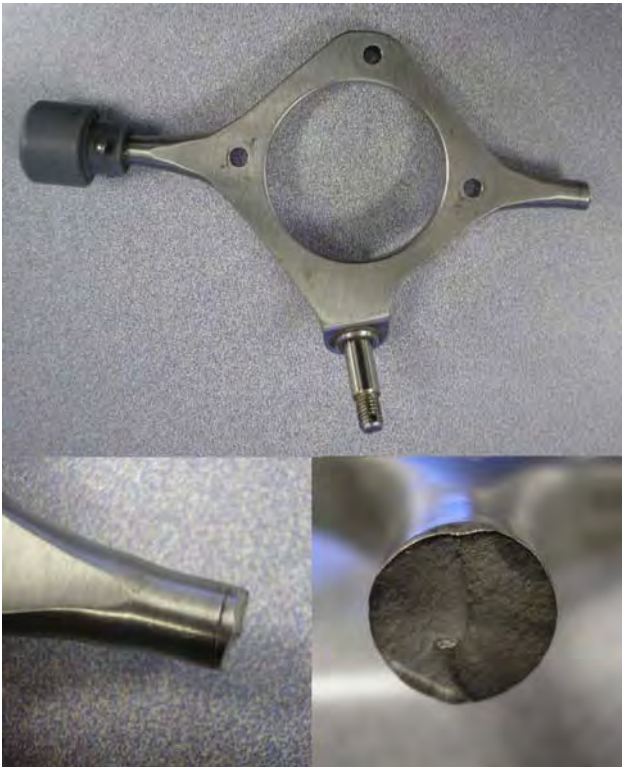
During cruise flight severe vibrations in the area of the tail rotor were recognized. Subsequently the pilot initiated a safety landing which was successfully finished without further events. A visual inspection of the tail rotor after landing revealed a rupture of one arm of the control lever and the loss of the attached propeller moment weight. In consequence, the rupture resulted in the reported vibrations.

Figure 10 shows the affected control lever which was immediately sent to the laboratory for further root cause investigation.

Figure 10. Rupture of the attachment arm of the propeller moment weight

The ASB contained the visual inspection of the control lever for possible mechanical damages in the area of the cotter pin and the contact area of the propeller moment weight. For this action, the removal of the propeller moment weight was necessary.

The first inspection was requested before the next flight, a further inspection 10 Flight Hours (FH) later and then in repetitive inspection intervals of 25 FH. Figure 11 shows an excerpt of the ASB which describes the actions to be performed.

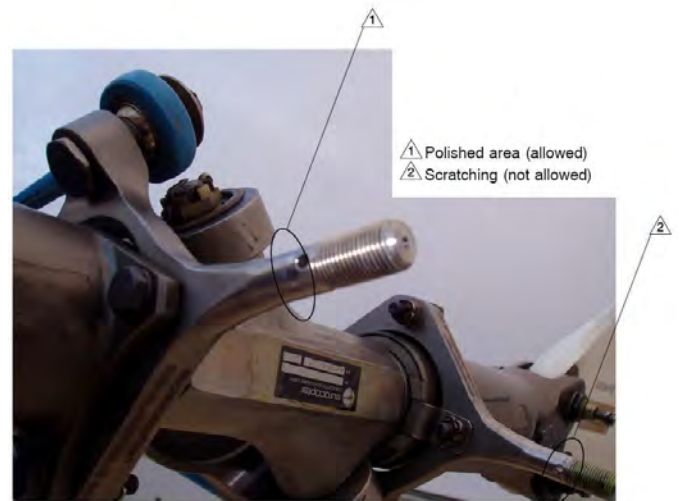
Figure 11. Visual Inspection of the control lever for mechanical damages

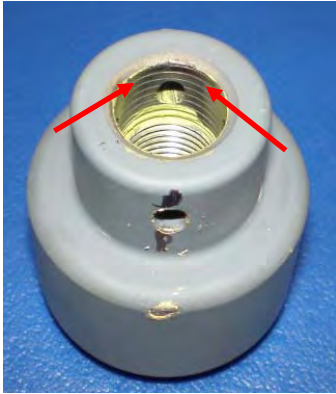
After removal of the second propeller moment weight of the damaged control lever, markings were found on the inner circumference of the close tolerance fit borehole which were caused by the thread manufacturing in the blind hole (Figure 12).

Figure 12. Markings on the inner side of the propeller moment weight

These markings could have imprinted on the control lever arm and have caused an additional stress concentration increase. The concerned components were analysed in detail at the EADS Innovation Works (IW) laboratory. Thereby the following results were achieved: the rupture was caused by at least two fatigue cracks (marked with red arrows) as shown in Figure 13.

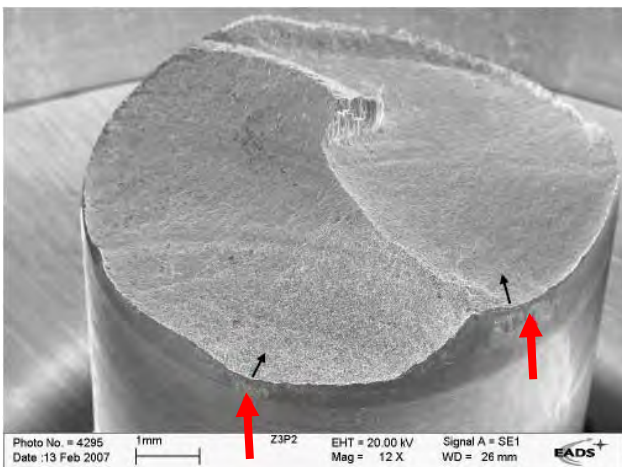
Figure 13. Rupture surface with two crack initiation points (red arrows)

The metallurgic investigation findings caused implications on the assessment of the existing design. The close tolerance fit between propeller moment weight and control lever arm which is in addition interrupted by the cotter pin borehole has a rather short length. Together with the eccentricity of the propeller moment weight centre of gravity, in relation to the close tolerance fit, the centering and fixing against tilting of the weight is not sufficient. The herewith allowed small tilting motions have caused fretting corrosion. At least one of the various surface cracks has subsequently grown under the dynamic bending stress and has finally led to the rupture of the control lever arm.

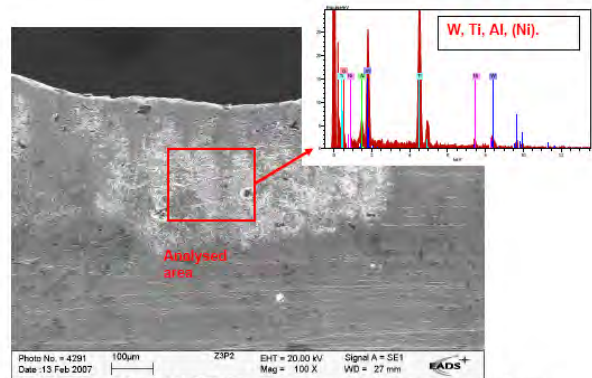
In the vicinity of the two corresponding crack initiation points are zones with significant fretting corrosion (Figure 14) which show various surface cracking indications (Figure 15).

Fig. 3.3: Control lever S/N 9078: The surface area of crack start 1 shows fretting corrosion. Abrasion from the weight (W... tungsten) can be registered.

Figure 14. Zone with fretting corrosion

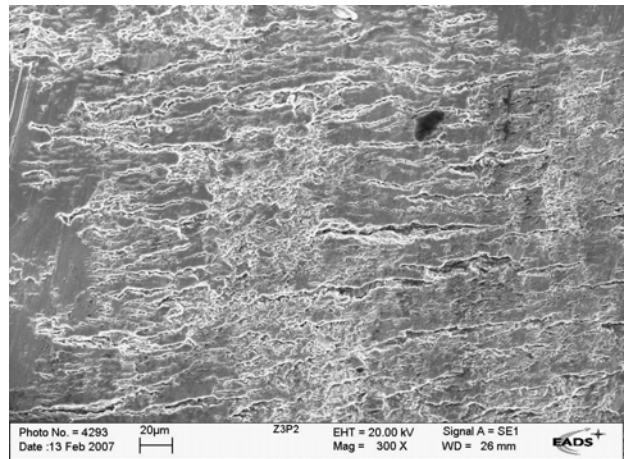
Figure 15. Surface cracks in the area with fretting corrosion

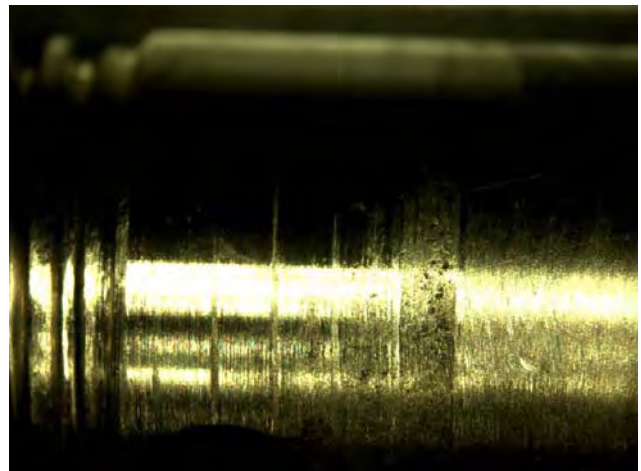
The EDX (Energy Dispersive X-Ray Spectroscopy) analysis conducted for the surface provided evidence of tungsten particles (coming from the propeller moment weight) attached to the surface of the titanium control lever. In addition the markings on the inner side of the propeller moment weight could be located and confirmed on the control lever arm (Figure 16).

Figure 16. Markings on the surface of the control lever

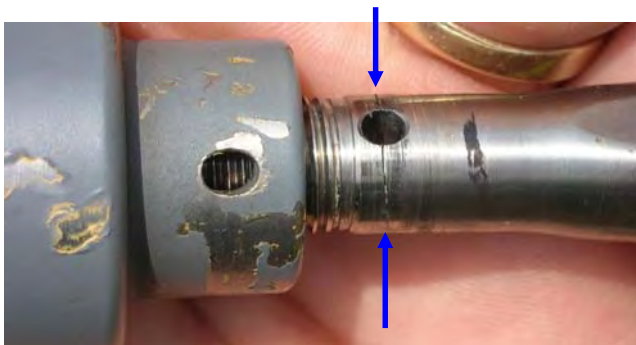
During landing approach of an helicopter onto a platform a rupture of a control lever arm occurred. This was recognized by the pilot through an increased vibration level, whereas the helicopter still remained fully controllable. After the successful landing, the broken arm of the control lever with the still attached propeller moment weight was found. The rupture appeared 23 flight hours after the last inspection that means within the allowed limit of 25 flight hours as described in the ASB.

In coordination with the national aviation authorities (NAA) of the affected operator and the national authority of the design organisation of the helicopter, the inspection interval for the control lever was reduced by the factor of 3, to allow also in case of an imperfectly conducted inspection the detection of mechanical damages before it could lead to an in-flight separation of the propeller moment weight.

Figure 17. Broken control lever arm in the area of the cotter pin borehole

The re-defined inspection interval of 8 flight hours was published with revision 1 of the ASB on 09.07.2007, followed by EASA AD 2007-0189-E on 12.07.2007.

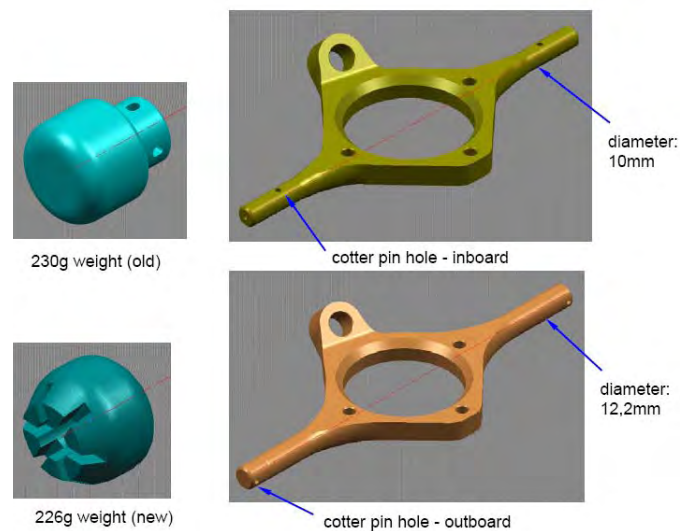
Figure 18 compares the modifications individually. Row one shows the initial design (affected by the ASB). Row two shows the improved control lever and propeller moment weight.

Figure 18. Comparison of the initial design (row above) and the improved design (row below)

- The diameter of the control lever arm was increased from 10 mm to 12,2 mm.
- The borehole for the cotter pin was moved outboard. To achieve this, the length of the arm was increased from 100 mm to 108 mm.
- The geometry of the propeller moment weight was improved and the close tolerance area to the control lever was increased by 55%.
- The contact surface between weight and control lever is treated with corrosion preventive paste prior to assembly.

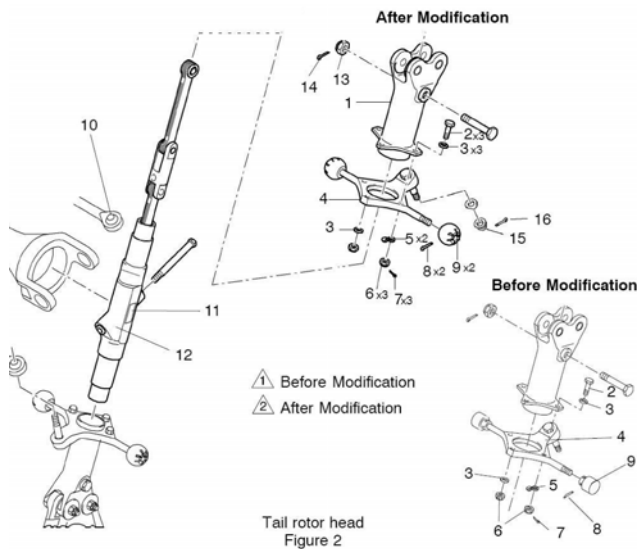
Figure 19. Introduction of the design modification by Alert Service Bulletin (ASB)

Figure 19 shows an excerpt of the retrofit documentation. To allow and describe the operators the necessary modifications, a new revision of the ASB was created, which requests the further continuation of the repetitive inspections until the implementation of the retrofit.

The 31.10.2007 was defined as due date until the retrofit has to be performed at the latest. From this date on no control lever is any more allowed in service which is listed under the inspection criteria of the ASB. The definition of such a concluding action is in general called "terminating action". To have these actions been conducted as mandatory actions by the operators, the revised ASB was also covered by EASA Airworthiness Directive AD 2007-0237 on 31.08.2007.
