EH101 - MAIN ROTOR HEAD COMPONENTS EVALUATION OF THE DAMAGE TOLERANCE CAPABILITY

M. Biasini - Stress Engineer - Rotor Dept.
U. Mariani - Senior Stress Engineer - Fatigue Dept.
F. Oggioni - Senior Stress Engineer - Rotor Dept.

AGUSTA s.p.a.
C. Costa - Italy

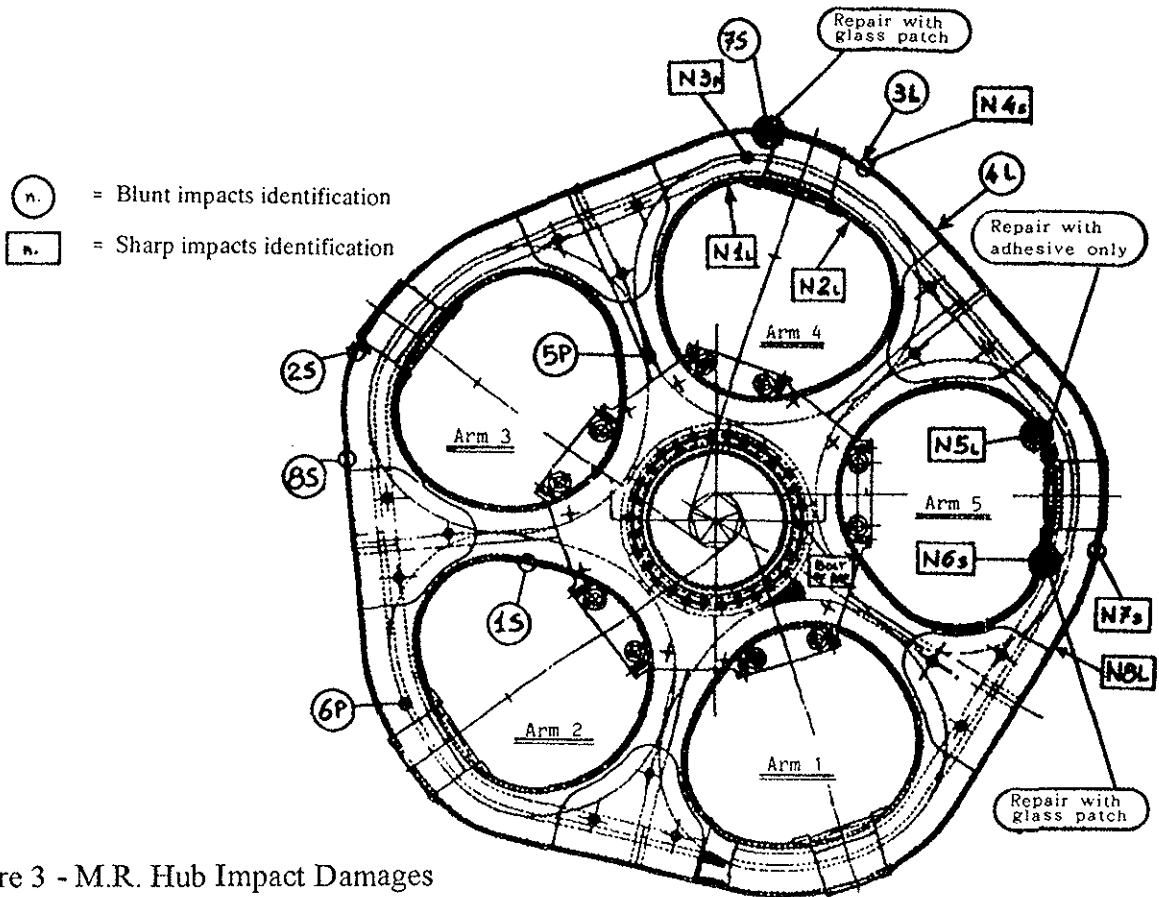
No damage growth in the service life was proved by tests in composite parts, which were impacted at 50J with a spherical impactor $\phi=25$ mm, for Barely Visible Impact Damages (BVID), and with a 90° pyramid, as a sharp tool, for Clearly Visible Impact Damages (CVID), figure 3. In addition, relevant scratches and delaminations in the glass wrap due to amplified loading of safe life test proved a slow flaw growth in the start-stop cycles of the D.T. test, and no damage growth at flight loads, figure 4.

Figure 3 - M.R. Hub Impact Damages

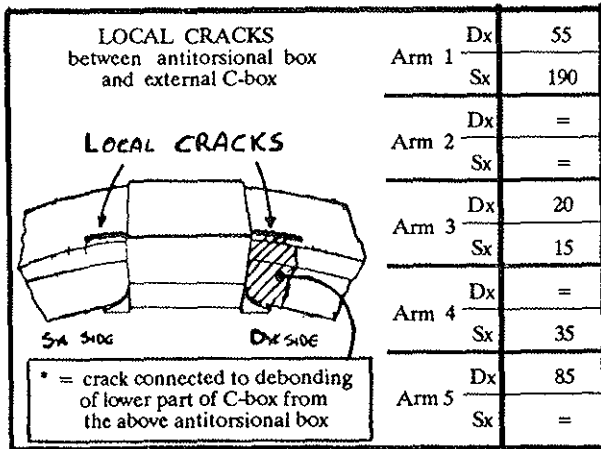
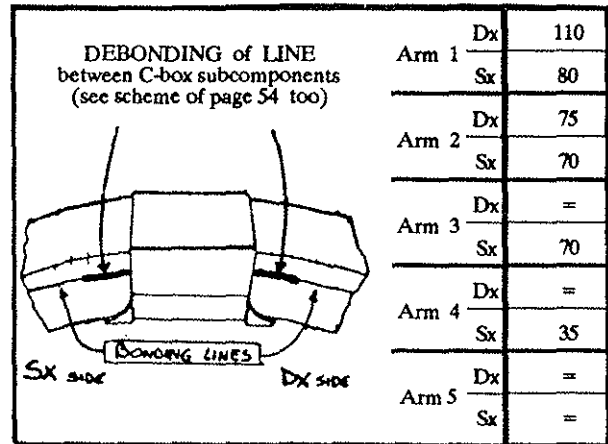
Type of DAMAGES - damages extension in mm

Figure 4 - M.R. Hub Damages after Safe Life Test

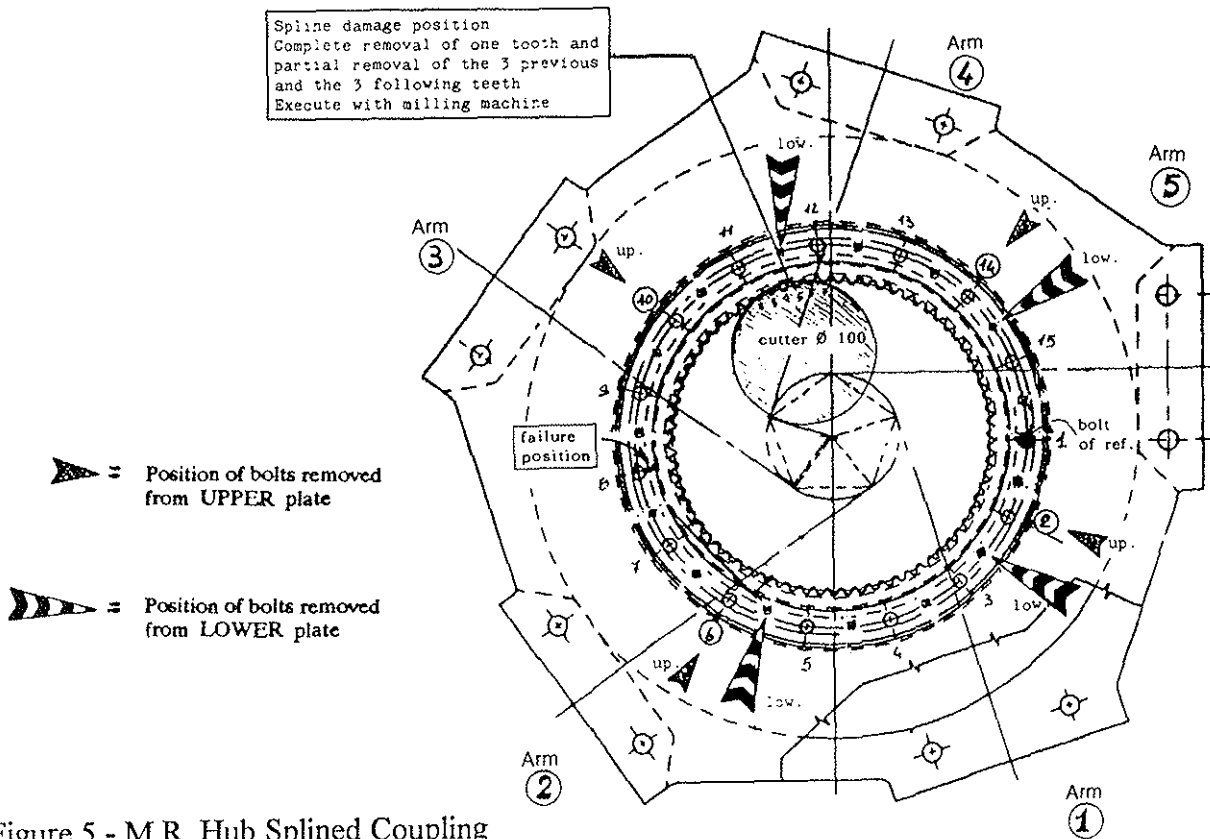
After the safe life test, tolerance to fretting in the titanium splined core was checked removing the solid lubricant and 10% of the Hub teeth in the splined coupling with the M.R. Mast and testing again at amplified Torque equal to safe life test, see figure 5.

The component could sustain the same loading cycles without failures.

Figure 5 - M.R. Hub Splined Coupling

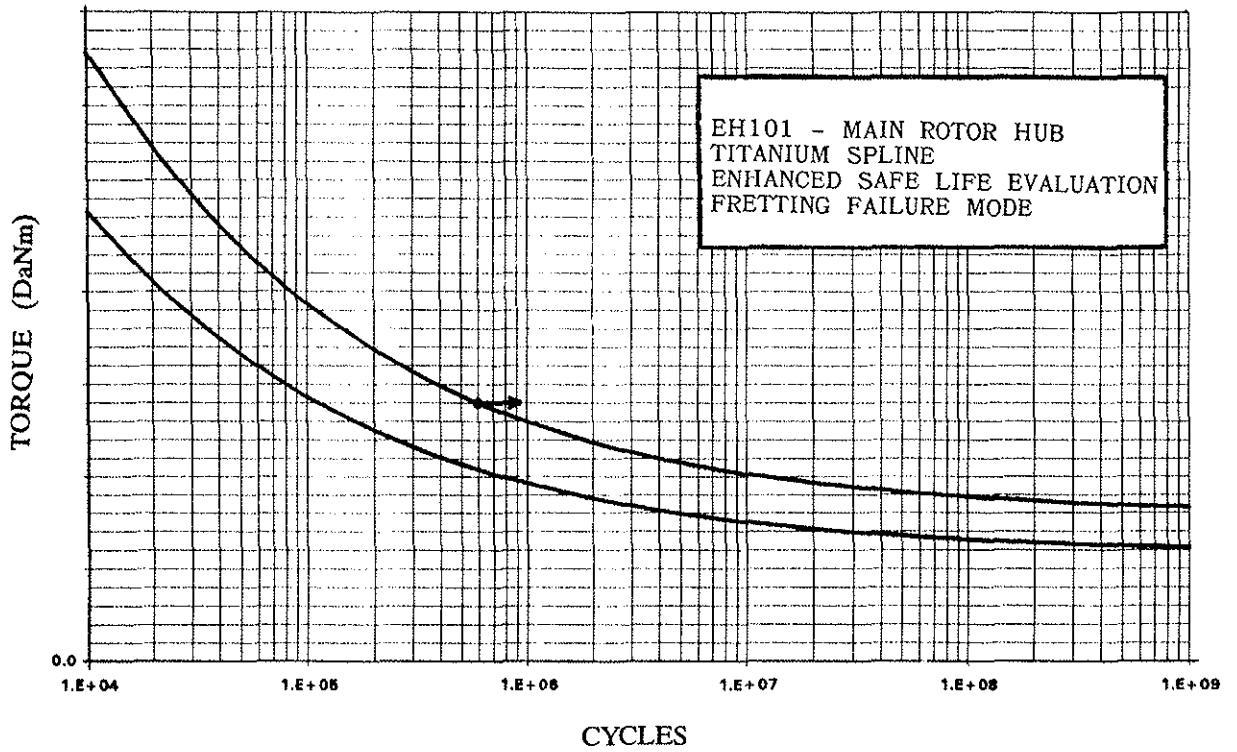
The S/N curve for the fretting failure mode was computed using a two mean standard deviation reduction for the Enhanced Safe Life evaluation, instead of the standard three standard deviations used for pristine components, considering structural redundancy and the relevant flaws under test, figure 6.

Figure 6 - M.R. Hub Splined Coupling - S/N Curves for Enhanced Safe Life Evaluations.

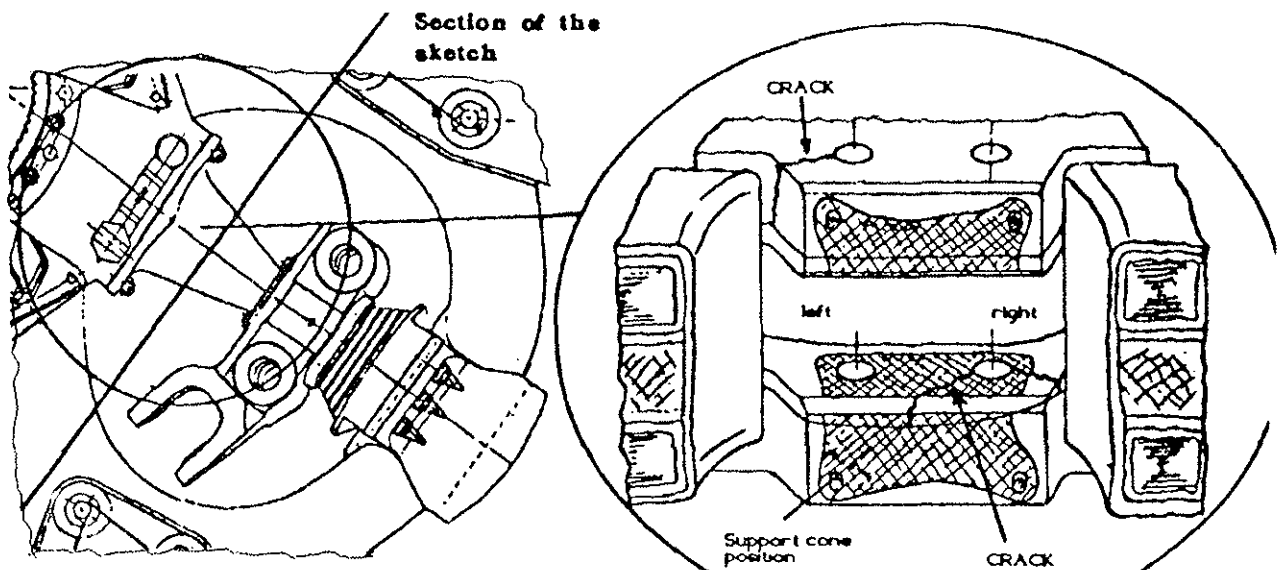
Flaw tolerance of the Aluminium Upper and Lower Plates was checked removing 4 out of 15 bolts on both plates in the spline area and testing the Support Cone coupling area with relevant cracks and fretting due to the previous safe life tests, figure 7.

Also for this case the S/N curve was computed for the Enhanced Safe Life evaluation.

The residual fatigue life computed according to these data is used to establish in service inspection intervals.

Figure 7 - M.R. Hub Flaws in Aluminium Plates and Titanium Core

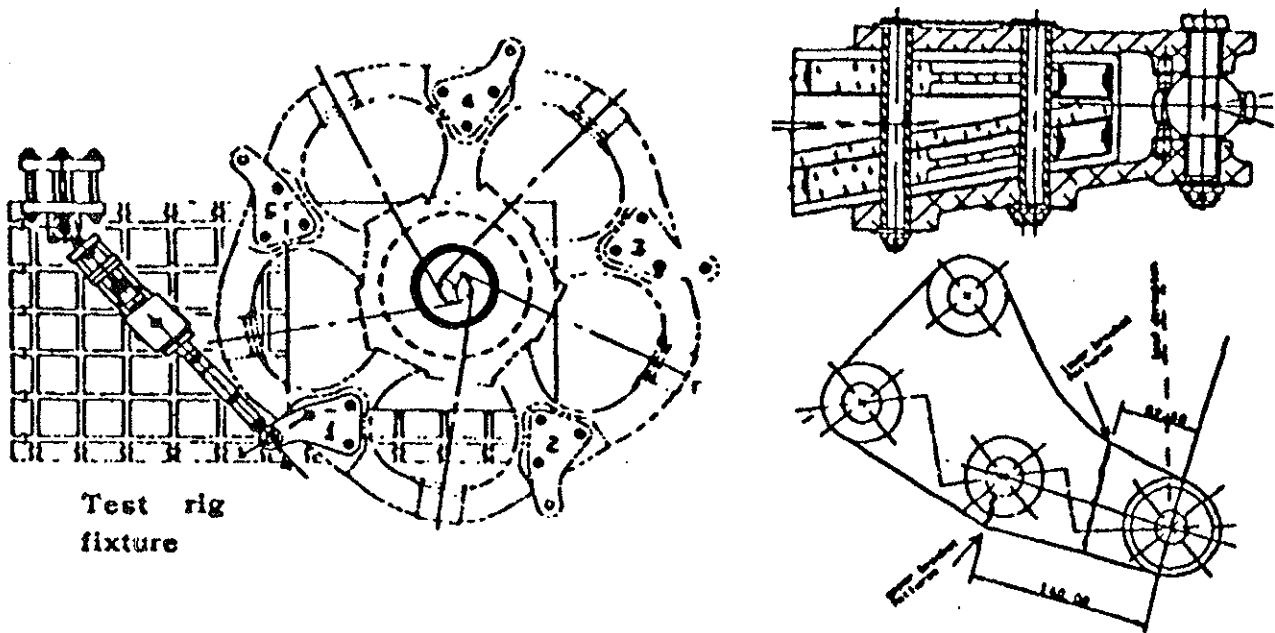
After the upper plate failure during the safe life test at amplified loads, the crack growth in the upper plate was monitored at maximum in flight loads proving relevant fatigue strength to propagation.

An artificial flaw was then made by a saw cut in the lower plate, in the section which has showed an additional failure mode in the safe life tests.

According to the favourable test evidences a significant 'enhanced safe life' evaluation can be computed for this item.

Figure 8 - M.R. Damper Hub Attachments

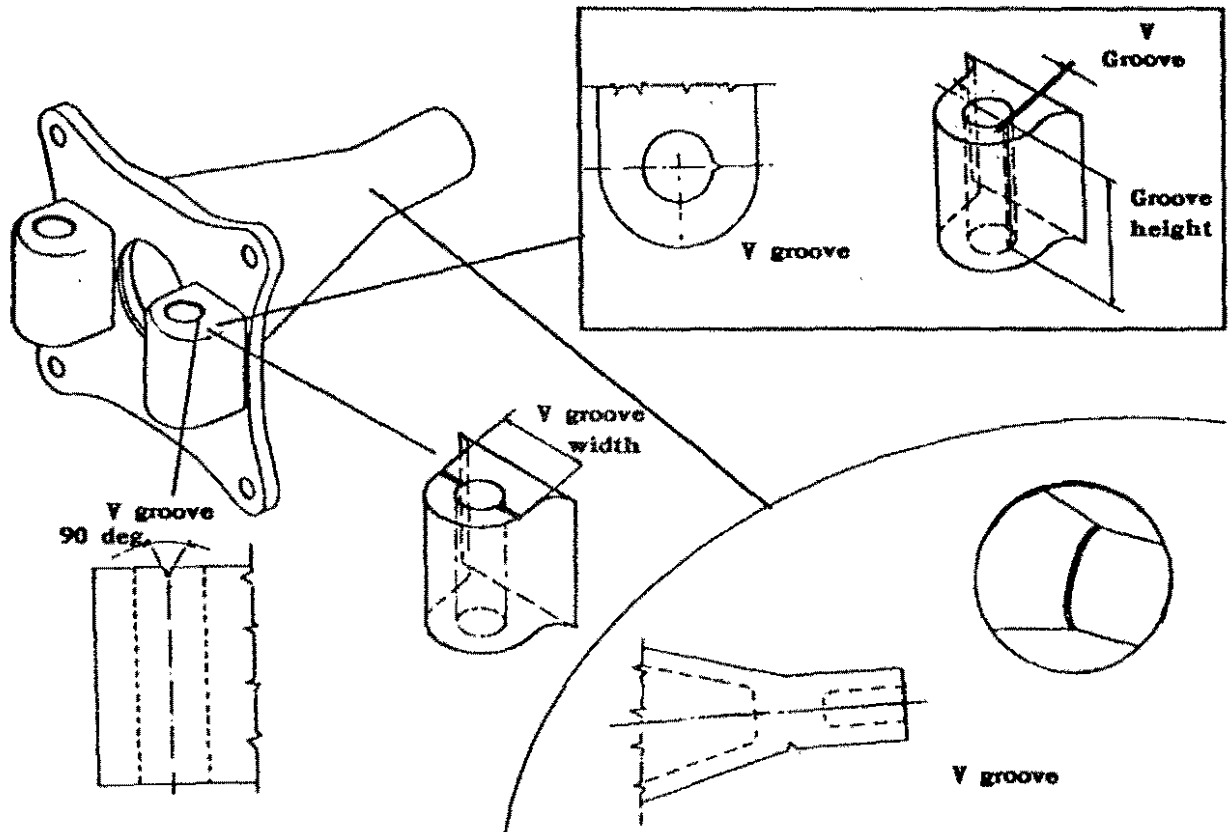
- the Stud Bolts failure, which is not critical for the item due to redundancy of the two Special Bolts
- fretting of the Special Bolts
- flaws in the lugs of the Special Bolts, simulating flaws that could be done during assembling and disassembling operations, figure 10. 'V' grooves were made on components tested at constant amplitude loading to determine the Wohler curve of the flawed specimen for the 'Enhanced Safe Life' calculations
- flaws in the cylindrical part of the Support Cone, for simulation of improper production or maintenance operations, figure 10.

Figure 10 - M.R. Hub Support Cone - 'V' grooves of flawed components for fatigue tests

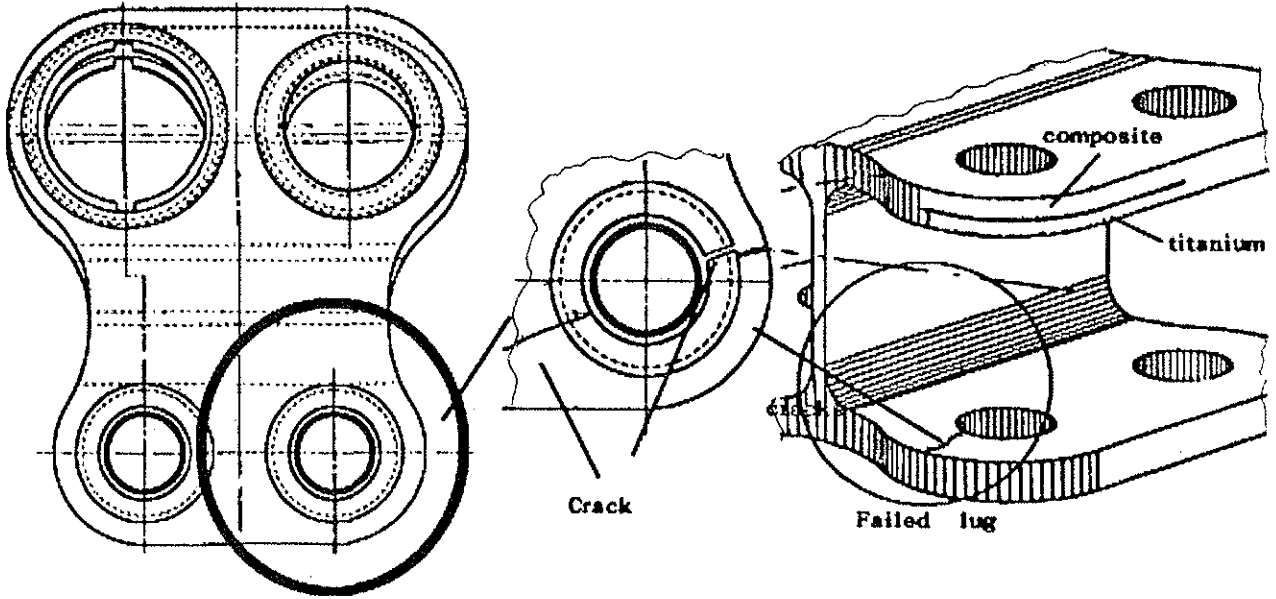
The capability of the composite plate to provide a redundant loading path after local failure of the titanium lug was checked by full size test of the Outboard Tension Link, figure 12, proving relevant fail safety at maximum flight loads and residual static strength up to limit loads. Equivalent capability is expected by the outer lug section of the Inboard Tension Link.

Figure 12 - M.R. Outboard Tension Link fatigue cracking of the titanium lug
