OPERATIONAL EXPERIENCE WITH THE ADVANCED TRANSMISSION HEALTH MONITORING  
TECHNIQUES ON THE WESTLAND 30 HELICOPTER

M. E. Collier-Marsh

Westland Helicopters PLC

September 10-13, 1985

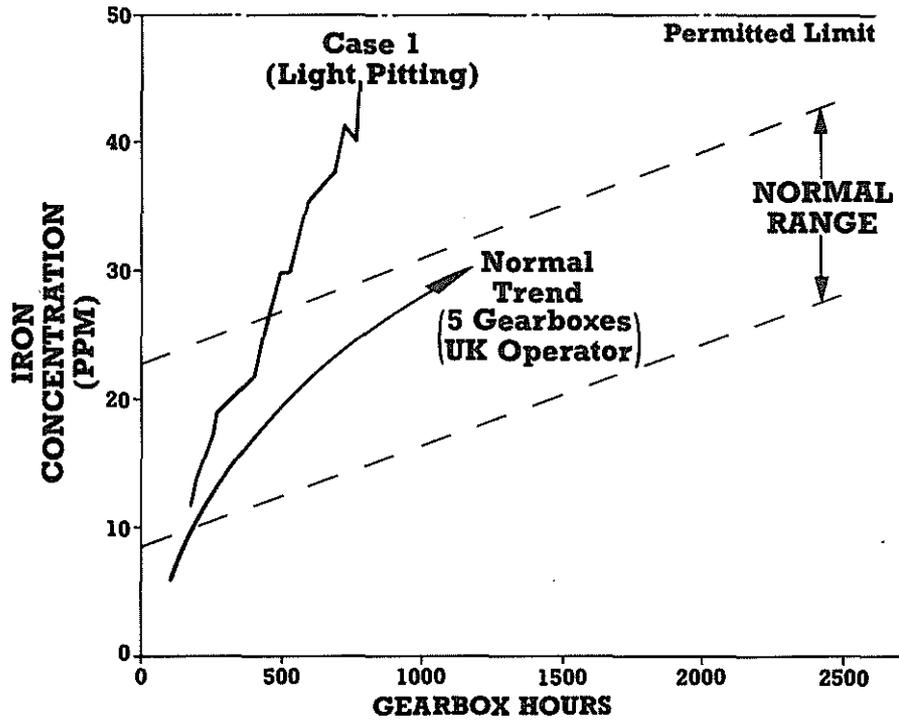
**Fig. 1 Spectrometric Oil Analysis Results for Main Gearboxes**

After approximately 200 hours of flying it could be seen from S.O.A. results that this gearbox was generating a rising trend of iron particles in the oil, which was clearly different from the trends of the other gearboxes in service as depicted in Figure 1. This trend continued until the gearbox had achieved 837 hours at which stage the level of particles in the oil was approaching the permitted limit. At this stage the Ferrographic Analysis indicated an increase in the larger particle size.

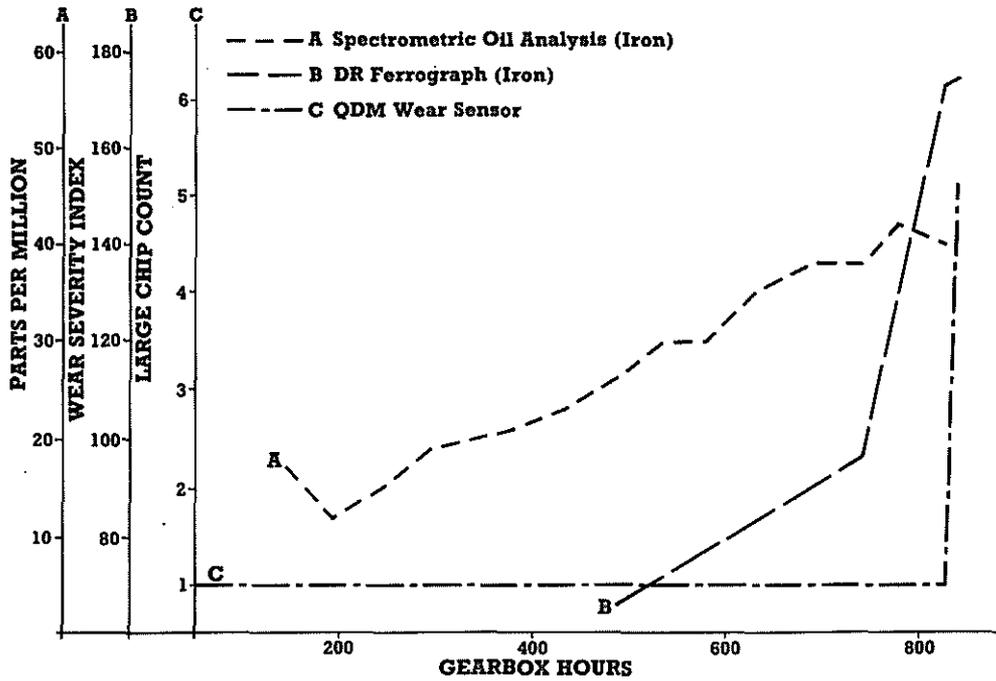
**Fig. 2 Main Rotor Gearbox — Case History 1 (Light Pitting)**

However at the 826 hour stage the Q.D.M. indicated a rise and by 837 hours had risen four counts on the large chip counter and on this evidence the gearbox was removed from the aircraft, reference figure 2. Subsequent stripping revealed modest pitting of the output gears.

This case shows the sensitive detection powers of the Q.D.M. monitoring system in supporting the removal of a gearbox well in advance of potentially catastrophic failure.

Examination of the vibration enhanced signal average did show some abnormalities but did not affect the M6\* value significantly. It is felt that any further growth of the pitting might have affected the gear meshing dynamics sufficiently to be detected in the vibration analysis as was previously found during development aircraft flying activities, where higher than normal flight loads were used.

This particular defect was not of a severe nature and the gearbox would have been expected to have achieved at least a 1000 hours flying when the routine introscope inspection would have found the pitting and the gearbox rejected. Modification action to alter the tooth lead and edge radius in the affected area has proved successful in eliminating the pitting.

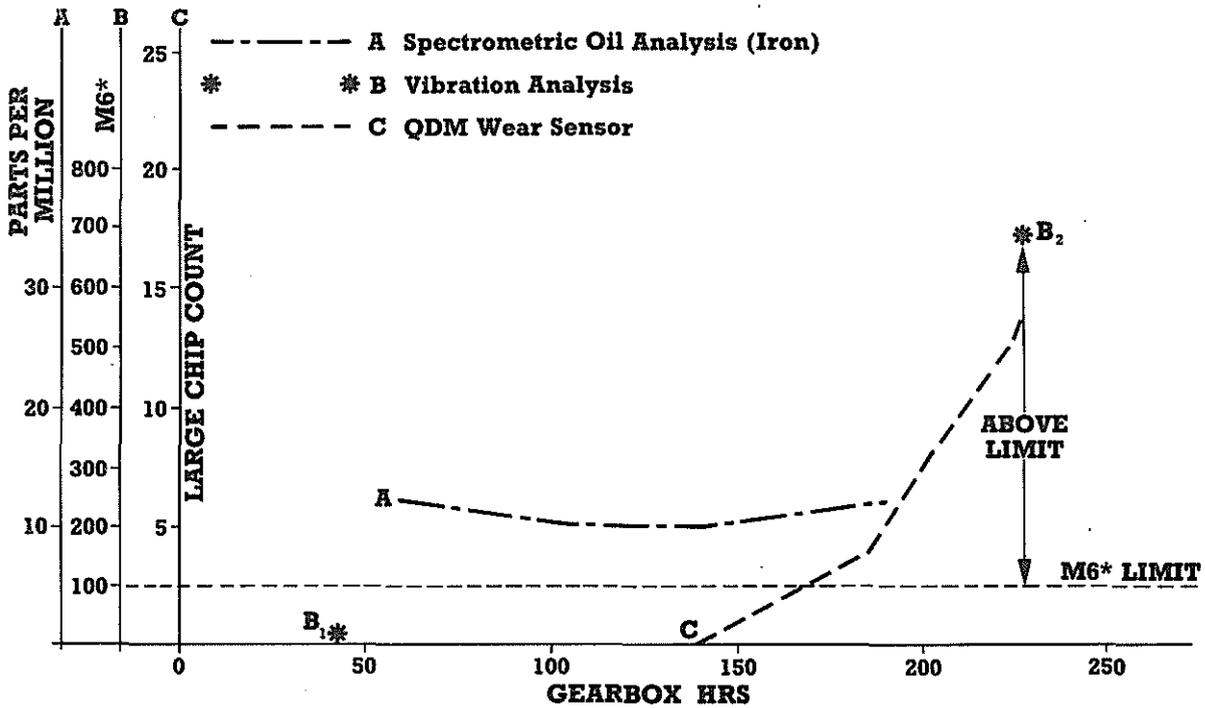
Fig. 3 Main Rotor Gearbox — Case History 3 (Tooth Fracture)

This gearbox was removed due to a rising trend in the Q.D.M. count, at 232 hours. Rumbling noises and vibration had been reported by the pilot at 216 hours at which time a vibration recording was taken. The plug examination and oil analysis did not reveal any problem areas up to and including the 193 hour stage. Subsequent stripping of the gearbox revealed one tooth to be missing from an output stage pinion. Analysis of the vibration tape, although after the event, did show the tooth failure. Figure 5 shows the enhanced signal averages obtained from the only two recordings from this gearbox.

From Figure 3 it can clearly be seen that if rejection limits promulgated for the wear sensor had been observed the gearbox would have been removed well before the pilot had sensed vibration.

Further examination of the pinion failure revealed a large non-metallic inclusion in the material which caused the tooth breakage.

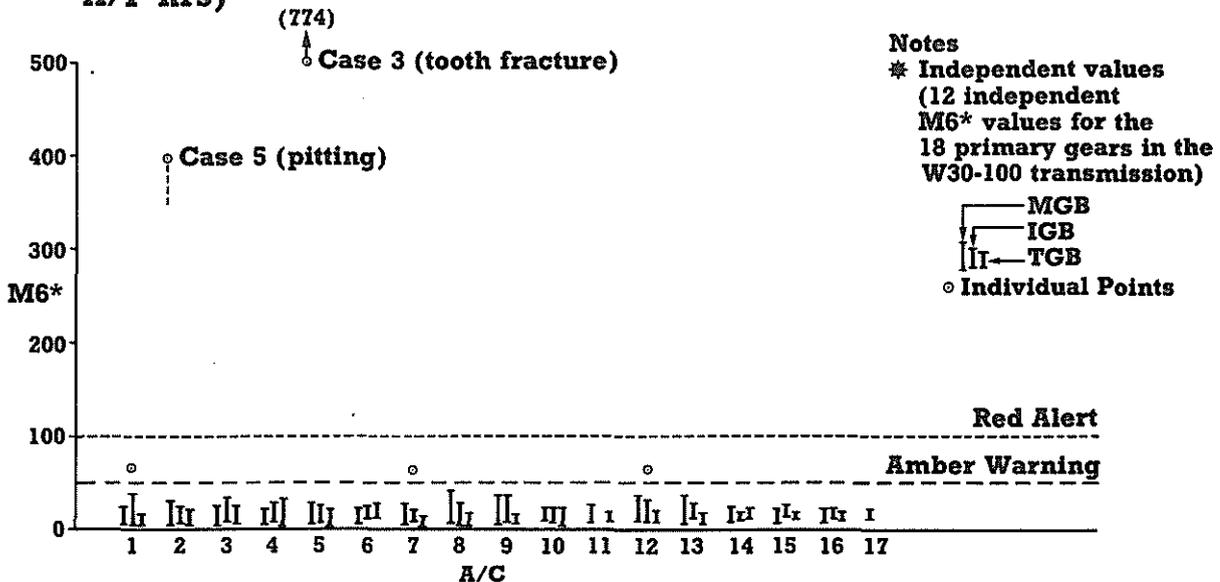
Fig 4. Vibration Health Monitoring Results

The M6\* value derived from the vibration analysis for each gear is presented in tabulated form for recording purposes for each aircraft. Figure 4 shows the distribution of M6\* results from service and development aircraft (1643 values obtained from 106 different gearboxes on 17 aircraft).

Two points are above the rejection limit of 100, one relates to modest pitting that occurred in a development tie down test (para. 4.5.), and the highest relates to a partial tooth fracture (para 4.3). Three points are in the cautionary region (M6\* = 50 to 100), the remainder are all below the caution level indicating the stability of the M6\* parameter for non-defective gears.

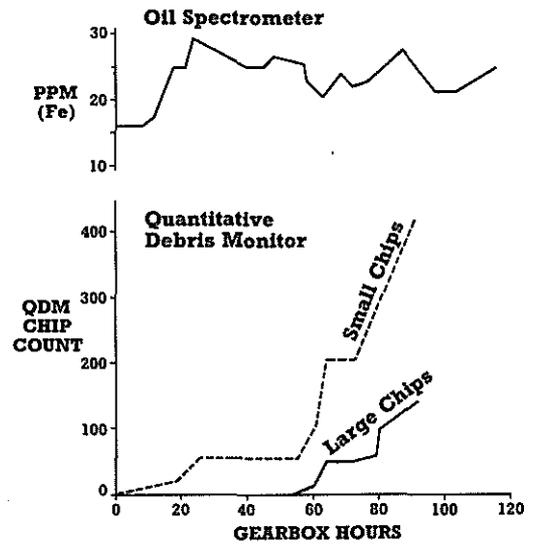
**Fig. 6 Main Rotor Gearbox Case History 4 (Development Test Bearing Liner Spinning)**

The first ground run on G-BGHF (tied-down test with the aircraft operating at high power levels) resulted in creep of the liner and bearing raceway at the lower end of the output hub, producing fine debris for a period of 56 hours running. It was decided to continue running with frequent monitoring inspections because the liner spinning had no significant influence on the functioning of the gearbox, and a design modification was being satisfactorily evaluated in parallel rig test. The only monitoring techniques which produced a definitely increasing trend during this period were S.O.A. and the QDM total chip count which responded from the start of the test, reference figure 6. With continued running the QDM large chip count also responded, some debris was collected by the magnetic plug, followed by the oil filter blockage indicator. Had this been a service aircraft, the gearbox would have been rejected at the 57 hour point when the QDM large chip count exceeded 4. However, the development test was continued to 145 hours during which time, the filter clogged several times.

During this period there were no indications of dynamic abnormalities from vibration analysis, and the oil analysis techniques, spectrographic analysis and DR Ferrography produced zero and decreasing trends respectively. Some debris was collected by the magnetic plug, but the QDM and filter blockage indicator were the only systems which followed the progression of damage, the 'plateaus' in the QDM response corresponding to filter element changes and start-ups (at ambient temperatures down to  $-10^{\circ}\text{C}$ ). The QDM indications were also confirmed by debris found on the probe, and by the bearing liner condition at strip, the larger debris resulting from trepanning and fracture of some of the bearing retention features.

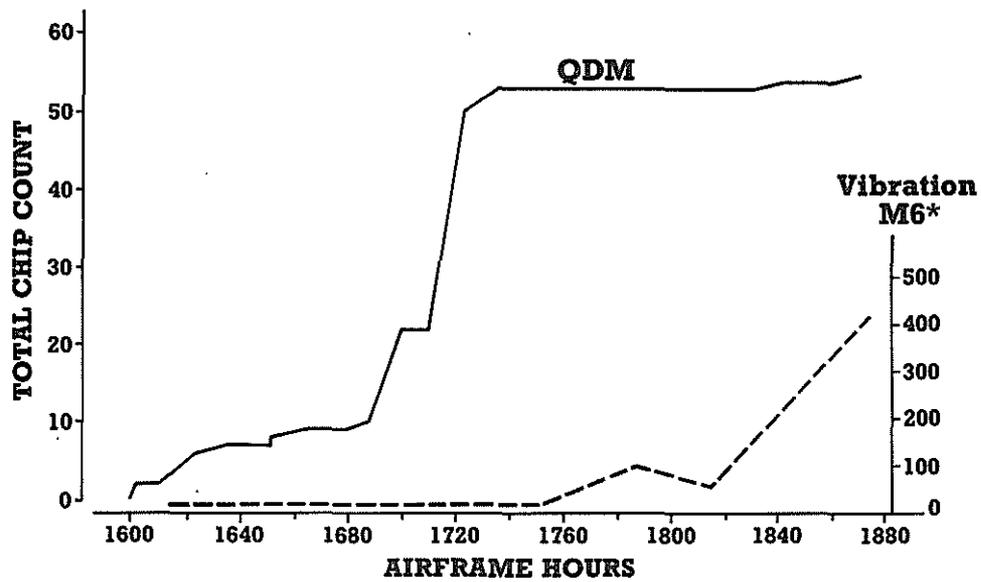
**Fig. 7 Main Gearbox Case History 5 (Development test — light pitting)**

During tied-down aircraft certification testing of the transmission with Rolls-Royce GEM 60 engines fitted (W30 series 100-60) modest pitting occurred on some teeth of one of the pinions driving the output wheel. The increased power transmitted by the same gearbox resulted in slightly different deflection characteristics of the casing, necessitating slight modification of the end-relief on the pinion teeth. The QDM total chip count (small chips, since no large chips were counted) increased from 1680 airframe hours at a rate increasing to nearly three counts per hour until 1720 hours, after which it levelled out. From 1750 hours onwards, however, the vibration analysis results increased for this particular pinion and passed the rejection limit ( $M6^* = 100$ ) at 1815 hours, reference figure 7. The tied-down test was completed at 1870 hours and a borescope inspection confirmed slight tooth wear on the pinion identified by the vibration analysis. The tooth modifications referred to in para. 4.1. have demonstrated freedom from pitting in subsequent tests.
