PREVENTION OF CORROSION AND FATIGUE FAILURE
OF HELICOPTER GAS TURBINE COMPRESSORS

R.J.H. Wanhill, H.J. Kolkman, A.J.A. Mom and G.F.J.A. van Gestel*
National Aerospace Laboratory NLR, Amsterdam, The Netherlands

Corrosion pitting leading to fatigue cracking and failure of a rotor blade or stator vane was found to be the most probable cause of disintegration of a helicopter gas turbine compressor during normal operation in The Netherlands.

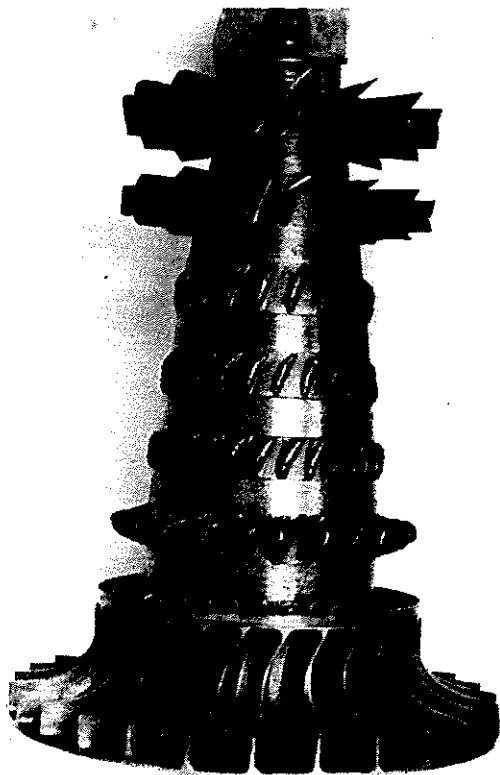
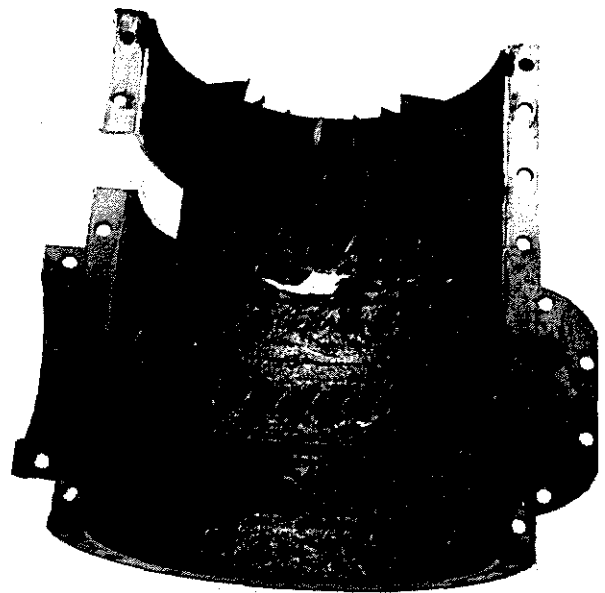
Fig. 2 Service failure compressor rotor assembly and one of the two compressor casing sections

The compressor rotor assembly and one of the two sections of compressor casing are shown in figure 2, and a summary of the damage is given in table 1. The most significant features of this list are the occurrence of corrosion pitting and fatigue cracks initiating from corrosion pits. An example of this is given in figure 3.

ROTOR ASSEMBLY	FIRST STAGE	<ul style="list-style-type: none"> ● blade tips rubbed against casing ● corrosion pitting on concave sides of airfoils
	SECOND STAGE	<ul style="list-style-type: none"> ● blade tips rubbed against casing ● trailing edges heavily damaged ● severe corrosion pitting on concave sides of airfoils ● fatigue cracks originating at corrosion pits
	THIRD STAGE	<ul style="list-style-type: none"> ● airfoils missing ● severe corrosion pitting on concave sides of blade remnants ● corrosion pitting on convex sides of blade remnants
	FOLLOWING STAGES	<ul style="list-style-type: none"> ● fourth and fifth stage airfoils missing ● sixth stage airfoils heavily damaged ● inlet side of centrifugal compressor heavily dented
STATOR VANE AND CASING ASSEMBLY	FIRST STAGE	<ul style="list-style-type: none"> ● vane tips rubbed against rotor hub ● corrosion pitting at vane roots ● decohesion of plastic sealant at vane roots

SECOND STAGE	<ul style="list-style-type: none"> ● all but four airfoils missing ● one identifiable airfoil fracture: fatigue originating at corrosion pits on convex and concave sides ● fatigue cracks originating at corrosion pits on concave sides of two of the remaining airfoils ● corrosion pitting at vane roots ● decohesion of plastic sealant at vane roots
	FOLLOWING STAGES	<ul style="list-style-type: none"> ● airfoils missing ● vane platform bands torn out of casing ● casing penetrated

It was our opinion that the most effective way of counteracting corrosion would be to apply protective coatings. Accordingly, we evaluated the corrosion resistance of components from the same type of compressor with and without coatings. The results are reported in the next section.

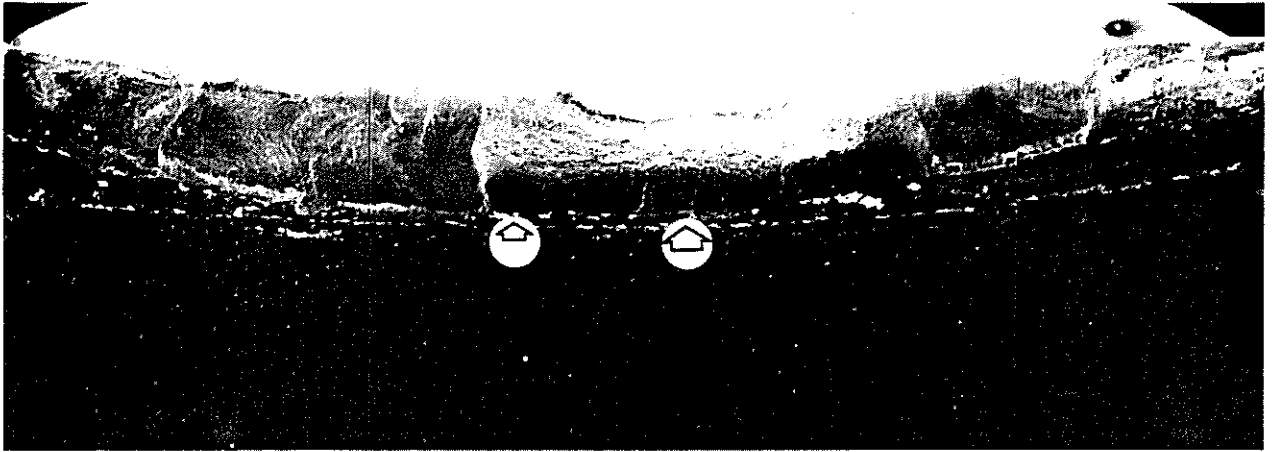
(a) Overview of the fracture surface: fatigue initiation sites arrowed (x17)

Fig. 3 Forcibly opened crack in a second stage stator vane from the service failure

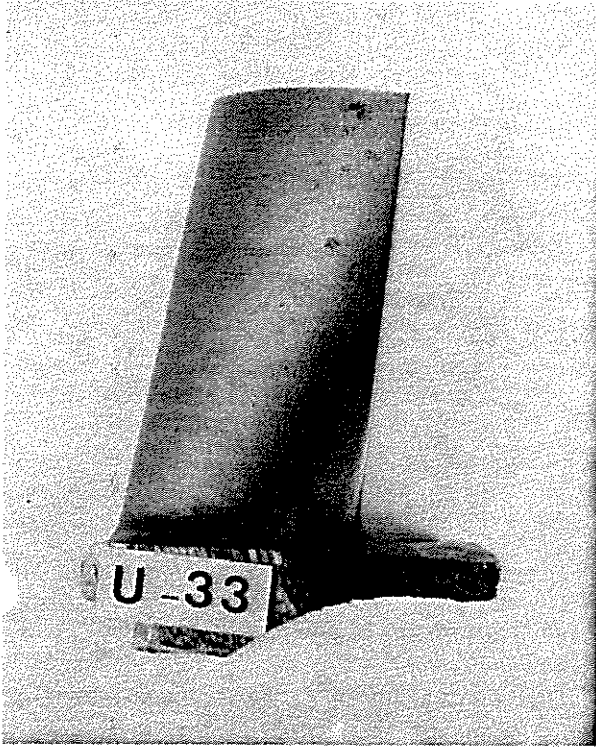
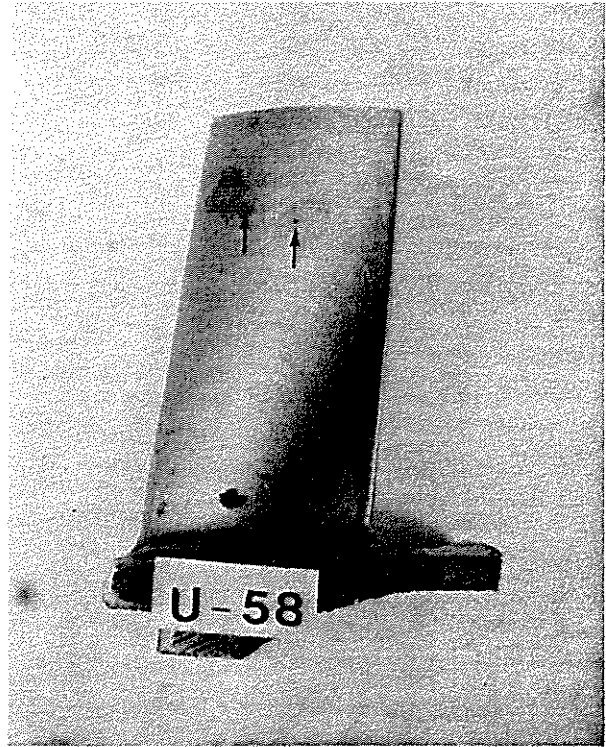
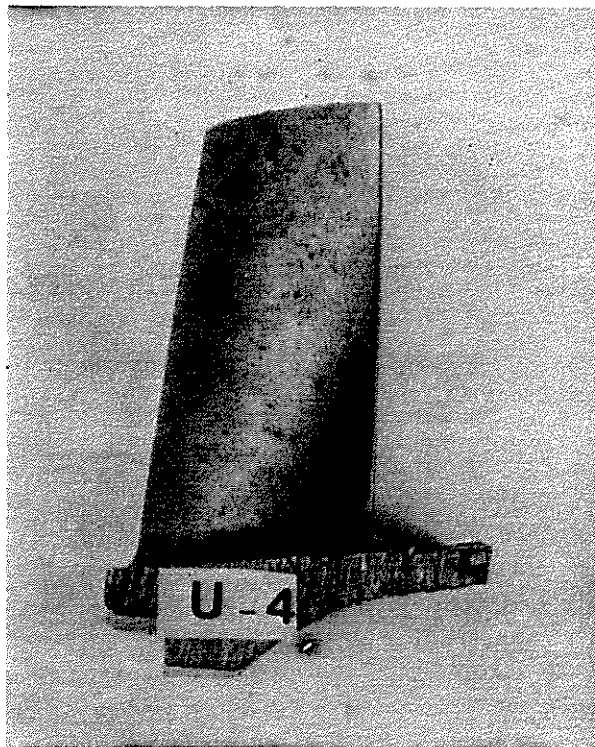
Fig. 6 Convex sides of uncoated airfoils after corrosion testing (x2)

Figure 6 compares the appearances of three uncoated airfoils exposed to neutral and acid salt sprays and compressor rig testing. The much greater amount of pitting owing to compressor rig testing is evident. In this respect compressor rig testing was more representative of corrosion pitting in service.
