Crashworthiness of rotorcraft on water, an experimental test campaign

Abstract

The present paper describes the preparation and results of two water impact test performed at CIRA. The activities were included in the research project CAST, devoted to improve crashworthiness of rotorcraft on water. First test was executed on a Westland WG30 sub-floor section, the second was the water impact of a complete full scale WG30 fuselage. For both tests, impact velocity was 8 m/s with flat attitude. Test specimens were fitted with ballast masses to recreate realistic load conditions, and equipped with pressure transducers and accelerometers to obtain objective quantitative data representing the severity of the loading, to which the structure was exposed. Moreover tests results were needed to assess numerical simulations performed by other partners of the project. Pre-test numerical simulation results produced by DLR together with advice from Westland led to the final test configuration of the component. This avoided unrealistic failure of the test specimen in question. The test specification for the full scale test was provided by Westland

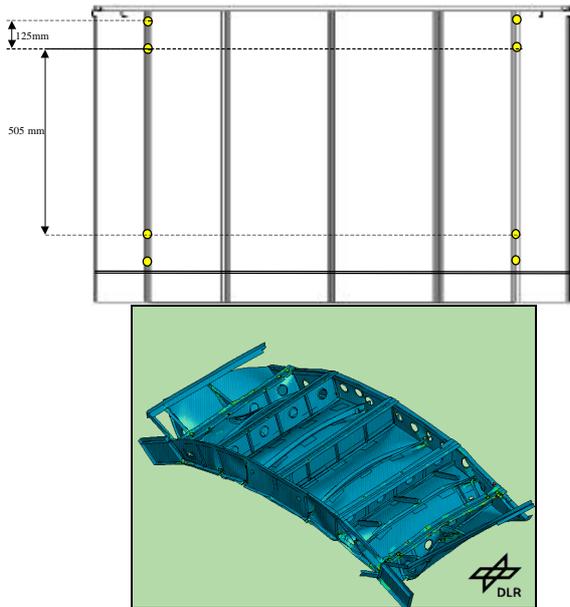
Fig. 2 Eight hosting point lay-out and simulation results

As shown in Fig. 2, the eight point arrangement would have caused an unrealistic bending failure of the structure. The pre-test simulation on the new configuration led to the final test set-up. Fig. 3 shows the simulation result with the eighteen-point configuration.

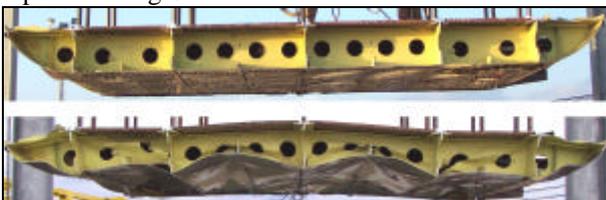
Fig. 8 Frame 240A pre- and post-test

After testing, the specimen preserved its structural integrity. Relevant deformations were observed on the skin panel, which bent under the pressure of water. Frame 240A also reported large deformation as shown in Fig. 8. Ruptures were observed on panels close to frame 1210A, which was considerably stiffer and did not allow panel deformation. Main damages are reported in Fig. 9.

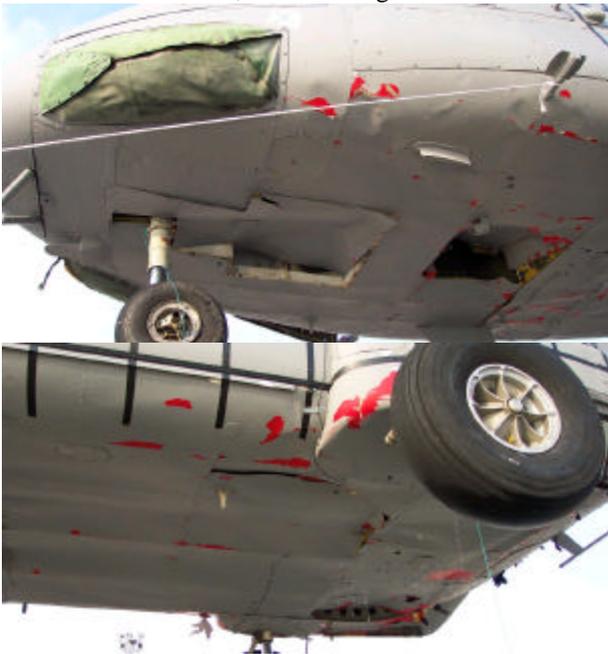
Fig. 20 Belly skin damages

The largest damages in the fuselage were observed on the belly skin and sub-floor structure. Some panels were ripped off, as shown in Fig. 20, and the sub-floor frames also exhibited evident deformations as can be noticed in Fig. 21 (picture taken after removal of seats and floor panels). The side frames underwent a plastic bending deformation as well because of the heavy rotor and transmission load, shown in Fig. 22.

As highlighted by the test results, the skin panels underwent a large deformation and ruptured at some places because of high loads caused by the water pressure. In fact, during an impact on water no energy absorption and load reduction is provided by the landing gear. For this reason, occupants can be exposed to high deceleration loads, as demonstrated by the accelerations recorded on the seat tracks and by the high load in the ATD spine.
