THIRTEENTH EUROPEAN ROTORCRAFT FORUM

4.1
Paper No. 55

THE ROLE OF MANUFACTURER IN
THE ACCIDENT INVESTIGATION

AGUSTA - ITALY

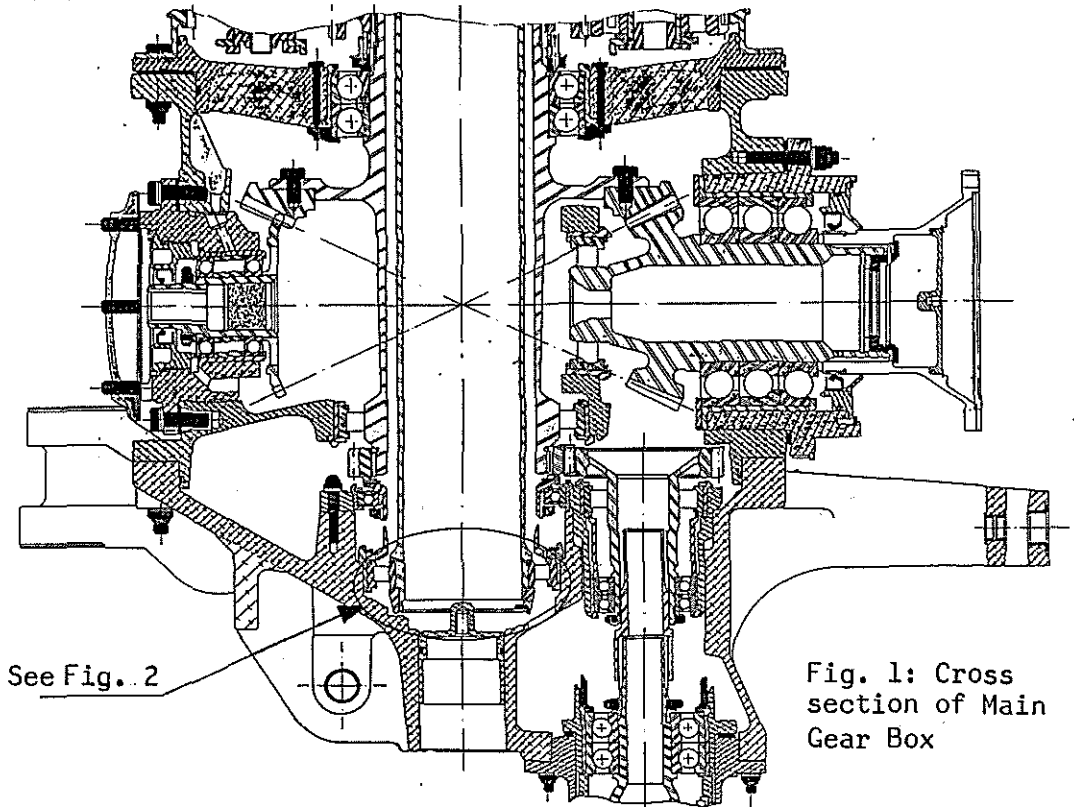
- Step 1. Interference of the eye of the cotter pins (item a) with case wall.
- Step 2. Failure of the cotter pins, after several flying hours with separation of the eye and loss of safety action.
- Step 3. Loss of torque on shaft nut (item b).
- Step 4. Interference of the nut with case wall and literally milling of the housing (see arrow on fig. 3)
- Step 5. Obstruction of lubricating oil jets orifices.
- Step 6. Partial loss of lubrication of the gear box.
- Step 7. Braking action of the nut between main rotor shaft and gear box case.

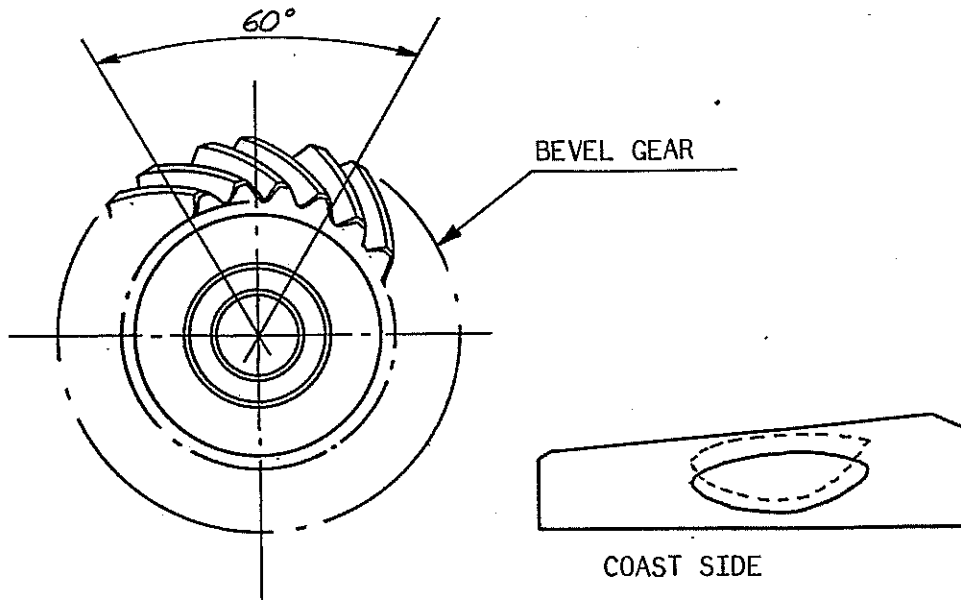
Fig. 6: 90° Gear Box Bevel Gear - Detail of Coast Side imprints

Unusual patterns were found on the coast side of the teeth for a sector approximately 60° of the bevel gear.

Only a super trained eye could realize that something had occurred to the dynamic components which slowed down the main rotor and made the tail rotor inertia forces load, on the apposite side, the gears.

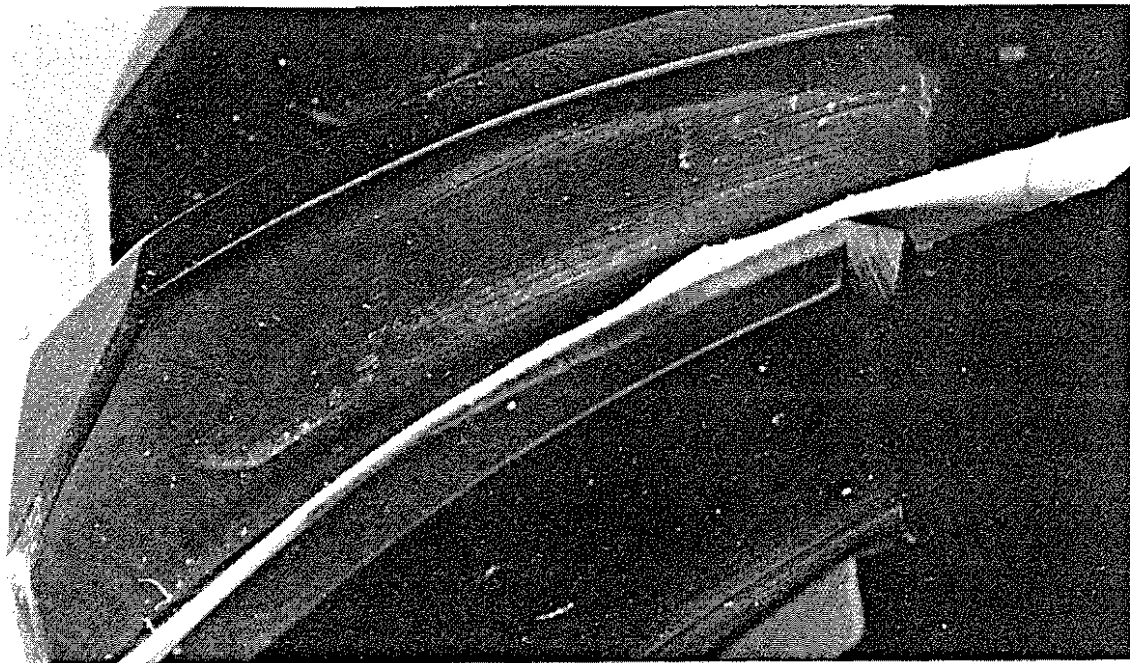
Tooth overstressed

The imprints, see arrow, show that a sudden very high load has been transferred from the gear box to the tail rotor system. This is the case when the tail rotor strike against foreign object. Of course the same know-how is used to show that no sudden stoppage if the tail rotor happened.

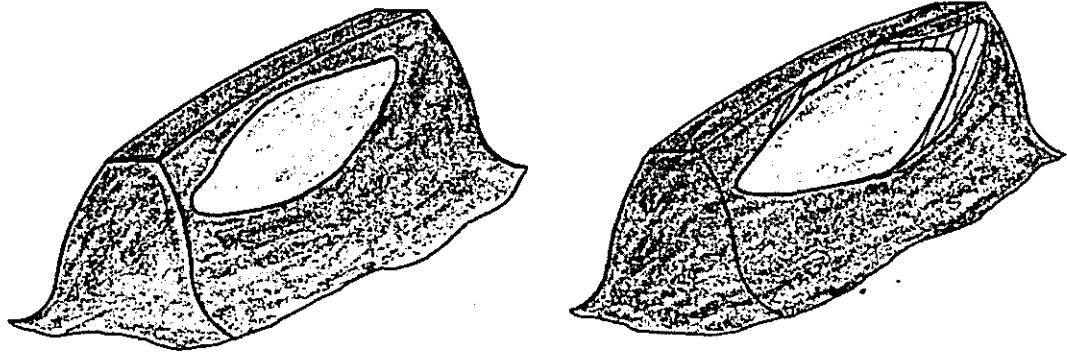
Fig. 11: Over Torque Pattern details.

The patterns indicate, in this case, that an over torque happened. This can be evaluated by the shifting of the tooth pattern due to the higher level of stress on the gear and the housing; it can be seen as an additional pattern located out of the normal working position.

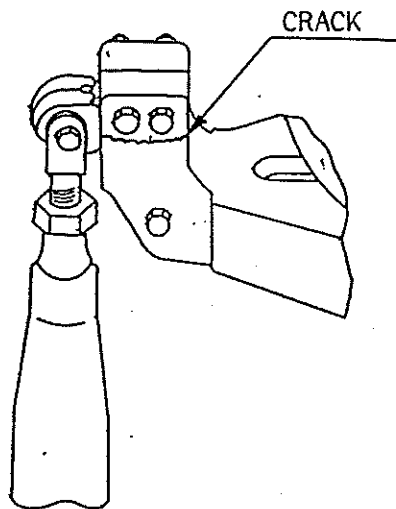
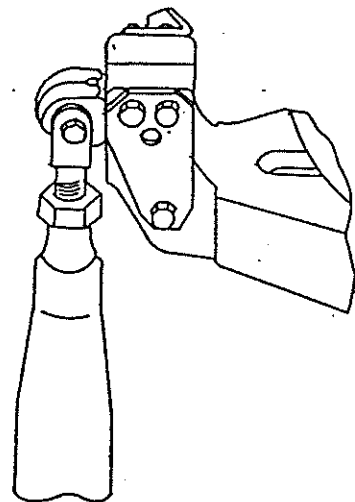
We experienced, in factory, during the assembly phase of swash-plate, a very strange failure of the horn-lug as indicated by the arrow, which kept Agusta experts puzzled for a while.

The horns were assembled with the trunnions and torqued according to the specs. without any problems; half a day later we could see clear evidence of failure, with loss of torque and therefore possibility of trunnion separation in flight. I'll tell only the end of the story; we found out that the casting alloy aging naturally, became creep sensitive and the failure was classified as a creep failure for bending stresses. A different casting material removed the problem.

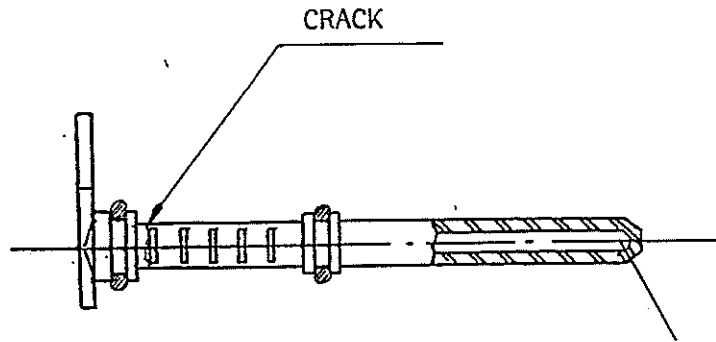
Fig. 17: Detail failure

Due the following reasons the head of the oil jet sepatated from the core, so permitting a slight rotation of the core itself with respect to the head, diverting the oil flow from the gears.

If You try to remove the jet with the use only of one screwdriver pushing from one side first and the, from the other, You stress for bending the oil jet in the cross section where the resistant area is very low for oil passages. In our case we had a real fracture of the jet with the rotation as explained.

In this case the oil jet was modified prescribing to the Operators a different system of oil jet removal to prevent bending stresses.

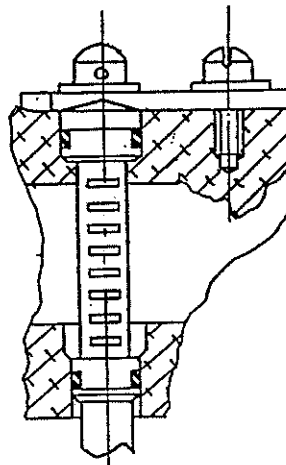
Fig. 18: Oil jet installation System

The removal of the oil jets during the maintenance operations is permitted by means of two opposite chamfers milled on the head to bring the jet out of the case.
