SECOND EUROPEAN ROTORCRAFT AND POWERED LIFT AIRCRAFT FORUM

BALLISTIC AND IMPACT RESISTANCE
OF COMPOSITE ROTORBLADES

K. Brunsch, P.M. Wackerle

Messerschmitt-Bölkow-Blohm GmbH
Munich, Germany

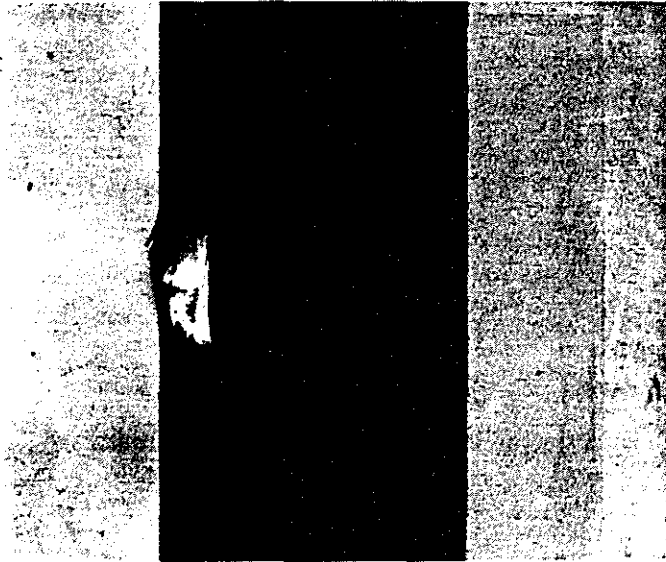
| Condition 1 | 30 million cycles, crack in titanium nose cap starting from 2a impact area |
| Condition 2 | 6.8 to 11.8 million cycles, three additional cracks in titanium and carbon |
| Condition 3 | 0.5 million cycles, cracks in titanium nose cap propagated into unloaded area towards leading edge. Partial debonding of nose cap in 2a area were bullet left blade |
| Condition 4 | .017 million cycles, further cracks in nose cap. Slow growth of delaminated 2b area.

Figure 13 NUMBER 2 TEST SPECIMEN
AREA "a" BULLET ENTRY

Figure 14 NUMBER 2 TEST SPECIMEN
AREA "a" BULLET EXIT

Figure 15 NUMBER 2 TEST SPECIMEN
AREA "b" BULLET ENTRY

Figure 16 NUMBER 2 TEST SPECIMEN
AREA "b" BULLET EXIT

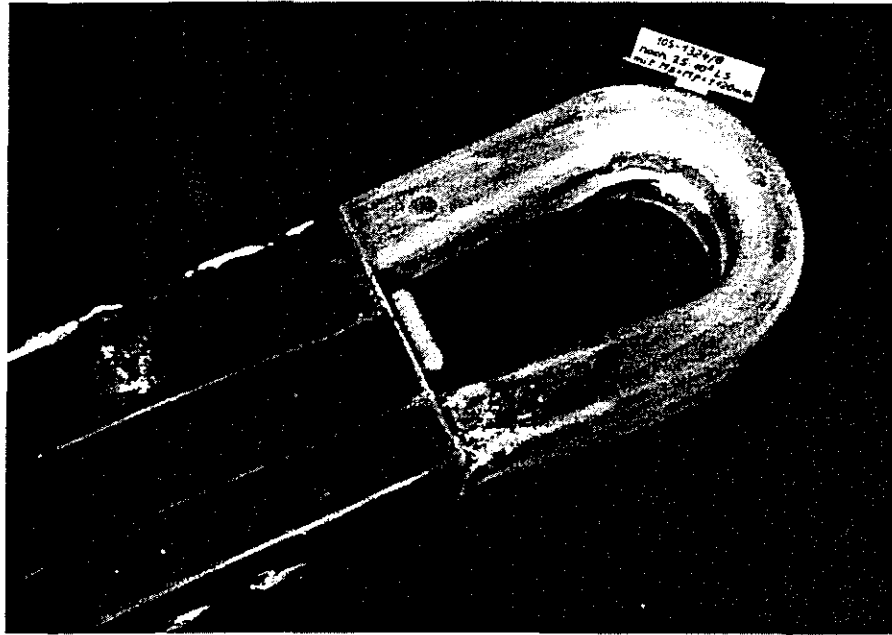
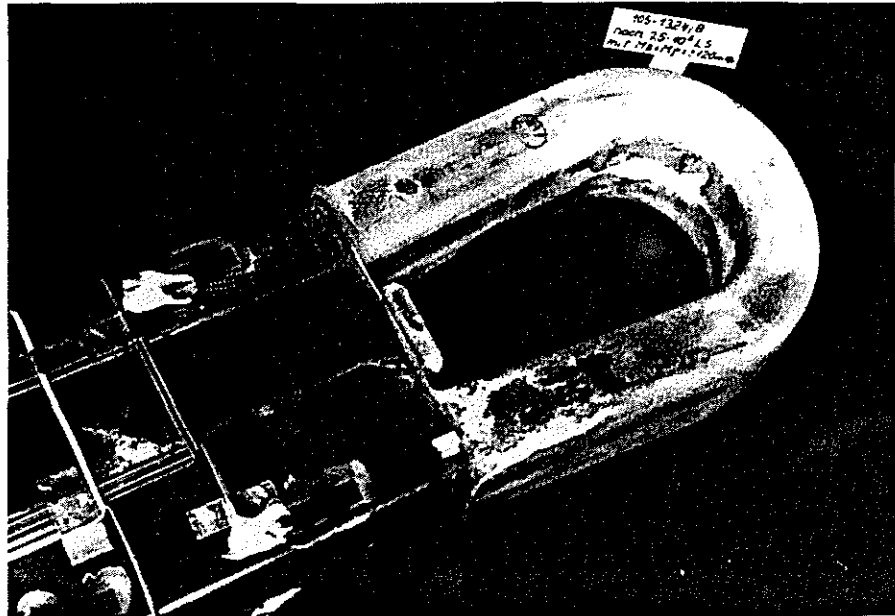
A blade root section was hit by .30 APM 2 again and then fatigue tested, see Fig. 22, 23. This - from here on number 3 specimen was loaded with constant tension and alternating bending, both in flap- and chordwise direction. The 12 t tensile load introduced by cable resulted in a .135% strain. The flexural deformations being applied by excentrics and push-pull rods resulted in additional .15% alternating strain. After application of 7.5 million cycles with bending load the test was completed. The damage again had not propagated at all. The no. 3 test specimen also was cut through the impact area for visual inspection , see Fig. 24.

Figure 22 NUMBER 3 TEST SPECIMEN
BULLET ENTRY

Figure 23 NUMBER 3 TEST SPECIMEN
BULLET EXIT

Figure 24 CROSS SECTION OF PENETRATION
AREA "3"

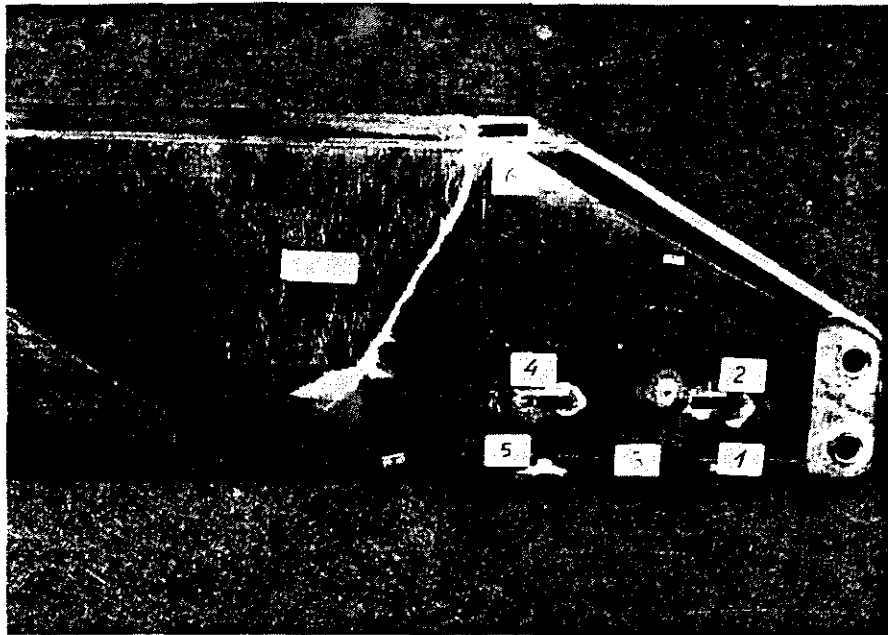
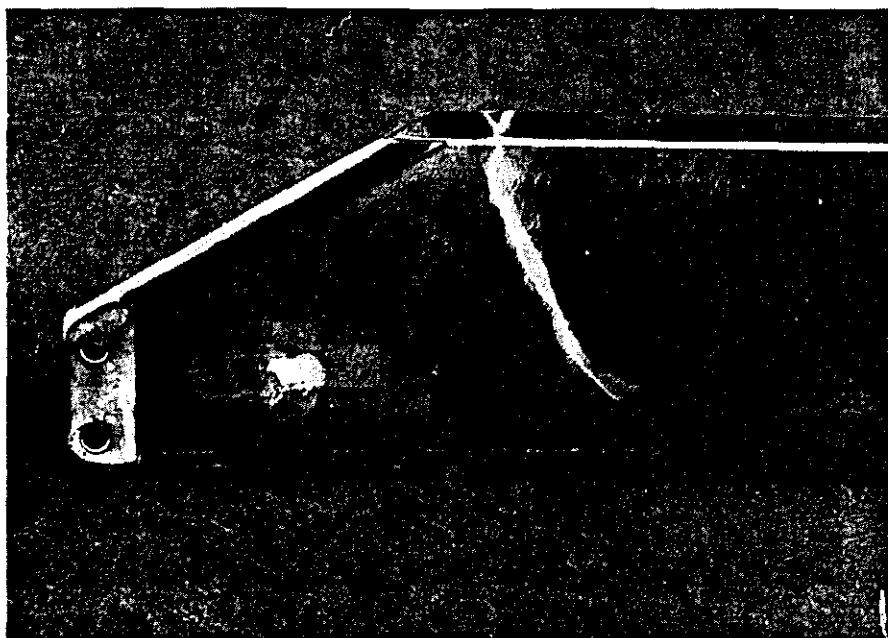
After $35,1 \times 10^6$ cycles the blade failed in the homogeneous part, see Fig. 28, 29. This type of failure is known from undamaged rotorblades.

Figure 28 FATIGUE TESTED TAIL
ROTORBLADE BULLET ENTRANCE

Figure 29 FATIGUE TESTED TAIL
ROTORBLADE BULLET EXIT

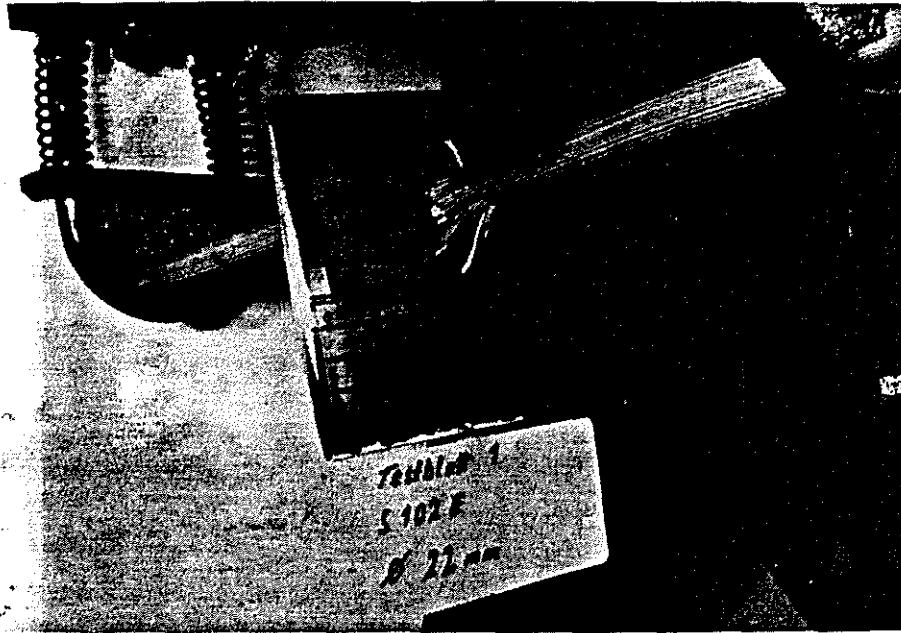
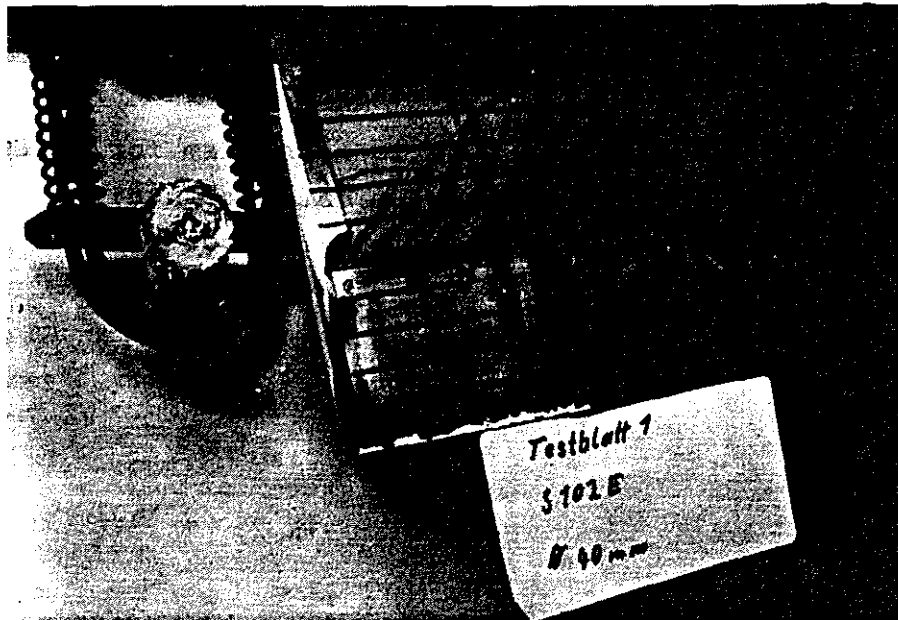
The first run with test blade 1 should demonstrate how many strokes the blade can resist with full action capability. This was found up to the point where a safe landing becomes impossible. Test blade 1 resisted a total of 10 strokes, see fig. 31 and after a visual inspection by design- and stress people and by pilots a "safe landing possibility" was attested. During all tests the test blade 1 had no change in its ballance properties. The damage is to be seen in Fig. 32, 33, 34.

Figure 32 IMPACT OF TAIL ROTORBLADE ON
WOODEN ROD
NO VISIBLE DAMAGE

Figure 33 IMPACT OF TAIL ROTORBLADE ON
WOODEN ROD
FIRST SURFACE BUCKLING

Figure 34 IMPACT OF TAIL ROTORBLADE ON
WOODEN ROD ϕ 55 mm

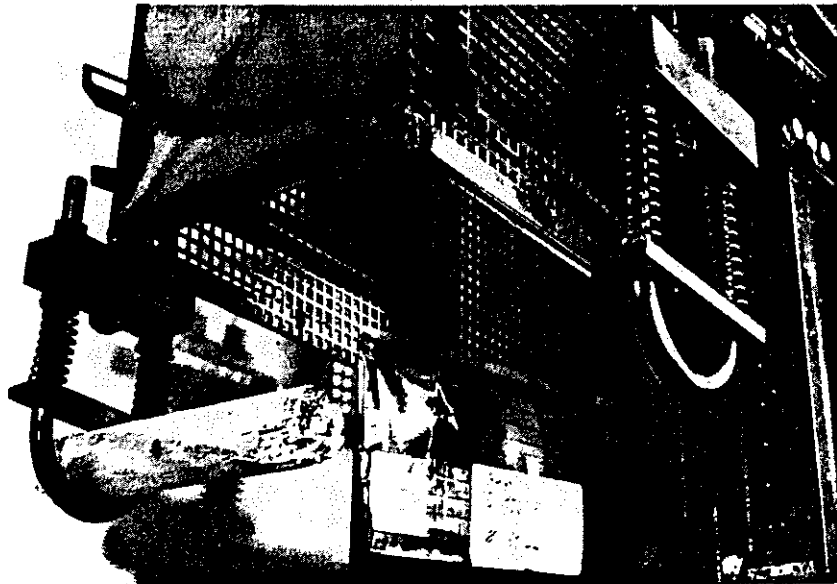
With test blade 2 there were three strokes, see Fig. 31. The first on a 55 mm rod initiated the same failure as the test blade 1 had after 10 strokes. The figures 35, 36, 37, 38, 39 are showing the damage increase up to total failure. After the 60 mm rod test an immediate landing seems to be possible although an imbalance initiated by the loss of skin and core parts was detected. A normal landing after the last 65 mm rod impact is impossible because the imbalance initiated by the lost parts will cause secondary failures in tailboom components.

Figure 35 IMPACT OF TAIL ROTORBLADE ON
WOODEN ROD
SKIN SEPARATION, TIP CAP CRACKED

Figure 36 IMPACT OF TAIL ROTOR BLADE ON
WOODEN ROD ϕ 60 mm
SKIN SEPARATION, TIP CAP CRACKED

Figure 37 IMPACT OF TAIL ROTORBLADE ON
WOODEN ROD
TOTAL FAILURE

Figure 38 IMPACT OF TAIL ROTORBLADE ON
WOODEN ROD
TOTAL FAILURE

Figure 39 IMPACT OF TAIL ROTORBLADE ON
WOODEN ROD
TOTAL FAILURE
