MANUFACTURING CONTROL OVER THE REPRODUCTION OF HIGH
INTEGRITY PARTS: A WAY TO IMPROVE THE SAFETY OF
AERONAUTICAL PRODUCTS

COSTANTINO BIGLIETTO — CESARE ARCARI

QUALITY DEPARTMENT
COSTRUZIONI AERONAUTICHE
GIOVANNI AGUSTA
ITALY

TENTH EUROPEAN ROTORCRAFT FORUM
AUGUST 28 – 31, 1984 – THE HAGUE, THE NETHERLANDS

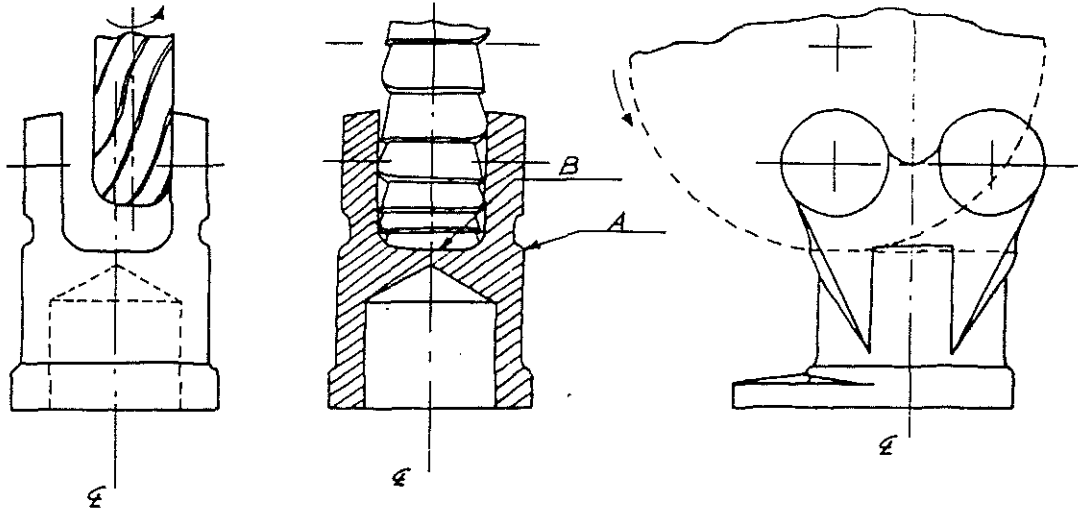
Tail Rotor Hub

The part has been manufactured in the plant for a long time without problems; then it was subcontracted to a subsidiary facility and, apparently no major defects has been found before acceptance phase of the first item.

Then during the survey was discovered a hardness level below minimum required in areas A and B (see sketch), even though the hardness test was not required.

The subcontractor machined the slot by use of a heavy milling cutter, machining both sides and the bottom at one time, whereas, in Agusta's shops, that was obtained by employing a candle cutter and several cuts.

The excessive heat developed caused some of the forgings areas (2024 Al alloy) to be partially annealed.

We believe that the check of the subcontractor's operations sheets against the Agusta manufacturing document would have prevented the problem.

In addition the drawing has been updated to include some hardness test requirements after the final machining.

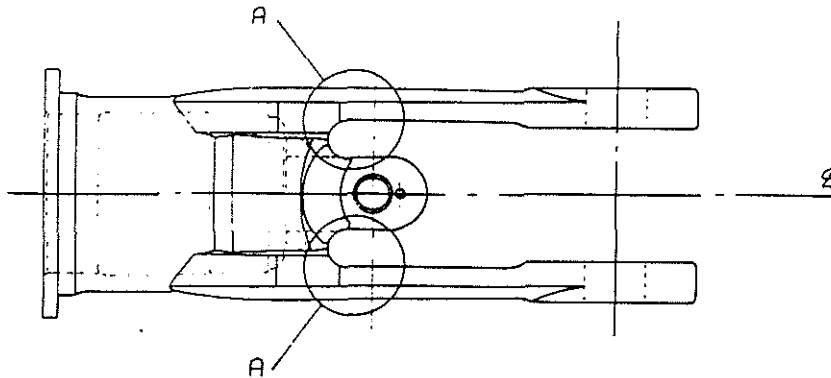
Main Rotor Hub

The part initially manufactured in the plant was sub-contracted to a subsidiary facility according to a general plan of work sharing. During the acceptance phase of the first item performed by the chief inspector who originally accepted the parts in Agusta, was discovered a hardness level below the minimum requirements in areas A.

The subcontractor machined the slots by heavy milling operations and the excessive heat developed caused some spots to partially anneal.

We believe that the check of the subcontractor's operation sheets against the Agusta original manufacturing data would have prevented the problem, because the sensitivity of that area had been previously experienced by Agusta. In addition the drawing have been updated to include some specific hardness checks after machining.

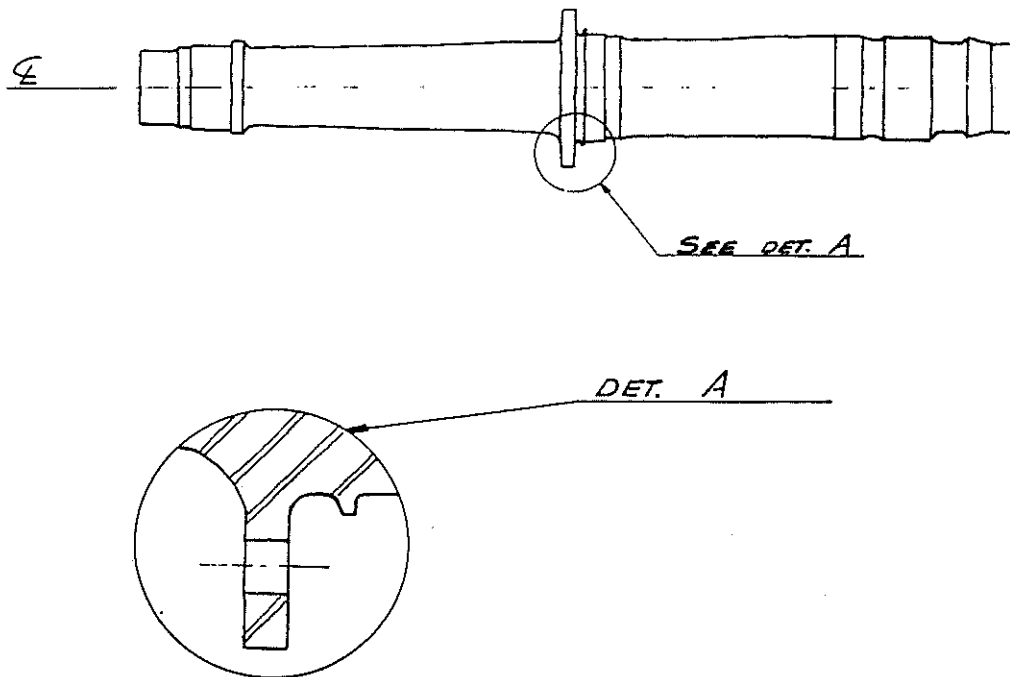
Main Rotor Shaft

When the first lot of masts had been reproduced by a different source, they failed to recognize some hardened spots, mainly in the flange radius relief zone (see detail A of the sketch).

The defects had been found by Agusta Receiving inspection, which requested some additional nital etching checks.

In house experience in manufacturing the shaft suggested in the past some additional inspection requirements, besides those of the drawing, which have been included in Agusta's work and inspection sheets.

One of those requirements calls for a nital etching check after machining (not grinding) of the relief, because due to the high strength of the material (44-48 Rc - 126-146 Kg/mm²) subjected to very high frequency vibrations causing the contacting material to harden had been induced by the special slender tool.

Even though defective parts have not been put in service, timely manufacturing control would have prevented scraps. In this case the drawings have not been changed to include those additional requirements, considering them as pre-requisite of working and inspection sheets.

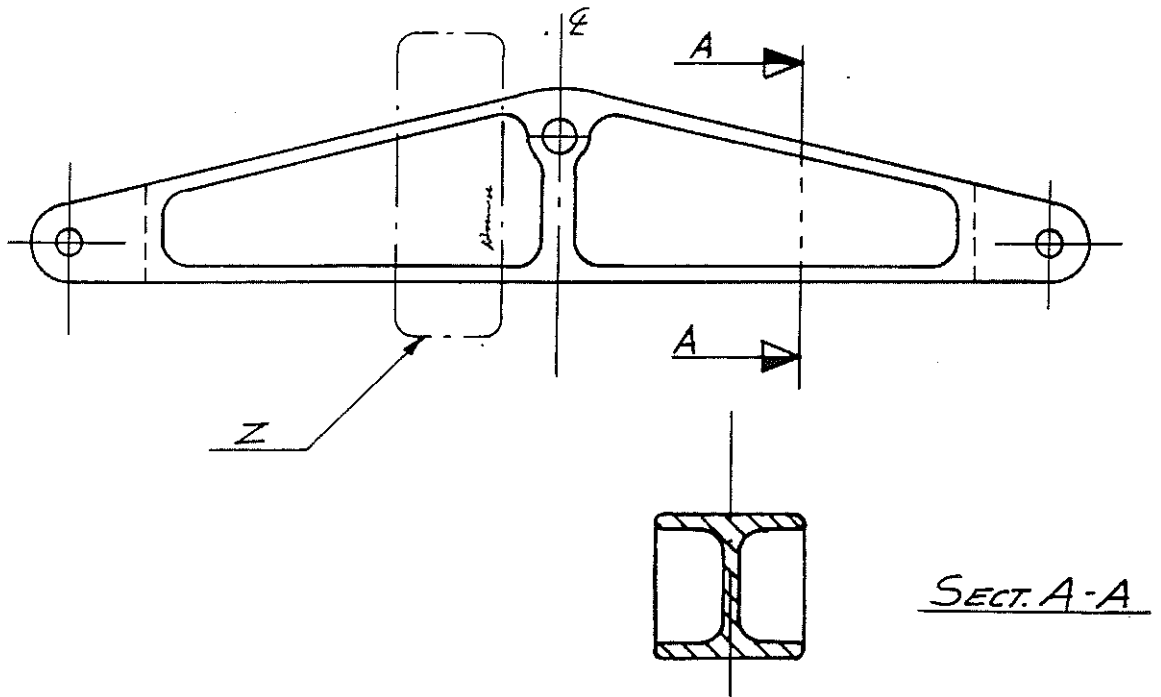
Stabilizer Bar Assembly

Early cracks had been found in Z area starting from the very thin web of the double T section. The helicopter was in pre-production phase but several ships had, at the time, already flown and logged several hours, without problems reported on the stabilizer bar. Several parts had to be removed from flight.

The investigation revealed the cracks started from a vibro-etched signature by the inspector who made the final acceptance of the part. Previous acceptance had been made in a different shop of the factory which manufactured the first pre-production articles and then transferred to a successive production shop for the series production. The transfer had been made without checking of the marking process, previously done by rubber stamp.

It has been found, that also the drawing was defective about the marking, not indicating precisely how and where to mark. Later it has been updated.

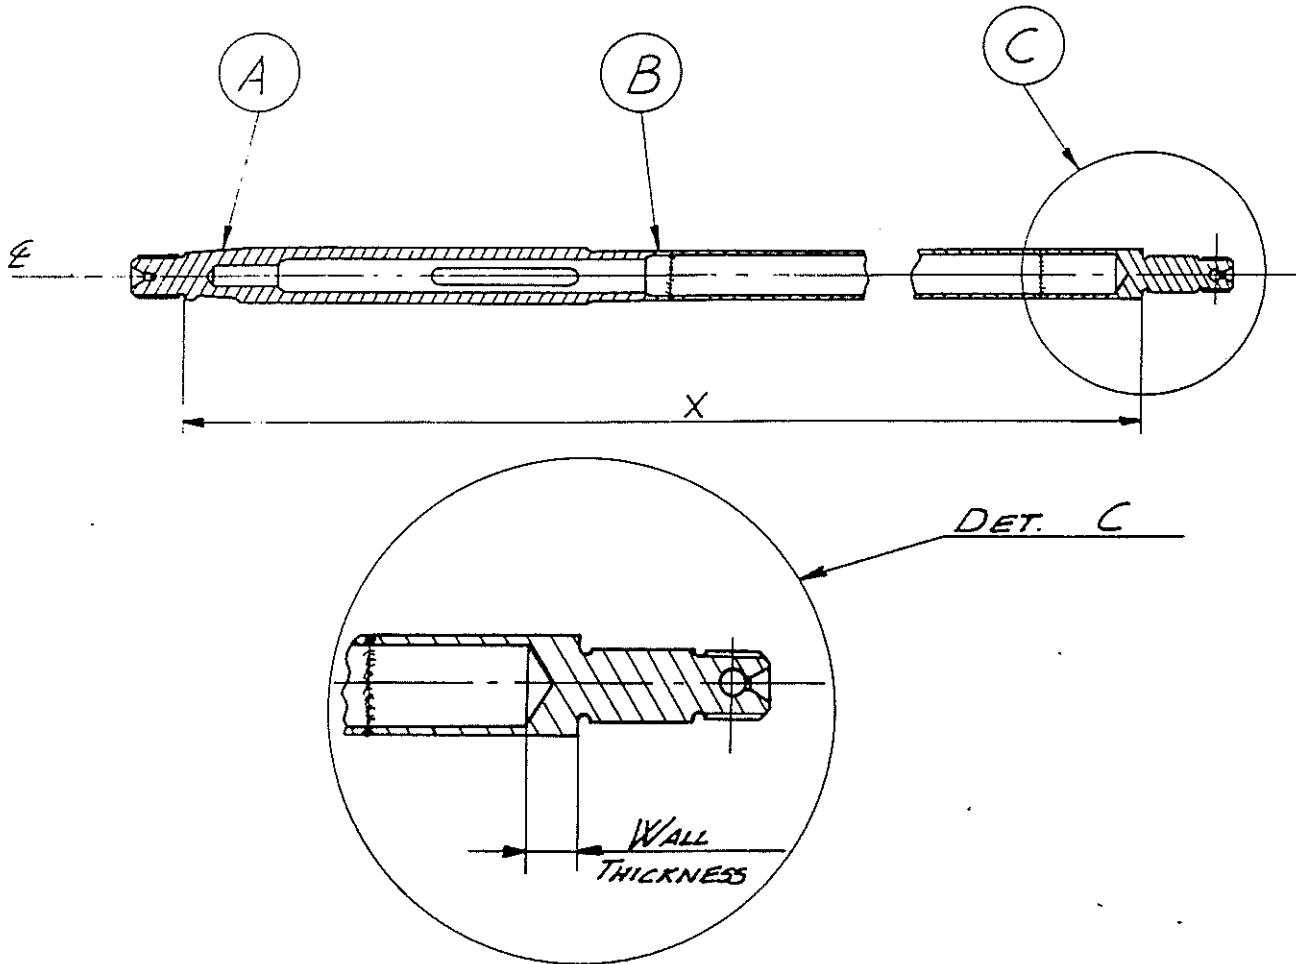
Tail Rotor Control Pitch Rod

The pitch rod, according to licensee drawing requirements is made by three different parts, namely A, B, C, machined separately to their dimension and then flash welded together. After welding, the final dimension X has to be machined according to B/P dimensions.

In this case Agusta did a positive manufacturing control, because with the first part produced has been evaluated the minimum wall thickness risk (part C being a hollow part) and an additional X ray inspection had been introduced on the Operation Sheets to monitor the real wall thickness on the finished part.

The Licensee issued, in the past, an airworthiness service bulletin requiring X ray inspection to the pitch control rods manufactured by him for the minimum wall thickness problem. The bulletin was not applicable to Agusta production.

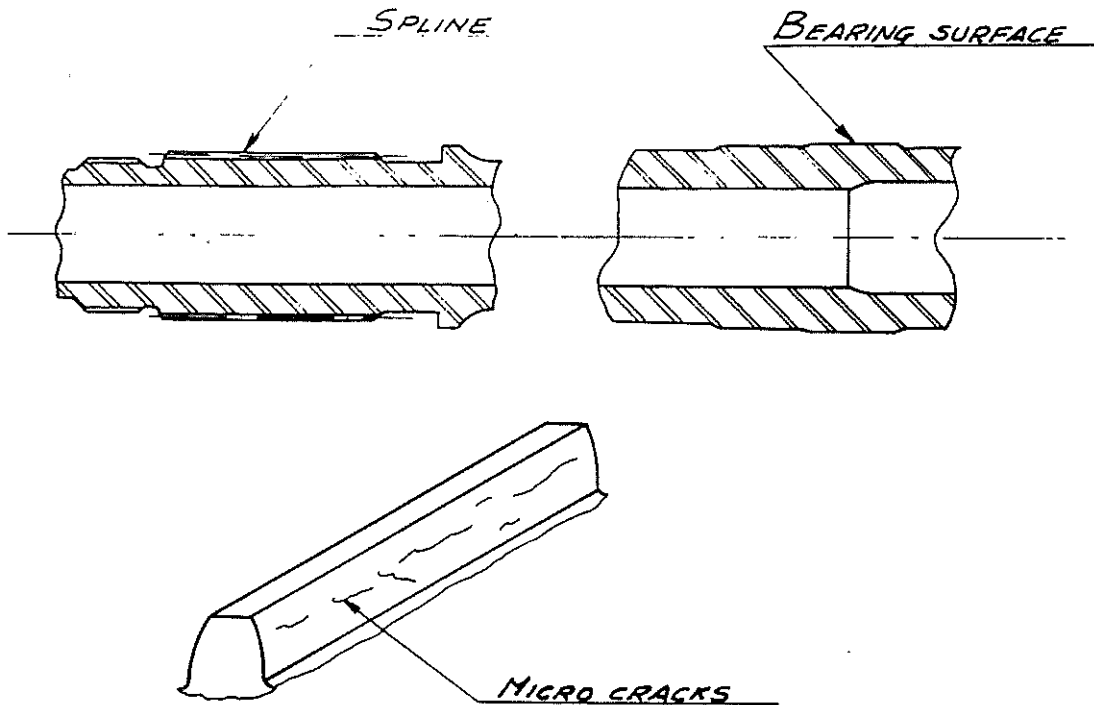
Tail Rotor Shaft Spline

The problem appeared evident even from the first time we reproduced the part: after the nitriding treatment according to specs., the parts were ground and then magnetic inspected.

Surface micro-cracks became apparent only on spline teeth, not on the bearing area, causing the rejection and scrapping of the parts, which happened several times.

Even with the Licensee support, it took time and efforts to clearly identify the correct temperatures and NH_3 dissociation required for the first and second phase of the nitriding process. In addition, in order to better control the in process development, a spline sector sample has been introduced, instead of the cylindrical sample, to check the microstructure on close to real part condition.

The magnaflux check has been introduced before and after grinding.

It goes without saying, that when this part will be reproduced by other source, the transferring of all the above significant manufacturing and inspection data is a "must" in order to receive back to Agusta a part with the same integrity level of that we are producing now.

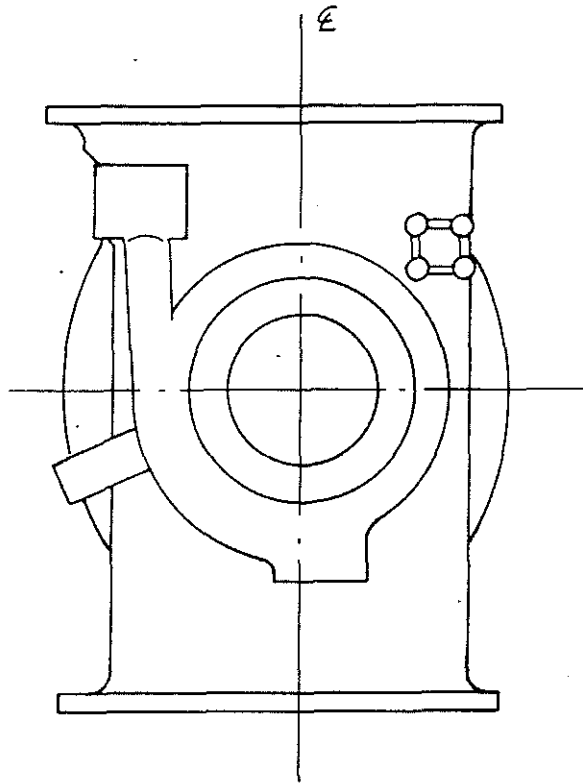
Acceptance Criteria

When a new Agusta subsidiary Plant for producing castings, was opened, in the south of Italy, we experienced a noticeable great amount of scraps and rejections.

A deeper analysis revealed, among other aspects, that castings accepted by subsidiary Q.C., were rejected by Agusta inspectors.

We had to transfer to them, in addition to the models already available, all the X ray inspection data for each P/N produced (current intensity, voltage, position) the same standard for acceptance we adopted in the past on our production, specifying the extent and location of permissible flows.

Today, we believe, from the quality stand point, that the method adopted is the only way to save the integrity of the parts and to avoid loss of money.

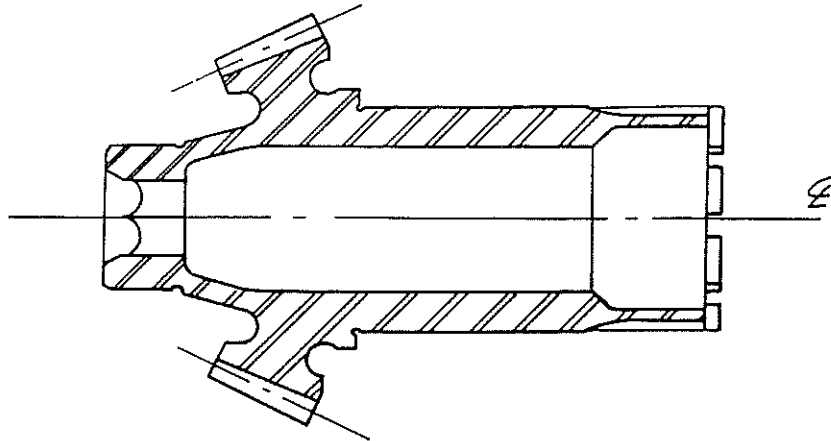
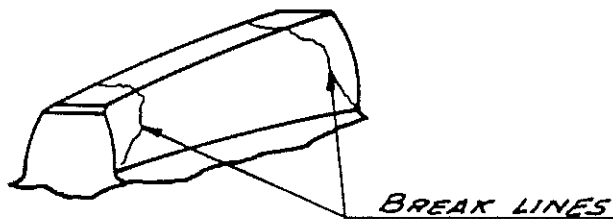
Gear

The defect was very singular; one lot of gears already machined, finished and waiting for final acceptance broke by themselves, on few teeth, generating cracks as shown by the sketch above.

The heat treating process was performed according to the specifications called out by the relevant drawing, but it has been discovered that the time elapsed from the deep freeze phase and the stress relief phase on that lot, was several days long, due to internal material flow which was recently changed. The reason of the cracks was the very high internal stress condition, after the deep freeze, not suddenly removed by the thermal relief as done previously. The operation sheet has been modified, specifying the tempering within a few hours after deep freezing, which was, not written before.

In gears manufacturing we learnt that the detailed manufacturing process must be closely followed in order to reproduce parts, in different lots, with the same characteristics.

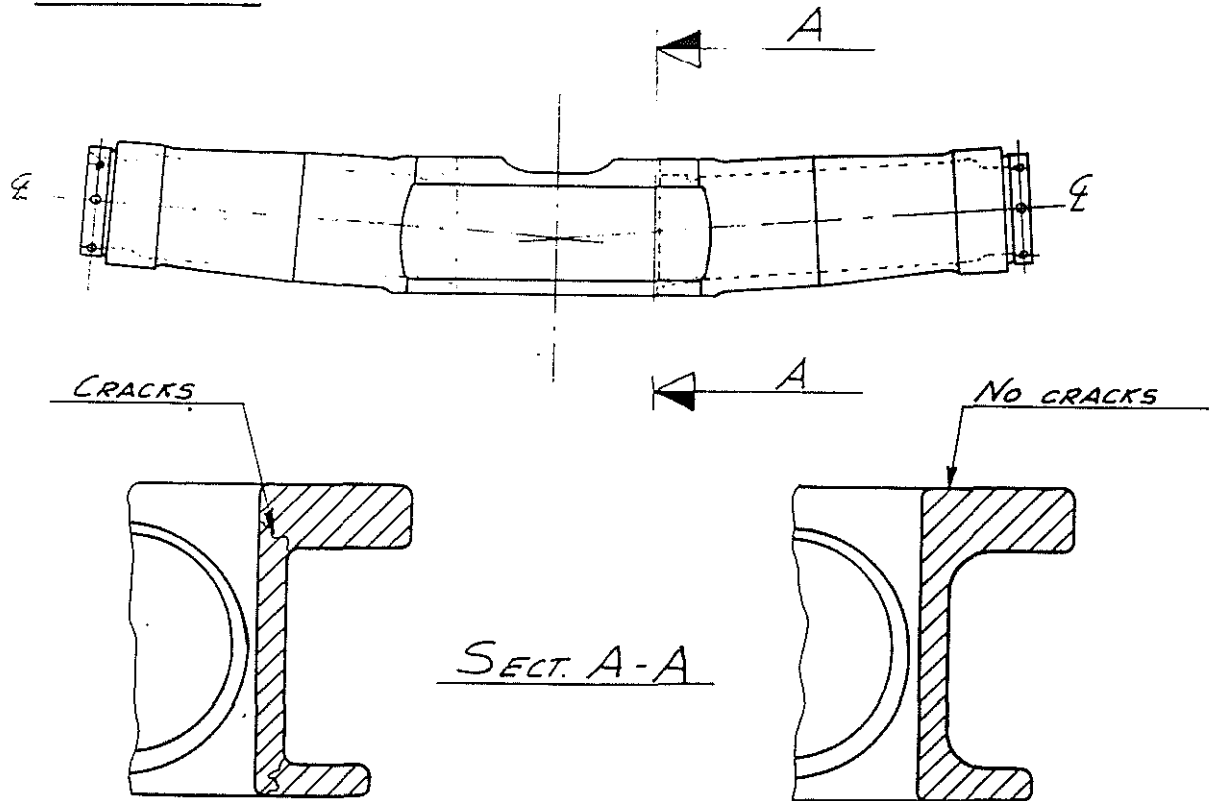
Main Rotor Hub

A high rate of scraps, due to heavy cracks, as shown, after heat treatment process in a semi-finished condition. The part being subcontracted to an Agusta supplier.

The investigation revealed that the subcontractor heat-treatment configuration was different from that adopted by Agusta in the previous years when the hub was manufactured in the Cascina Costa plant. The fault configuration showed too small radius between the web and the flanges. The heat treatment shape, already experienced by Agusta and more suitable to prevent internal stresses, solved the problem;

Similarly to the same previous cases shown, we believe that the check of subcontractor operation sheets against the Agusta manufacturing documents, would have prevented the scraps and the working hours lost.

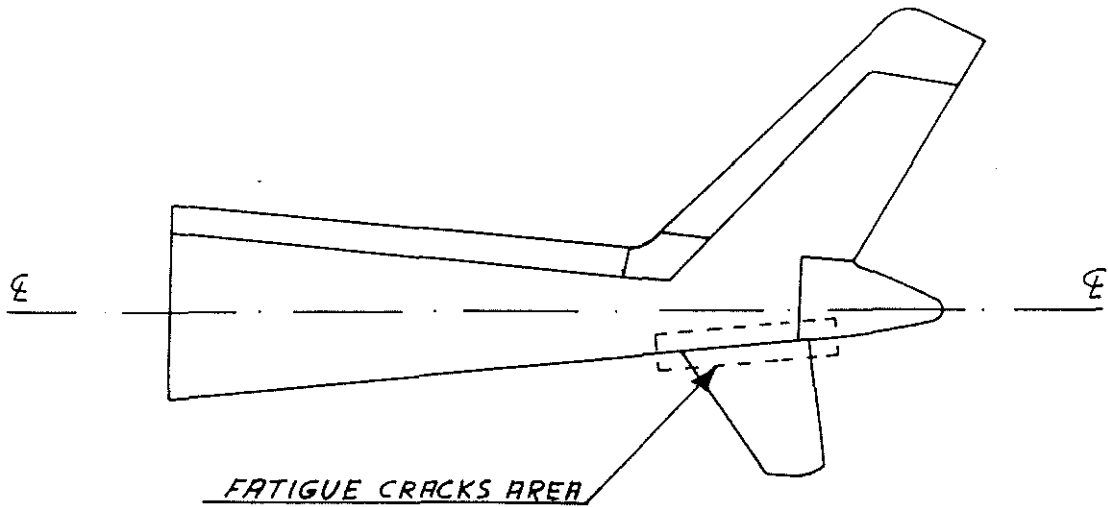
Tail Boom Assy

Later in service the helicopter experienced fatigue cracks originating in the joint area between the fin and the assembly sequence.

The industrialization did not properly replace the care adopted on the test articles, and suitable changes to the tool-chain and to the assembly sequence were made.

The case taught us to transfer to production articles as much as possible the assembly principles adopted on test items.

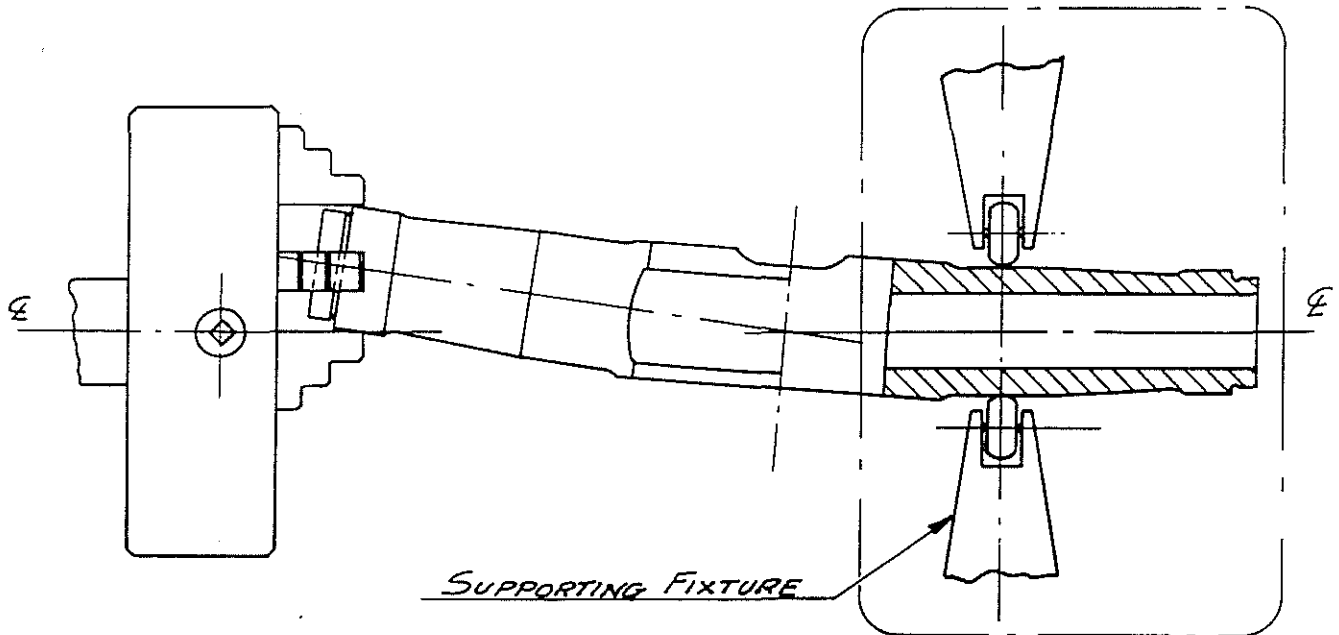
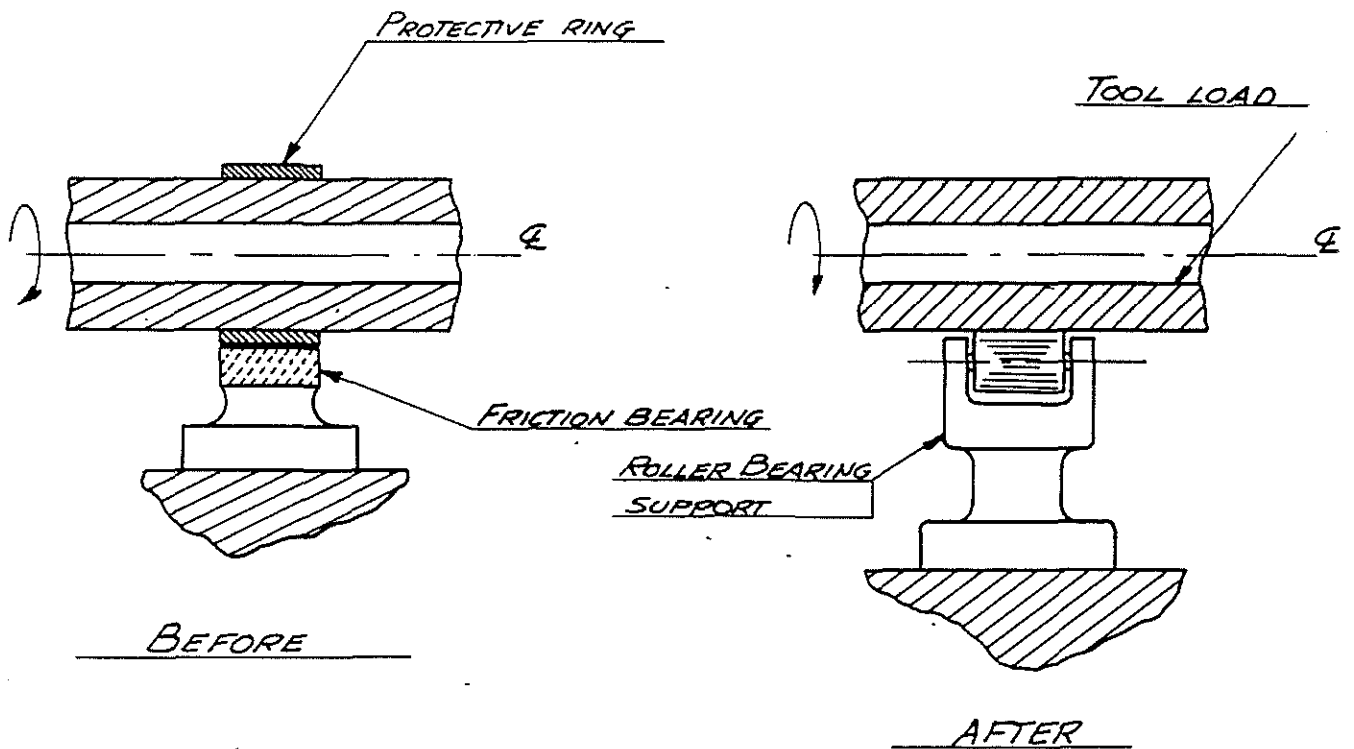
Arms of Main Rotor Hub

The shot peening operation performed according to the blue print requirements, showed a strange difference in brightness on the external surface of the hollow arm and it was tape masked along the circumferences.

Such area was later discovered being over hardened and not acceptable.

The part had been totally manufactured in plant for many years, so there was no guilty subcontractor to find out. The investigation revealed a different fixture adopted for internal boring of the hollow arm.

The new roller bearing support, adopted without protective ring, to permit higher cutting speed over hardened the external surface due to tool load.

This case taught us that, even minimum changes to a manufacturing process must be evaluated, before approval, against the integrity of the resulting parts. If doubts exist, let's try before with tests on samples.

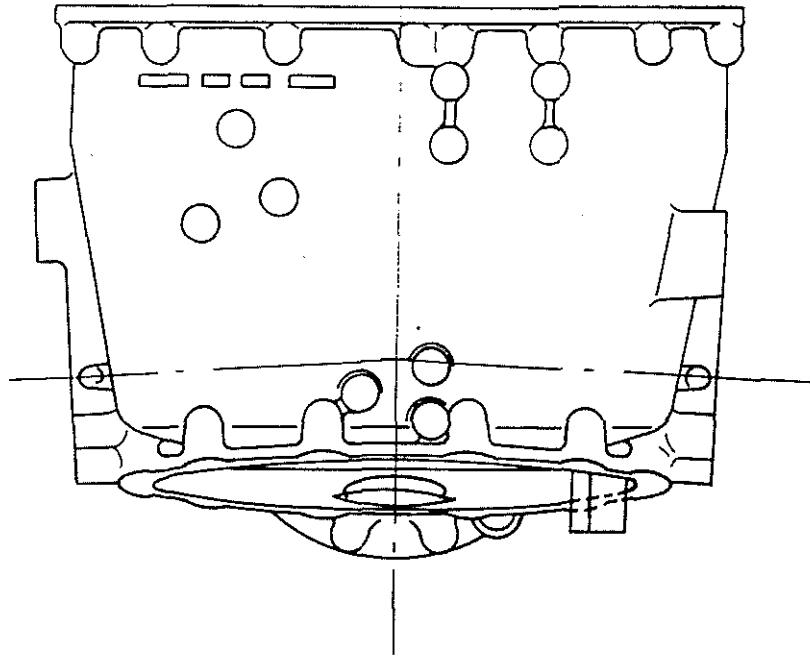
Main Gear Box Housing

The trouble was very singular and it took a lot of time to find out the solution. During the production test-run of a brand new main gear box, we experienced excessive lubricating oil temperature. The next tests gave the same results and the production was practically stopped.

The people involved to solve the problem, literally squeeze out their brains scratching their heads between one disassembly of the gear box and the other. At last they found defective circulation of lubricating oil due to difference of internal configuration of the housing casting.

It was a reproduction problem, because it happened the casting was the first item of a series produced by a new supplier. Agusta could'nt blame the vendor because it was found-out that the differences were within the drawing requirements. As usual we learn by error, and we introduced a specific configuration check sheet on high integrity casting in order to record the section shape of casting of the first item produced and to have it complied with any time the same part is produced by a new supplier.
