AIRWORTHINESS RELEASES AS A RESULT OF CONDITION BASED MAINTENANCE

William D. Lewis¹, Christopher D. Perry², and Jonathan A. Keller³

Aviation Engineering Directorate
Redstone Arsenal, AL 35898-5000, United States of America

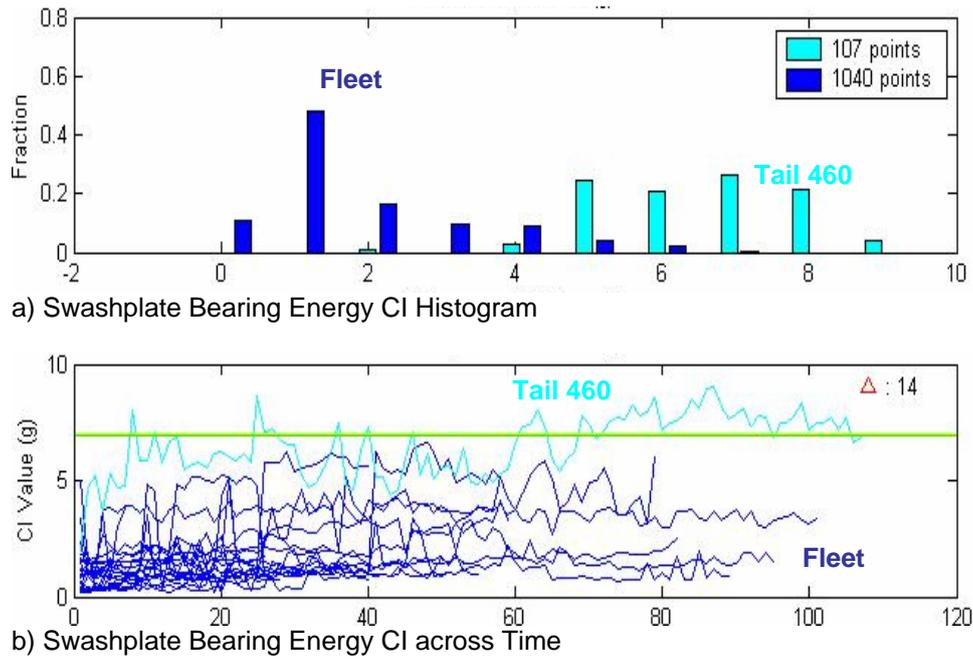
Figure 2. AH-64A Main Rotor Swashplate Energy CI

During the South Carolina Army National Guard (SCARNG) deployment to Kosovo in 2003-2004, the main rotor swashplate component for an AH-64A Apache, tail number 87-00460, went above the yellow caution level consistently beginning in November of 2003. Concurrently, the vibration data were also being monitored by the engineering team via automated Internet data transfer tools. Unit personnel checked the bearing in accordance with the Army Technical Manual TM 1-1520-238-23, paragraph 1.137. This particular check is required every 50 flight hours and involves checking the swashplate for grease leakage; and after the swashplate accumulates 1750 total flight hours it is also required to disconnect all the pitch change links from the swashplate and rotate the outer ring, noting any abnormalities in smoothness of rotation or axial play. The unit completed this check three times and no problems were noted. The unit personnel and the engineering team agreed on a plan to continue to monitor the component for additional increase in vibration while the aircraft was deployed.

While the aircraft was still deployed, the data was investigated further. The component caution was being driven by a CI associated with the accelerometer bonded to the underside of the non-rotating main rotor swashplate. This particular CI measures the vibration energy within a frequency band from 100 to 5900 Hz, which contains the fundamental and several harmonics of the main rotor swashplate bearing fault frequencies. This CI is also only calculated while the aircraft is on the ground in flat-pitch at full rotor speed to eliminate variations in the CI due to aircraft loading and drive train torque. The statistical review of the CI for tail 460 compared to the rest of the CBM-equipped aircraft is shown in Figure 2. The top plot shows a histogram of the data by CI level, while the bottom plot shows the value of the CI for each aircraft by acquisition number. Note that there were a total of 1147 acquisitions of this CI (107 for tail 460 and 1040 for the rest of the fleet), which encompasses a period of approximately 4 years and 32 aircraft. The majority of the fleet has a CI of about 1, while the CI for tail 460 was above the caution limit of 7 for the last 30 acquisitions which covered the period from November of 2003 to January of 2004. The aircraft accumulated approximately 250 flight hours during the period it had been monitored.

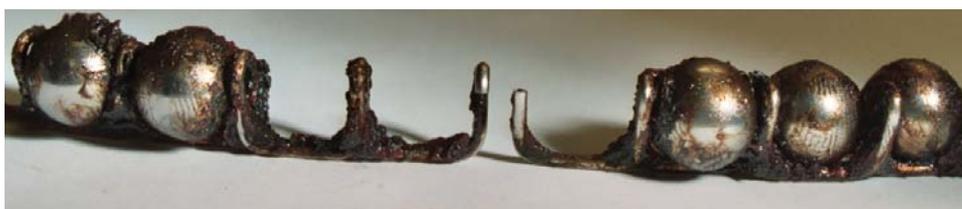
Once the aircraft returned to South Carolina, raw time-domain vibration data was collected during ground runs from tail 460 and two other aircraft chosen at random. Somewhat serendipitously, tail 460 was also scheduled to be turned-in to Boeing Mesa for conversion to an AH-64D Longbow. Coordination with SCARNG and the Apache Program Management Office enabled the removal of the entire swashplate for teardown analysis by AED. At the time of removal the swashplate had accumulated 1961 flight hours, out of a maximum life of 2250 hours. The swashplate assembly was shipped to Redstone Arsenal and the duplex ball bearing was removed per the Depot Maintenance Work Requirement (DMWR) and finally cut apart and inspected. The upper row was in good condition; however, the lower row had a broken cage, corrosion and pitting on the inner and outer races and blackened grease shown in Figure 3.

a) Broken Cage

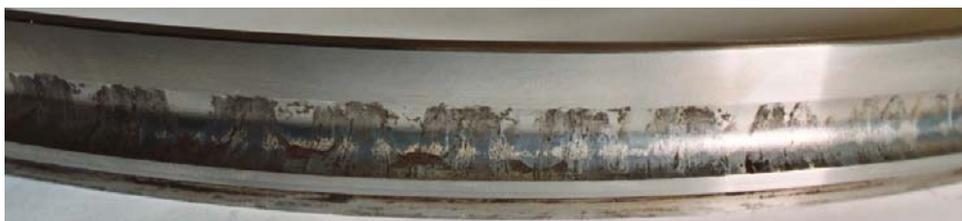
b) Corrosion and Pitting on Inner Race

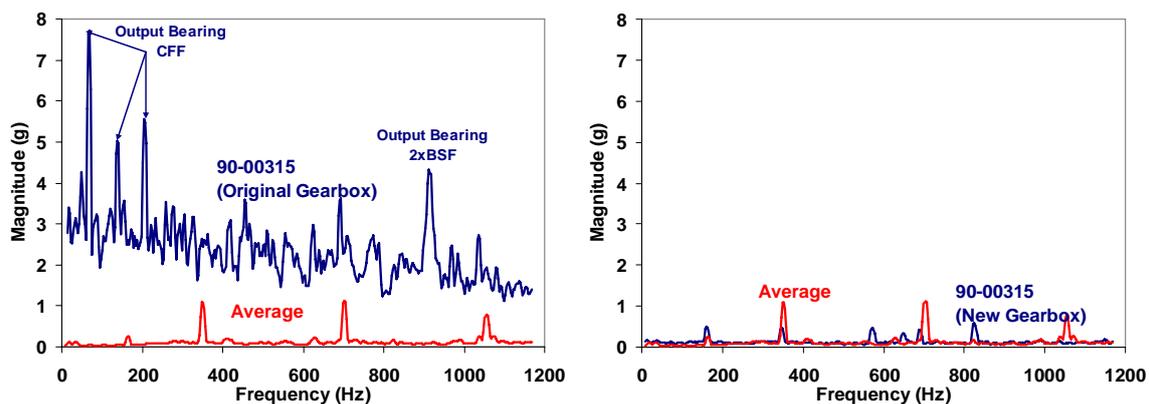
Figure 4. Original and New Nose Gearbox Vibration Spectra

In the summer of 2003, HUMS systems were installed on AH-64A Apaches at the Western Army National Guard Aviation Training Site (WAATS). During the standard installation checkout procedure, tail number 90-00315 was noted to have an extremely high vibration reading for the #2 (right) engine “nose” gearbox causing the component to be in the red exceedance condition. The vibration spectrum for tail 315 compared to an average spectrum for 7 other “normal” aircraft is shown in Figure 4. The spectrum for tail 315 appears to be drastically different than normal and has a very high noise floor. The largest peaks in the spectrum for tail 315 correspond to the first three harmonics of the cage fault frequency (CFF) of 69 Hz and the second harmonic of the ball spin frequency (BSF) of 892 Hz for the duplex ball bearing supporting the output bevel gear while the only peaks of note for the average aircraft occur at the engine power turbine shaft speed of 348 Hz and the nose gearbox output shaft speed of 164 Hz. During next test flight the crew noted that the #2 nose gearbox chip detector signaled that the gearbox had a chip, which caused the flight crew to land the aircraft at an off-site location. The chip detector inspection criteria called for the replacement of the nose gearbox. After unit personnel replaced the gearbox, the chip detector light went out and the CI returned to a normal level. The vibration spectrum immediately after gearbox replacement is also shown in Figure 4. Note the drastic reduction in vibration.

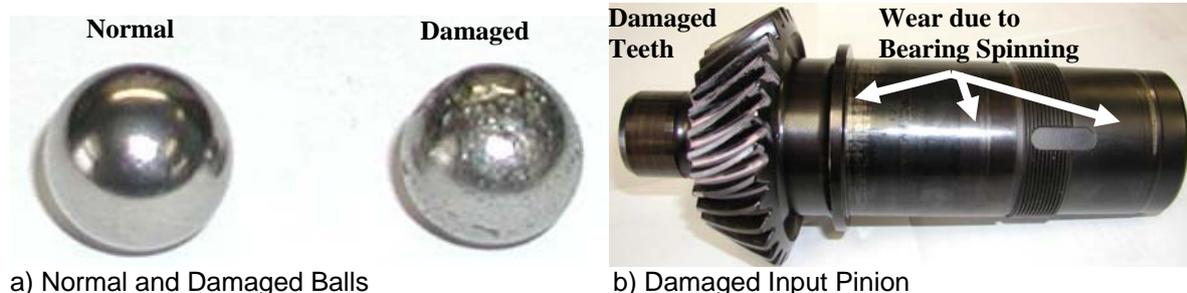
Figure 5. Spalled Duplex Output Bearing and Input Pinion

The original gearbox was sent to CCAD for overhaul. Teardown revealed the primary cause of failure was spalling of the inner race of the duplex ball bearing supporting the output bevel gear. Secondary damage then also occurred to the other parts of the gearbox. The input gear had a deep groove on the seal surface and metal breakout on the gear teeth; and the output gear had stress pitting on the teeth as shown in Figure 5.

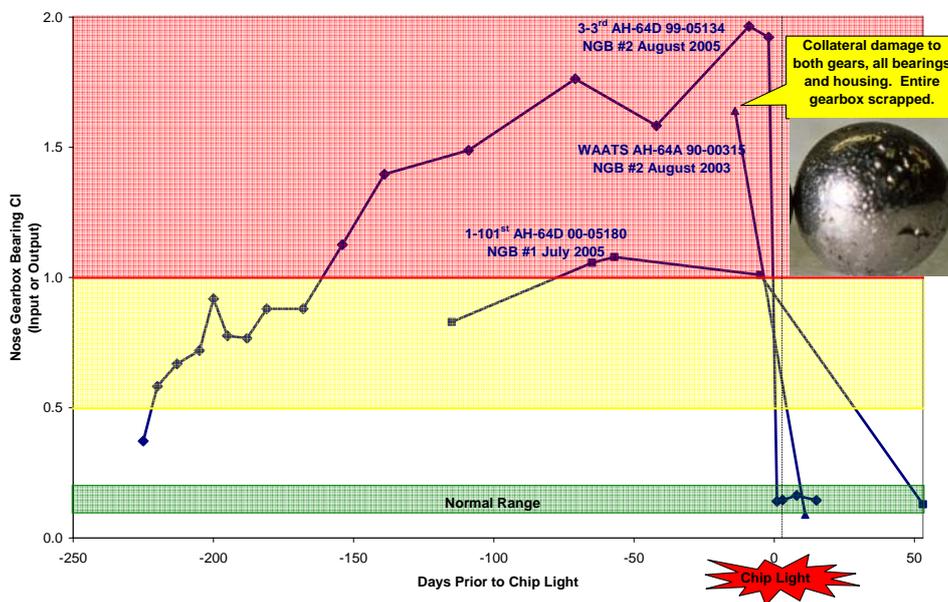
Figure 6. Original and New Nose Gearbox Vibration Spectra

Since that time, several additional examples of Apache AH-64A and AH64D nose gearbox problems have been detected with the VMEP/MSPU systems. In some cases, the gearbox was removed due to high vibration readings and a chip light, in other cases the gearbox was removed due only to high vibration levels because the aircraft was at a convenient maintenance interval prior to deployment. Follow-on vibration acquisitions after the gearboxes were replaced show that the new gearboxes have been operating normally as shown in Figure 6. Note a normal condition indicator level is about 0.1 to 0.2 per the figure. The red “exceedance” level is currently set at 1.0 and in 2 instances the gearbox had a value of 1.7 to 1.9 prior to illuminating the chip light. Additionally, in one case the unit was given approximately 80 days warning of an impending chip light; in the other case it was 160 days warning. From this information, there have been 2 additional nose gearboxes that have either entered the yellow “caution” condition or red “exceedance” condition that were changed at a convenient maintenance interval prior to the illumination of the chip light, so they are not depicted in Figure 6.

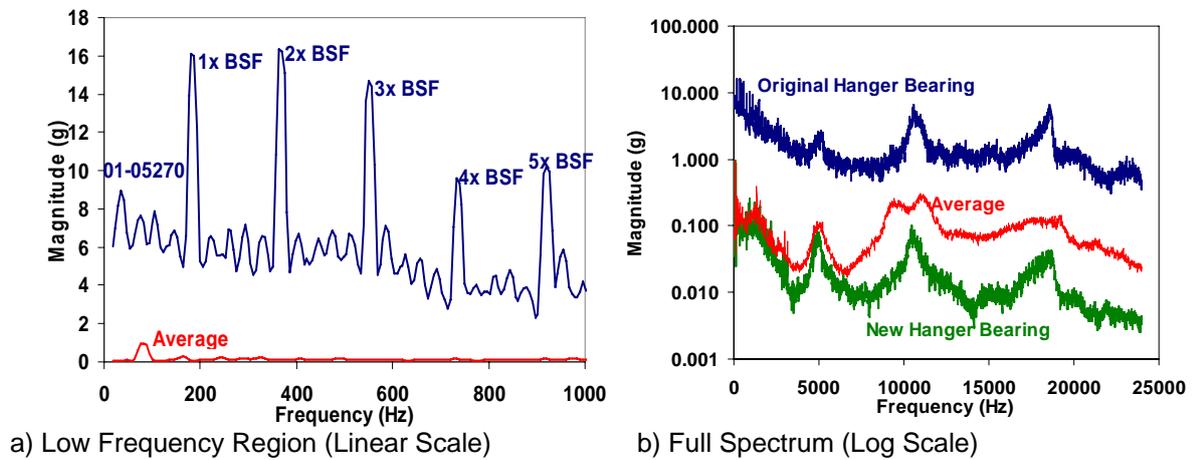
Figure 7. Hanger Bearing Vibration Spectra

In the fall of 2004, 8 HUMS systems were installed on AH-64D Longbow Apaches assigned to the 3-3rd ARB. Tail number 01-5270 was noted to have an extremely high vibration for the aft hanger bearing during the standard installation checkout procedure causing the component to appear in the red exceedance condition. Concurrently, AED engineering was reviewing the vibration data. The vibration spectrum for tail 01-05270 compared to the average spectrum for the 7 “normal” 3-3rd AH-64D aircraft is shown in Figure 7. Inspection of the low frequency region reveals large peaks corresponding to the hanger bearing ball-spin fault frequency (BSF) of 183 Hz and higher harmonics. After inspection of the vibration measurements, it was recommended to the unit perform the driveshaft and hanger bearing inspection in accordance with Army Technical Manual TM 1-1520-238-23, paragraph 6.1. Included in this check is a visual inspection for damage or looseness in the mounts, driveshaft and bearing support. No obvious damage was found. Additionally, the hanger bearing is also inspected for damage, grease leakage or roughness of rotation. Here, it was noted that the hanger bearing rotation was rough. No roughness is allowed per the TM, so the bearing was removed. A new hanger bearing was installed on the aircraft and another set of vibration

measurements were acquired during a ground run. The results, shown in Figure 7, demonstrate the new hanger bearing actually has lower vibration levels than the other 3-3rd Apaches. The drive shaft component returned to a green condition and the aircraft was released for flight.

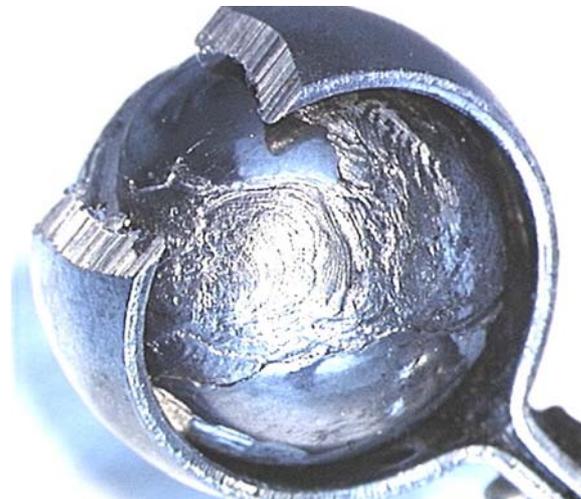
Figure 8. Spalled Hanger Bearing

When the original bearing was disassembled, it was noted that the grease adjacent to the ball bearing retainers appeared dark and over heated and had a high presence of dirt. The bearing was then cut apart and the AID investigators discovered that the failure was initiated by a single corroded ball bearing which was actually reduced in size due to spalling as shown in Figure 8. The spalled ball then caused secondary damage to the other balls and raceways.

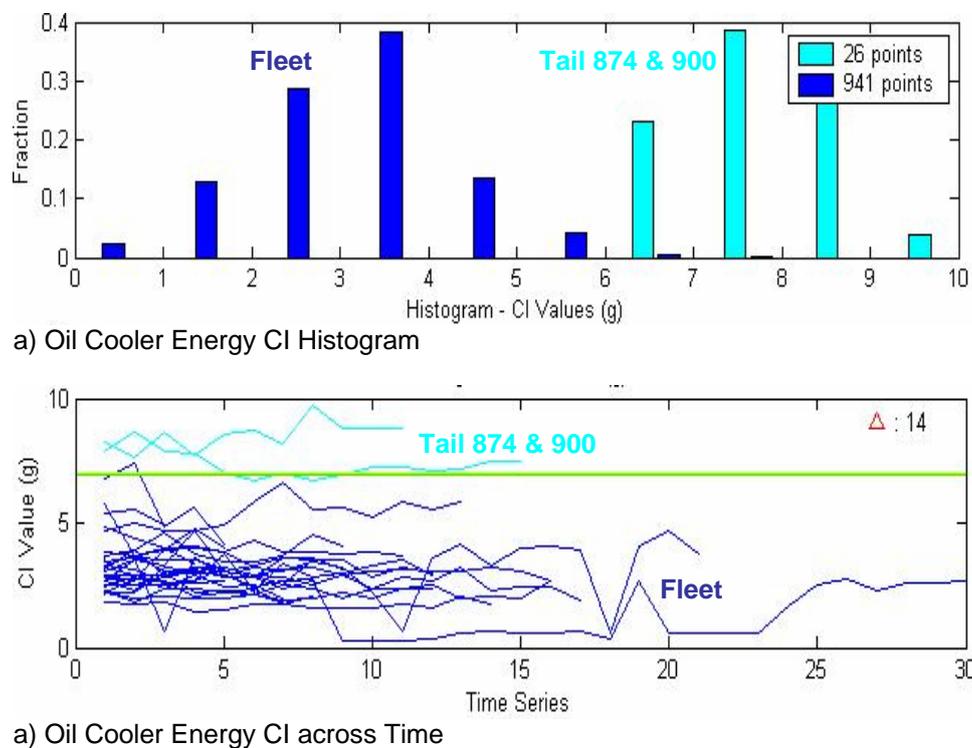
Figure 9. Oil Cooler Energy CI

During the fall of 2003 to spring of 2004, CBM systems were installed on 15 UH-60A Blackhawks at the 1-52nd Aviation Regiment in South Korea. Since then, the CBM systems identified 2 aircraft, tail numbers 83-23874 and 83-23900, with oil cooler fans that were in the yellow caution condition. Both of the oil coolers in question passed the US Army mandatory 120-hour vibration check, with axial vibration levels of approximately 0.25 IPS for the tail rotor driveshaft 1R compared to a limit of 1.0 IPS. The particular CI that drove

the oil cooler component into the caution level measures the axial vibration energy within a frequency band from 50 to 950 Hz, which contains the fundamental and several harmonics of the oil cooler fan bearing fault frequencies. This CI is also only calculated while the aircraft is on the ground in flat-pitch at full rotor speed to eliminate variations in the CI due to aircraft loading and drive train torque.

The statistical review of the CI for the two oil coolers in question compared to the rest of the CBM-equipped aircraft is shown in Figure 9. The top plot shows a histogram of the data by CI level, while the bottom plot shows the value of the CI for each aircraft by acquisition number. Note that there were a total of 967 acquisitions of this CI (26 acquisition for tails 874 & 900 and 941 acquisitions for the rest of the fleet), which encompasses a period of approximately 4 years and 33 aircraft. The majority of the fleet has a CI of about 3.5, while the CI for tails 874 & 900 were above the caution limit of 7 for all acquisitions since the HUMS was installed on the aircraft in February of 2004.

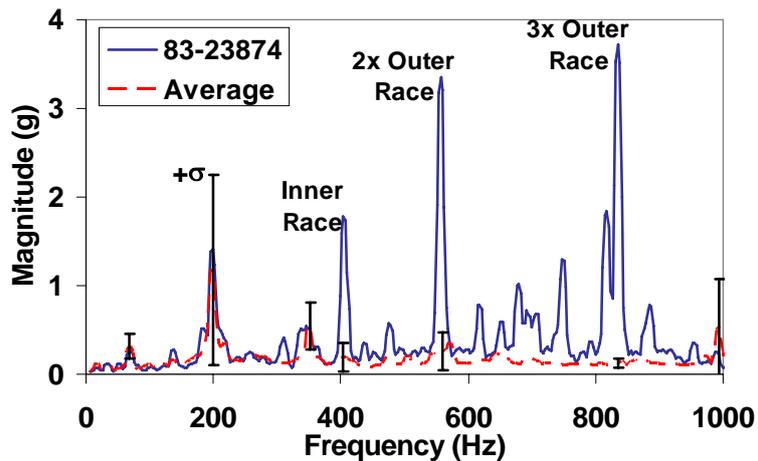
Figure 11. Oil Cooler Bearing Vibration Spectrum

Even though the CI was only slightly above the caution limit, further investigation of the vibration spectrum was cause for greater concern. The vibration spectrum for tail 874 compared to an average spectrum for 7 other “normal” aircraft from the same unit is shown in Figure 11. The vertical error bars for the “normal” aircraft are one standard deviation, σ . The vibration spectrum for tail 874 aircraft contains large peaks at the oil cooler fan bearing inner and outer race fault frequencies. Note the “normal” aircraft has very little vibratory magnitude at the fault frequencies, but does have a few peaks at 69, 197, 348 and 989 Hz. Those peaks are naturally occurring and correspond exactly to the tail rotor driveshaft once-per-revolution speed (1R), accessory drive 1R, engine high speed shaft 1R and the fundamental planetary gear mesh.

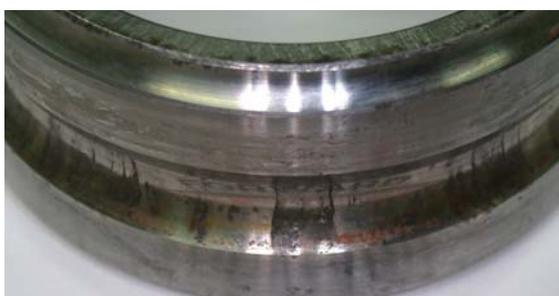
Figure 10. Oil Cooler Fan Bearing Teardown

Coordination with the unit and the Blackhawk Program Management Office enabled the removal of the oil coolers from tails 874 and 900. The oil cooler assembly from tail 874 was then sent to Corpus Christi Army Depot (CCAD) where it was disassembled and inspected by the Analytical Investigation Division (AID). At the time of removal the oil cooler has accumulated 1600 flight-hours, while the maximum service life of the oil cooler fan bearings is 2000 flight-hours. Compared to the suspect oil cooler, the rotation of a new oil cooler fan was noticeably quieter and smoother. The suspect bearings were then removed from the fan. The bearings and bearing grease were weighed, and the bearing dimensions were measured with no anomalies. Both bearings were then disassembled and visually inspected and exhibited significant corrosion pitting and spalling, examples of which are shown in Figure 10. The AID investigators stated that the fan had likely sat idle for a significant amount of time with moisture present in the bearings. It was possible to see a pattern on both races due to corrosion that had developed between the ball-to-race interfaces. The cages from each bearing also revealed corrosion pitting. Balls from both bearings showed evidence of spalling and deformation. The AID investigators stated that once the corrosion had developed, spalling then resulted when the fan was operated which exacerbated the poor condition of the bearings. It was the opinion of the AID investigators that it was a wise decision to remove the oil cooler fan from service.

a) Oil Cooler Fan Bearing Race

b) Oil Cooler Fan Ball Bearing

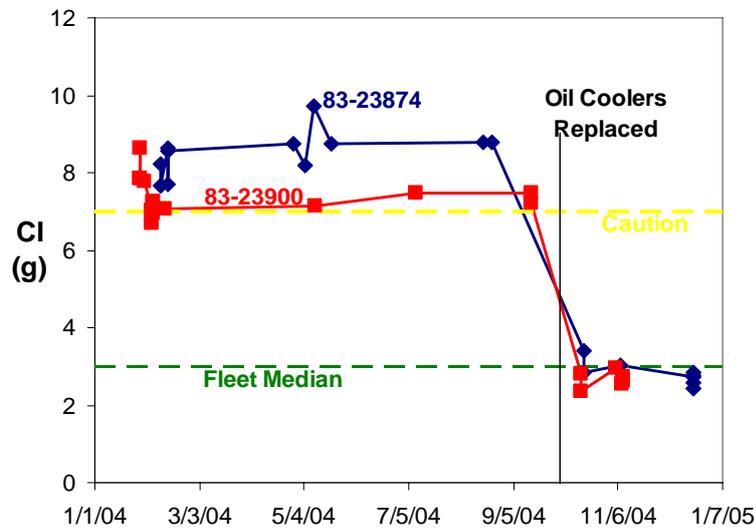
Figure 12. Oil Cooler Fan Energy CI

Once new oil coolers were installed on both aircraft, new measurements were acquired to determine the effect on the vibration and condition indicators. Figure 12 shows the energy CI before and after the oil cooler replacement for tails 874 and 900 only. The condition

indicator for the original set of oil coolers was relatively constant for the entire eight month period they were being monitored. After the oil coolers were replaced, the CIs for each aircraft immediately returned to the fleet median of 3.
