S-61N FREE WHEEL UNIT MALFUNCTIONING

F. LOUWERS AND F. SCHAPER

KLM HELIKOPTERS B.V. SCHIPHOL AIRPORT EAST, THE NETHERLANDS

FIFTEENTH EUROPEAN ROTORCRAFT FORUM

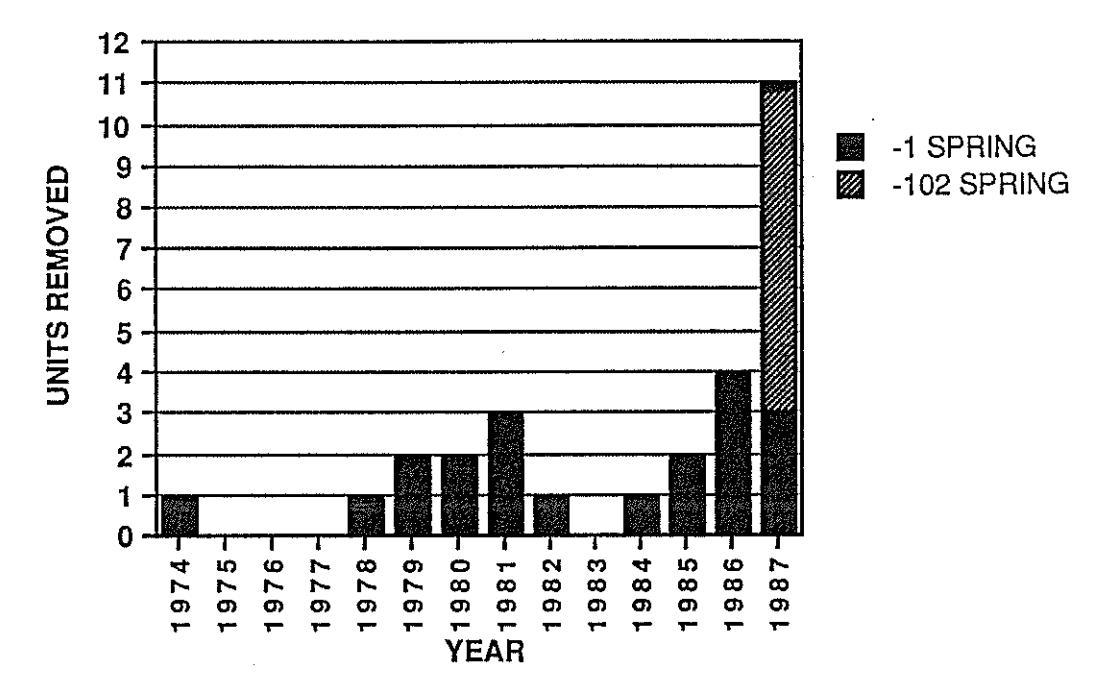
Figure 1: FWU spitouts vs. years, 'dash 1' and 'dash 102' springs

Figure 1 also shows that in 1987 most of the failed units incorporated the so-called 'dash 102' roller cage retention spring, introduced in that year with the objective to reduce FWU failures.

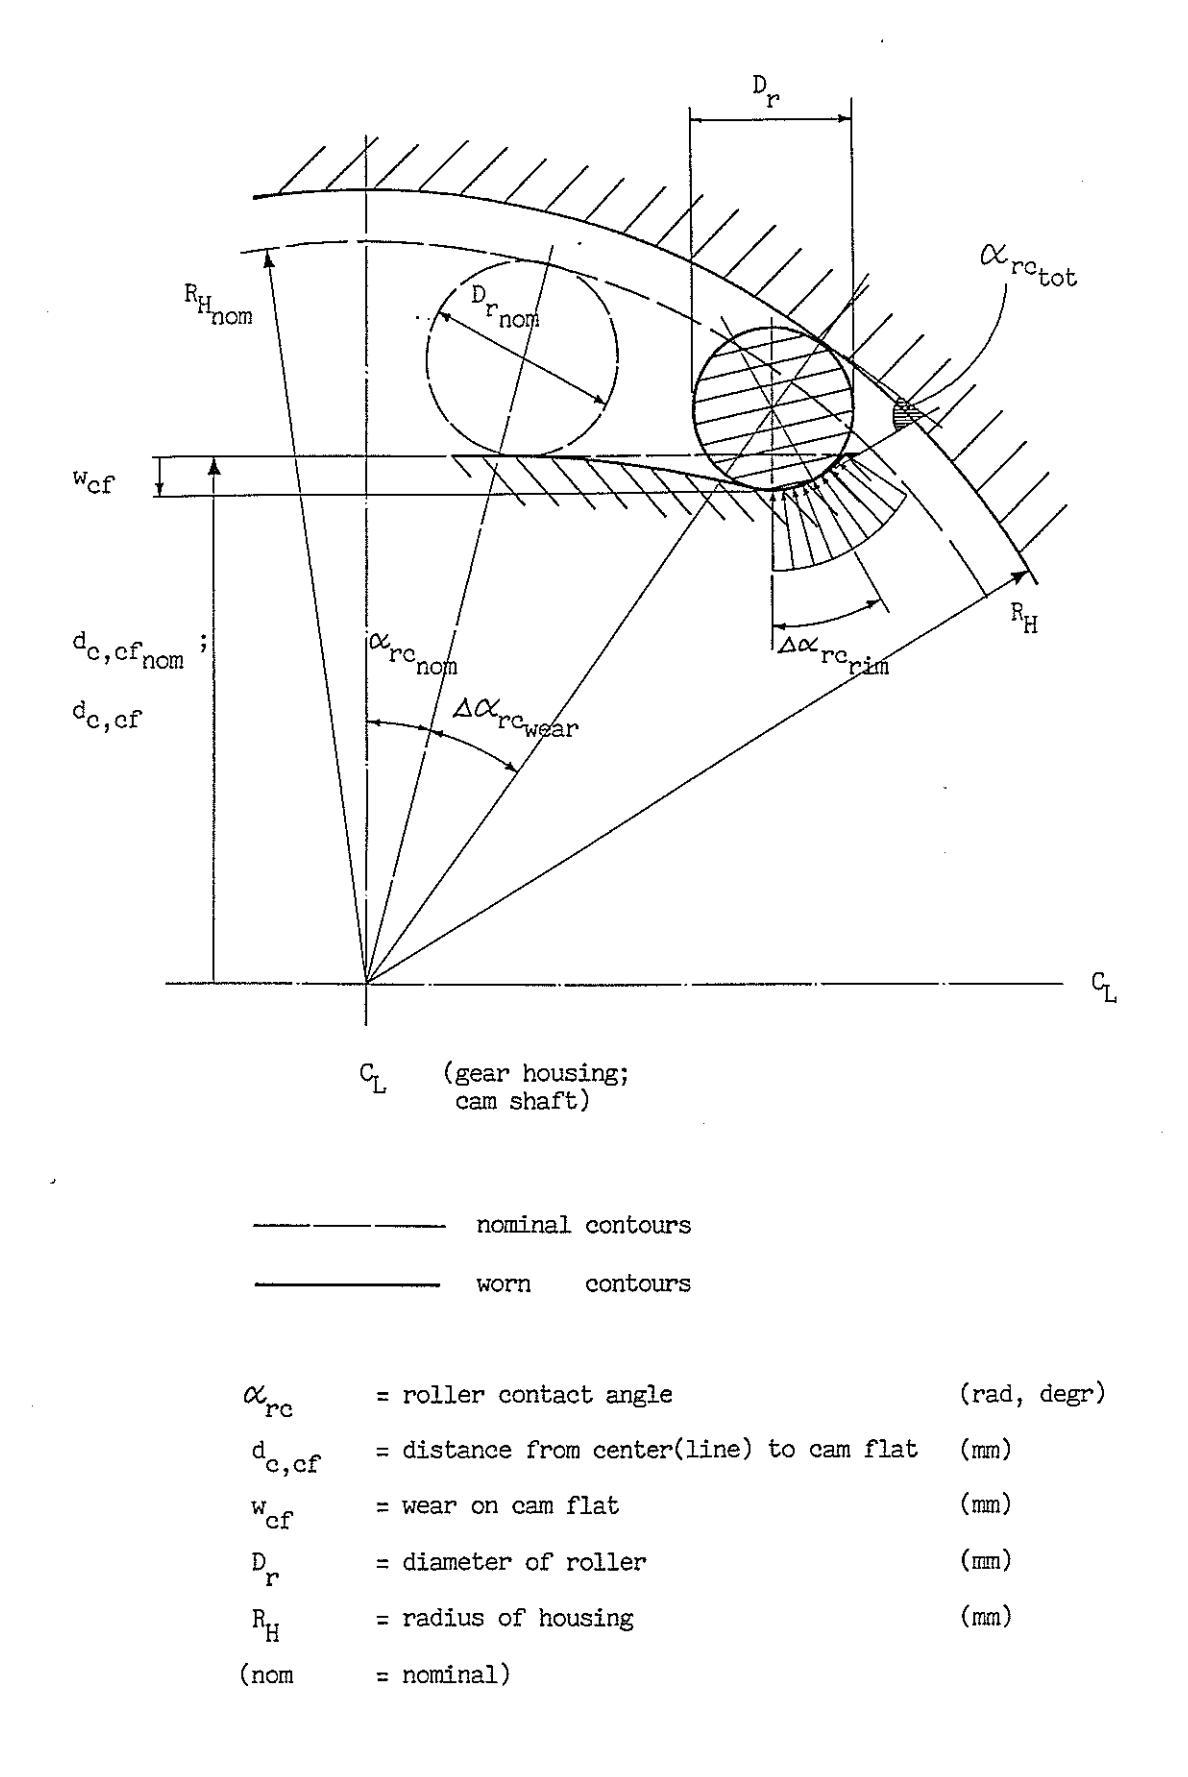
The FWU malfunctions appeared to be related to excessive wear of the unit components. The key parameter in the FWU failure mechanism is the total roller contact angle, the mean angle between the roller contact surfaces with the gear housing inner race and the cam flat respectively, see figure 4. If gear housing, cam shaft, roller cage and rollers are all new (no wear) and would have nominal dimensions (nominal value = average of lower and upper blue print limit) the (nominal) roller contact angle would be equal to 3,5 degr. At full working load this angle increases with approximately 2,5 degr due to elastic deformations. Roller spit out occurs at a critical roller contact angle of appr. 12 degr, see figure 5, leaving a margin of some 6 degr for wear on the main components.

<u>Figure 4:</u> Effect of wear on dimensions of FWU components; definition of characteristic angles

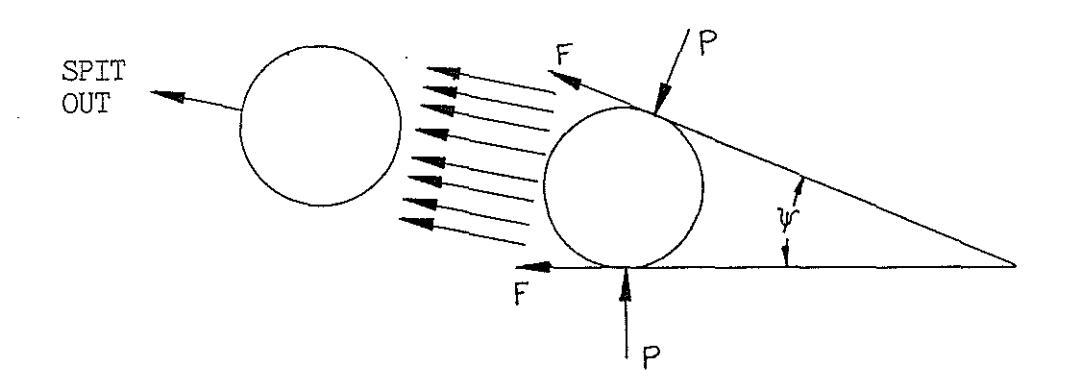
If the total angle exceeds 12 degr, spit out may occur, a phenomenon that can best be compared with a pee held by thumb and index-finger: if too much pressure is exercised, the pee will be pushed out. Something similar may happen to a roller, see figure 6 which also summarizes the possible consequences of one roller leaving drive position. In the worst case FWU drive is lost for a period long enough to shut down the fuel supply to the applicable engine. This automatic fuel shut off is a built-in protection against excessive overspeeding of the engine.

- ROLLER EXITS DRIVE POSITION
- CAGE CARRIES ALL OTHER ROLLERS
- DRIVE IS LOST
- MAY REENGAGE
- MAY CAUSE ENGINE SHUT DOWN

<u>Figure 6:</u> Roller spit out and consequences

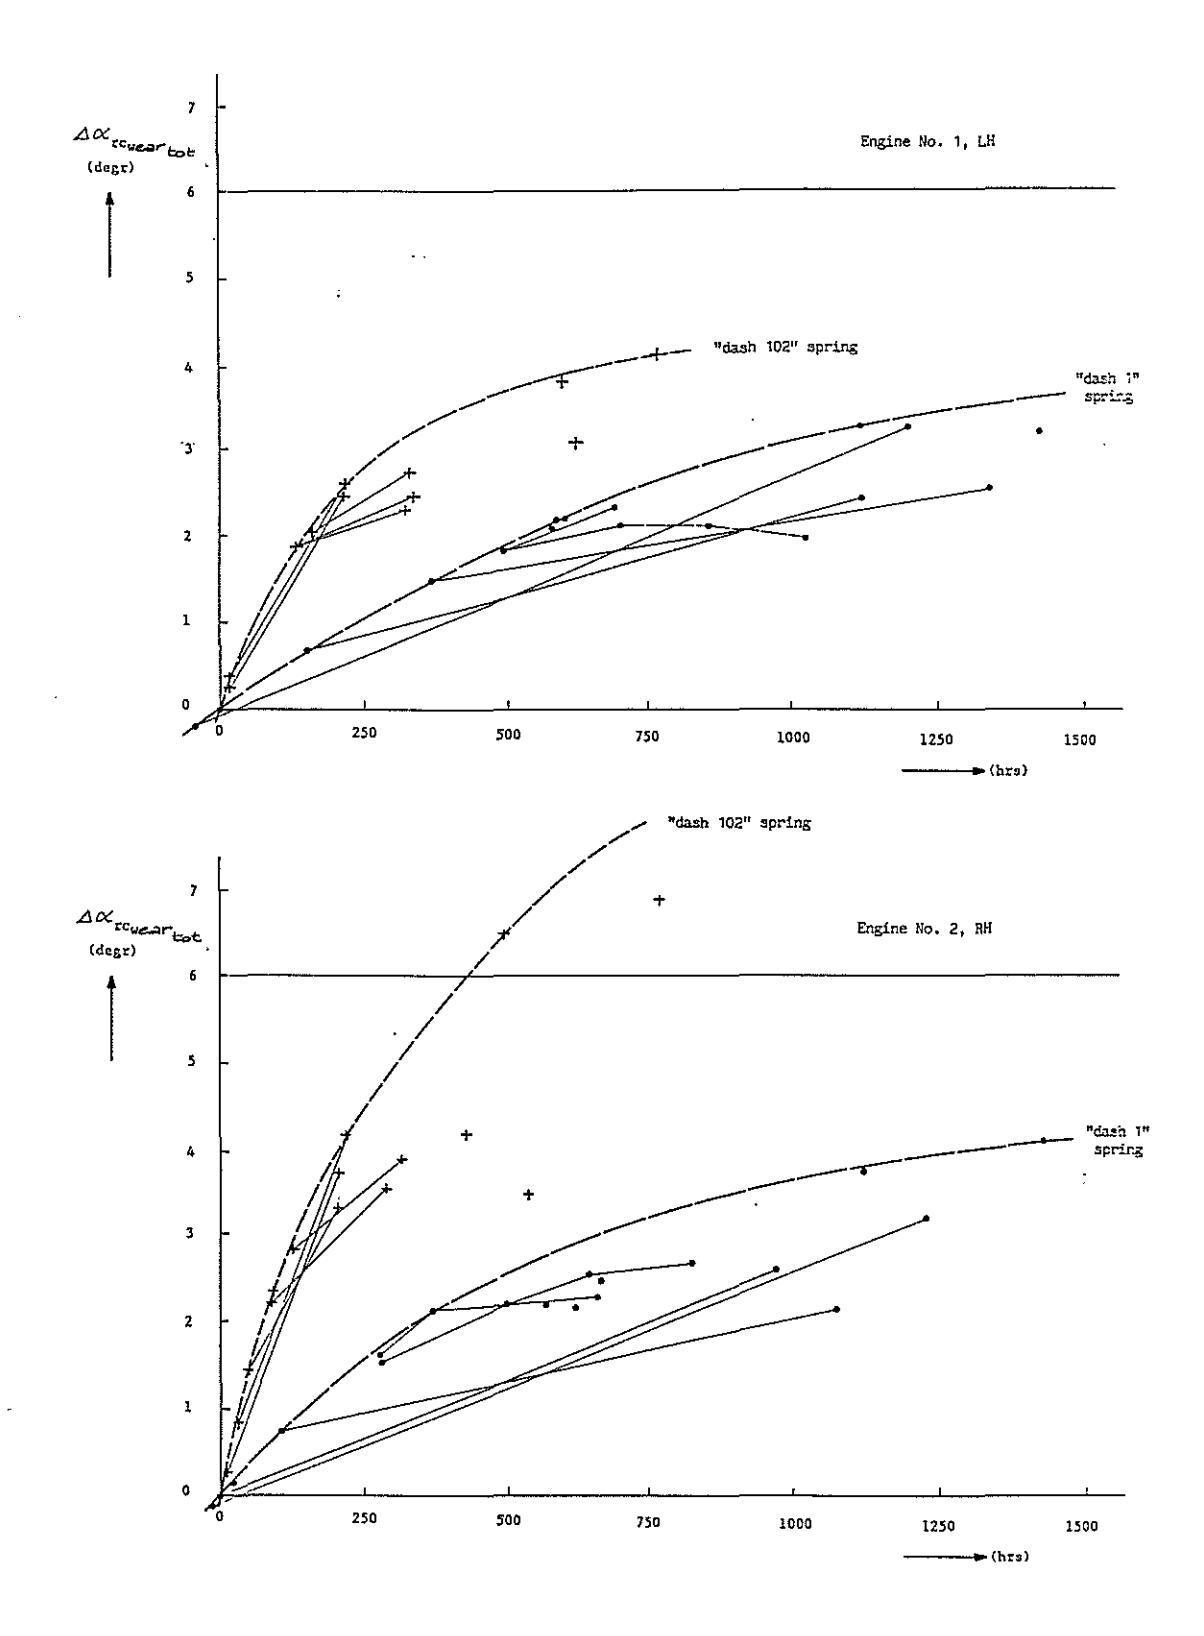
<u>Figure 7:</u> Increase in roller contact angle due to wear and imperfections versus flghthrs, for LH and RH engine and both 'dash l' and 'dash 102' spring (experience KLM Helikopters)

Results for the total wear angle are shown in figure 7: the dashed curves are limiting curves (worst cases to date) for LH and RH engine respectively and both for the 'dash 1' and 'dash 102' springs. The graphs reveal the following:

- the 'dash 102' springs were causing considerably more wear than the originally and presently used 'dash 1' springs, especially on the RH FWU;
- 2. the difference between LH and RH FWU wear is remarkable for the 'dash 102' spring, but marginal in case of the 'dash 1' spring;

- 3. in all four cases the wear rate decreases with increasing no. of hrs which may be attributed to the earlier mentioned rim in the cam flats, that increases the contact surface, thus decreasing contact pressure between rollers and cam flats;

- 4. the critical wear angle of 6 degr was confirmed by two engine flame-outs due to roller spit outs experienced by KLM Helikopers on two RH FWUs incorporating the 'dash 102' springs, with wear angles exceeding 6 degr. It also explains the sudden increase in FWU failures in 1987 after incorporation of the 'dash 102' roller cage retention spring: according to the lower graph RH FWUs with this spring would very likely have failed long before reaching a time between overhauls (TBO) of 2500 hrs;

- 5. there is a considerable spread in results, which may be due to hardness differences between the components, excentricity of gear housing and/or cam shaft, more than normal play on roller cage, (MGB) vibrations, etc;

- 6. considering the results with the 'dash l' spring, experience gained sofar seem to justify the assumption that the increase in roller contact angle due to wear remains well below the critical angle even when operating the FWUs from 0 to 2500 hrs.
