# ENGINE VIBRATION SURVEY TESTING ACTIVITIES

T-625 helicopter, created by the Turkish Aerospace Helicopter Group, serves as a light utility multi role helicopter. It is powered by a pair of CTS800-4AT turboshaft engines, which were developed by the Light Helicopter Turbine Engine Company (LHTEC). This paper presents aspects of engine vibration characteristics in powerplant integration of the T-625 helicopter. The results of engine vibration flight test campaign, engineering activities to control engine vibration amplitudes to acceptable levels accordance to the certification requirements. The impact of the helicopter's weight and center of gravity configuration on vibration levels are examined, with an evaluation of how specific configurations are affected depending on different kind of maneuvers. In this survey, the test points have been successfully completed by satisfying engine vibration certification regulations.

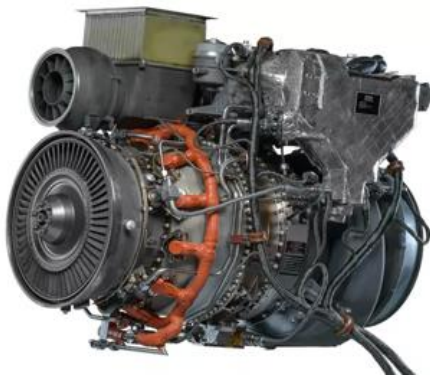
Figure 1 CTS800-4AT Turboshaft Engine

T625 Helicopter powerplant system consists of:

Each engine is attached to helicopter by means of three locking points; one front and two mid-mounts. The engine mount configuration is an “isostatic structure”; in the mid-mounts, all rods are connected to each other by means of spherical bearings to ensure allowance of axial and radial thermal expansion of the engine. At the forward mount location, a torque tube and a gimbal joint connect the engine to the main helicopter gearbox, which absorbs shear loads in three directions and torque in the engine longitudinal axis. Crosshead structure provides structural alignment between the engine and MGB.
