## AH-64 LOSS OF LUBRICATION STUDY

### Test of Isotropic Superfinished AH-64 (Apache) Engine Nose Gearbox Without Black Oxide Coating

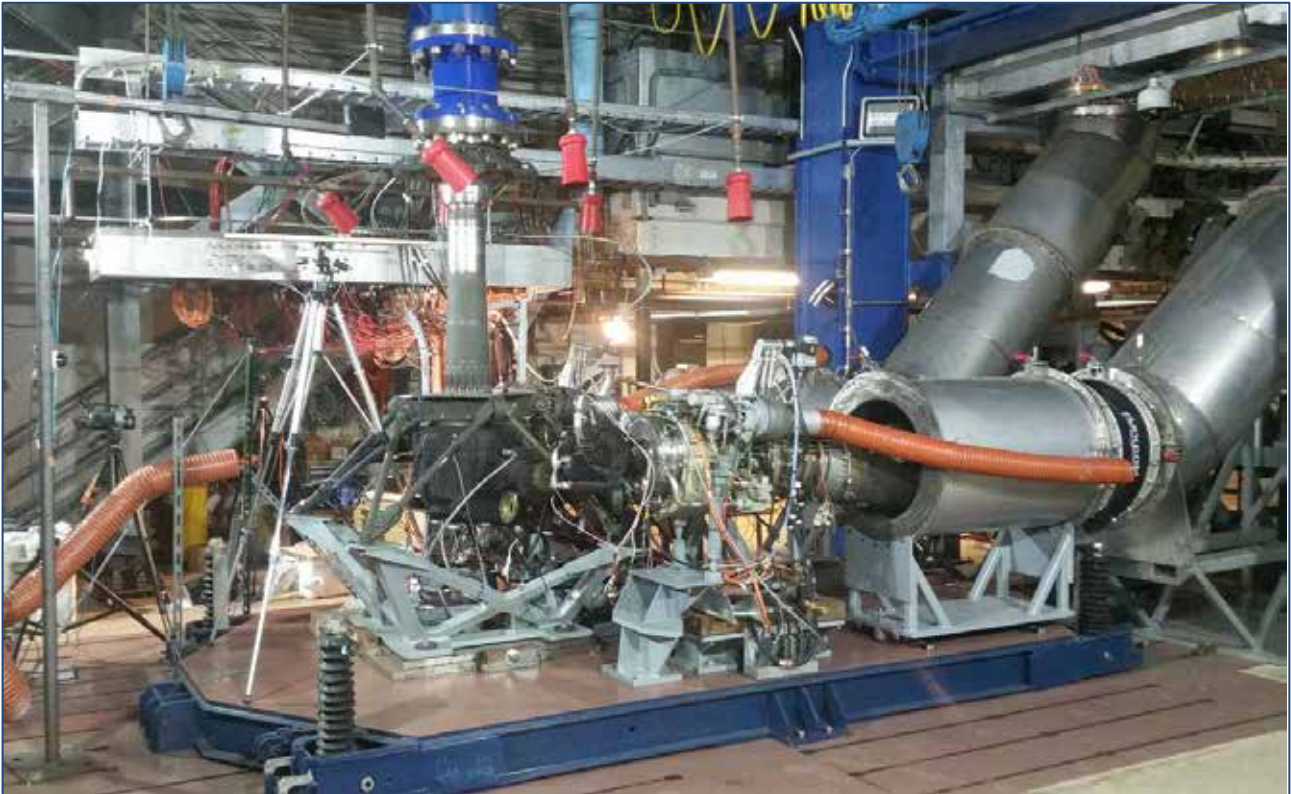
Figure 6. AH64 Apache Test Stand as configured for the LOL test.

The test was conducted at Naval Air Warfare Helicopter Drive Systems Test Facility (HeDS) Center in Patuxent River, Maryland on May 11, 2017. The Naval Air Systems Command Propulsion and Power Department (AIR 4.4) provided test facilities, installed the test articles into the HeDS Test Facility, and conducted the loss of lubricant test on a test article Engine Nose Gearbox with ISF gears. An Apache configured test stand was created by AIR 4.4.6 to be used in the HeDS facility. For this test, the Apache drive system consisted only of a main gearbox (MGB), two ENGBs, and two T700-701C engines. There

was no shafting coming out of the aft of the MGB, and no intermediate gearbox (IGB) or tail gearbox (TGB). Only the starboard ENGB (right hand) was used as a test article (P/N: 7-311320001-16, S/N: A14-0509), and the test article was installed after a check out run was performed with a legacy starboard ENGB with black oxide gears. To simulate forward flight, a Dayton Motor Model 4C330 blower (rated for 1319 ~ 1741 CFM) was installed that blew air across the starboard ENGB through a 6" diameter hose (a blower-hose combination had also been used on the previous ENGB loss of lube test). The lubricant used during the evaluation was MIL-PRF0-23699.

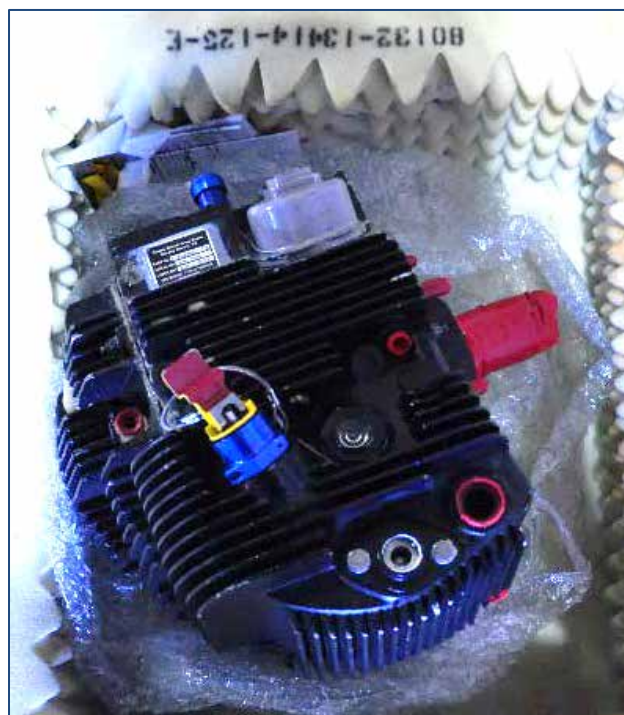
Figure 7. Front view of the Engine Nose Gearbox used in the LOL test.

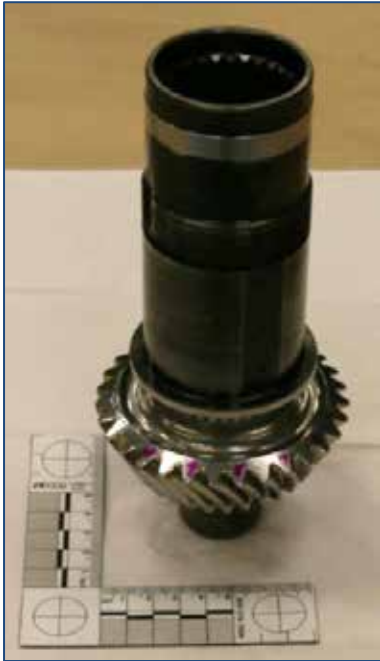
Figure 14. Input Pinion

AIR 4.4 shipped the test article and data back to the Army for post-test analysis at Redstone Testing Center (RTC). There, the gearbox was disassembled and inspected. The gear teeth showed no evidence of any distress (scuffing, pitting, heat related damage, etc.) on either the pinion or the gear. There was also no distress discovered on any of the gearbox bearings.

below. The measurements are consistent with the visible inspection, showing the surface finish and gear backlash remained basically unaffected. Additionally, no distress was discovered on any of the gearbox bearings.

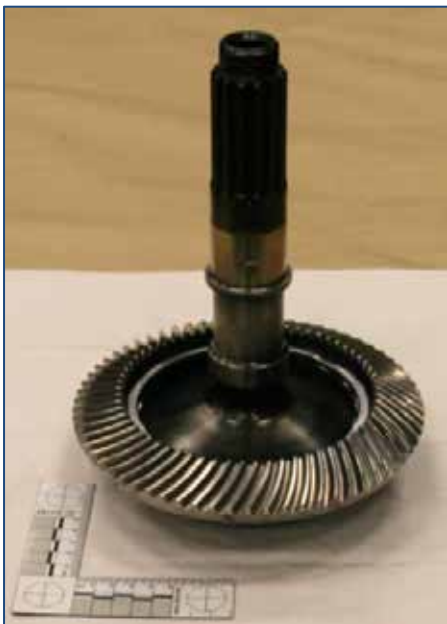
Figure 16. Output Gear
