# INNOVATIVE FLIGHT TEST INSTRUMENTATION FOR IN-FLIGHT NOISE MEASUREMENT OF A DAUPHIN'S FENESTRON

**Laurent Binet**, ONERA, Center of Salon de Provence, France

## ABSTRACT

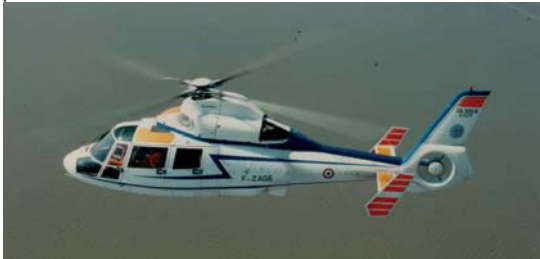
Figure 1: Dauphin 6075

The Fenestron blades, duct, fuselage sides and tail of the Dauphin 6075 helicopter (Figure 1) have been equipped with this advanced instrumentation. A complete description of the instrumentation installed on the fixed parts of the helicopter will be presented here after.

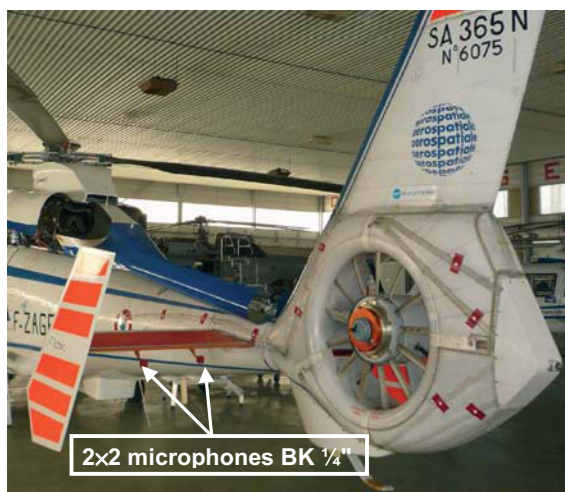
Figure 2: Implementation of the microphones

Acoustic measurements were performed by means of 4 microphones Brüel & Kjaer 1/4" mounted on the empennage, 2 on each helicopter side (Figure 2).

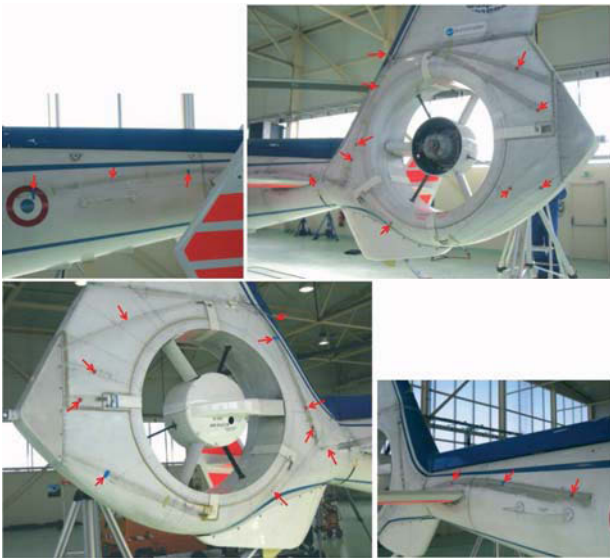
**Figure 6: Position of the pressure measurements**

In the next figure (Figure 6), red arrows show the positions of the pressure holes along the tail boom.

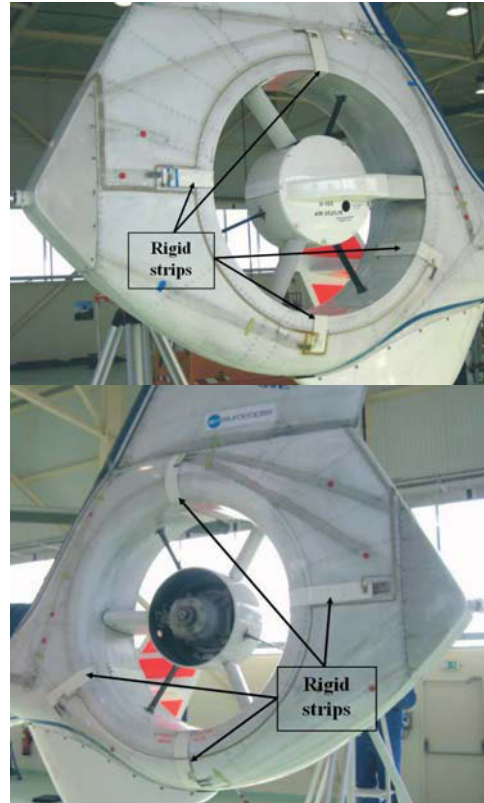
**Figure 7: Position of the rigid strips around the Fenestron**

Instrumentation was developed to provide also pressure measurements in the Fenestron duct. To perform these measurements, rigid strips were designed. The rigid strips were integrated inside and around the Fenestron as indicated in the following figure (Figure 7).

Mounted on both sides of the tail rotor hub, these strips were divided in two parts. One was mounted downstream of the Fenestron shaft, the other one upstream.

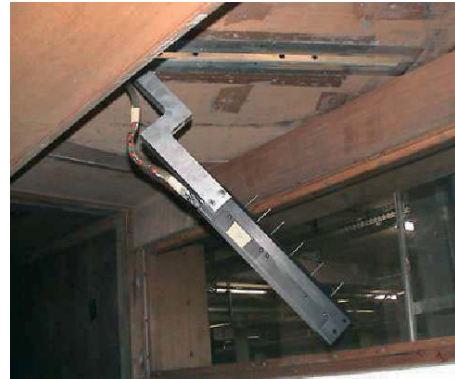
Figure 12: Calibration in wind tunnel

Calibration functions of the measurements in incidence, sideslip and speed were carried out in the subsonic wind tunnel S45 at ONERA Lille (Figure 12).

The calibration was made at three speeds of 20m/s, 40m/s and 60 m/s and for an angular domain of  $\pm 40^\circ$  for the incidence and  $\pm 60^\circ$  for the sideslip.

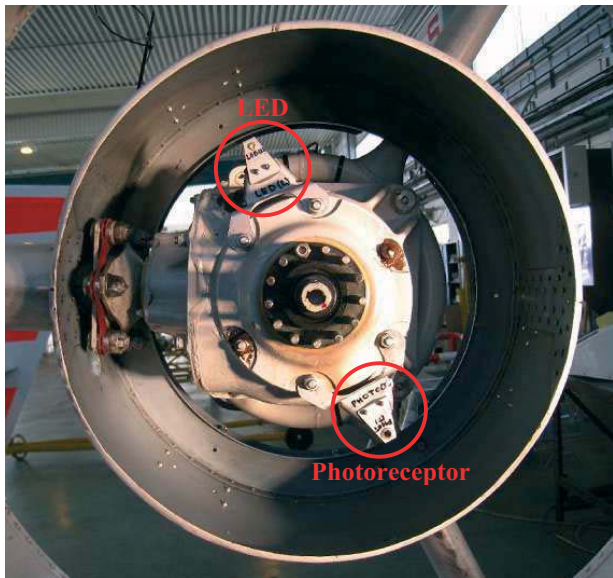
Figure 15: synchronizing signals

The following figure shows the LED and the photoreceptor mounted around the rotor hub (fixed instrumentation).

The hub is in the centre of the figure, the LED is in the upper part of the hub and the photoreceptor at the right bottom.

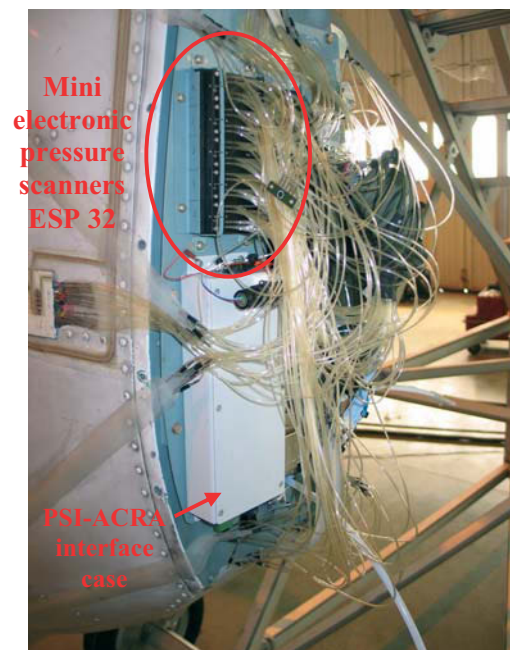
Figure 16: 5 mini electronic pressure scanners

Coming from the static pressure measurements (combs, rigid and flexible strips), the vinyl ducts are dispatched in 5 mini electronic pressure scanners of 32 channels each. These pressure scanners are measuring a differential pressure which is referenced to the helicopter static pressure. They are implemented in the rear part of the helicopter in the tail fairing as shown in the next figure (Figure 16).

There are totally 154 channels of pressure measures, that is a high density of vinyl ducts and a complex arrangement.

$\pm 0.7225$  psi;  $\pm 0.7225$  psi;  $\pm 0.7225$  psi;  $\pm 1$  psi and  $\pm 2.5$  psi

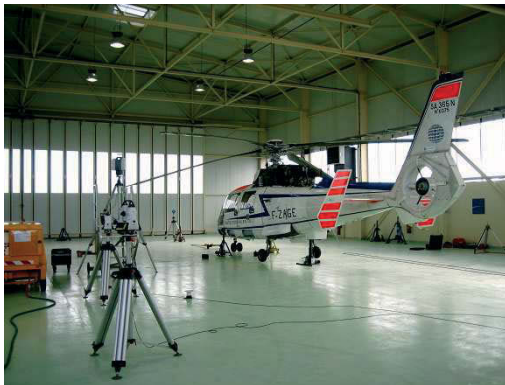
Figure 17: Positioning of the sensors in the helicopter frame

The location of the different sensors was very precisely determined by the CEV by means of a laser measurement system. These data will allow performing accurate comparisons between CFD calculations and in-flight measurements. 132 measures were performed with a precision of  $\pm 0.5\text{mm}$ .

Figure 17 shows the helicopter installed on hydraulic jacks (to reproduce a level flight) and the laser device.

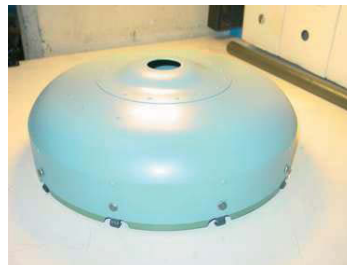
**Figure 22: New rotor hub cover**

The dimensions of this support on the tail rotor hub needed to redefine a specific rotor hub cover, larger than the conventional one (Figure 22).

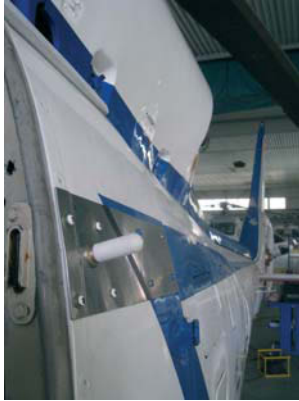
**Figure 24: Fixed antenna**

get the best transmission efficiency, the location of the fixed antenna was finally chosen behind the port side door as illustrated in Figure 24.

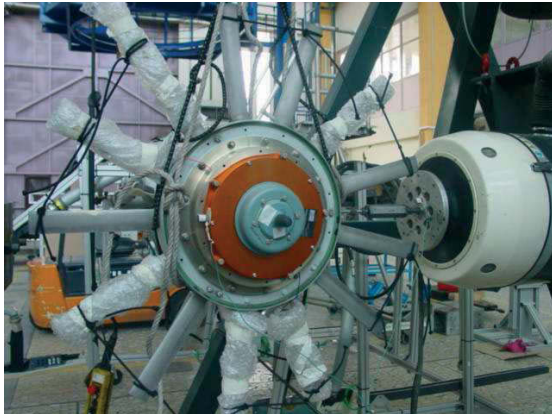
**Figure 28: vibratory tests**

In order to verify the good behaviour of the rotor equipped with the instrumentation with regards to vibrations, vibratory tests were performed (figure 28). The complete rotor was excited on two axes at different frequencies.

Moreover, as mentioned before, the nominal RPM of the tail rotor is 4700 rev/min with a transient maximal value of 5650 rev/min. In those conditions, a very precise dynamical balancing of the rotating system was required. A maximal unbalancing of 40 millimetre- grams was specified by Eurocopter.

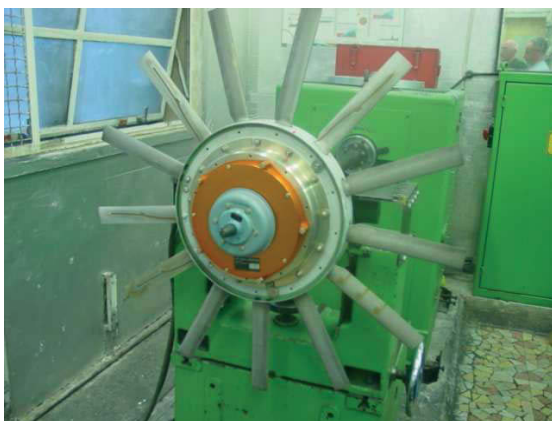
**Figure 29: rotor balancing**

The instrumented rotor was then balanced and a good functioning of the telemetry was first demonstrated in rotating conditions (Figure 29).

This first test performed in conditions close to flight conditions revealed that the centrifugal forces applied on the OMNETIC connectors could tear away and disconnect some of them from the telemetry slots.

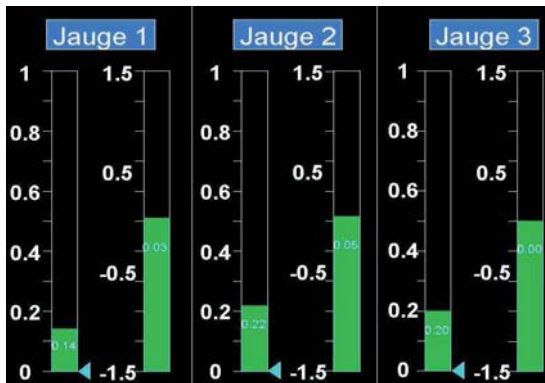
Figure 31: Blade strains monitoring in real time

This specification led to the development of a specific device installed in the helicopter cabin to monitor the blades loads (Figure 31). Hence, static and dynamic constraints (respectively left and right columns) on the gauges (jauges in the figure) were visualized by the flight engineer on a dedicated display as shown here after.

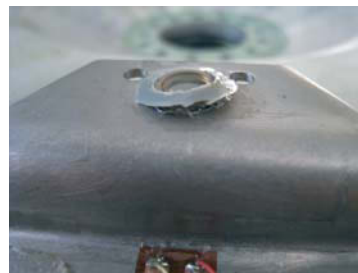
Figure 34: LED in rotating part

The glue used was not adapted to such high centrifugal loads.

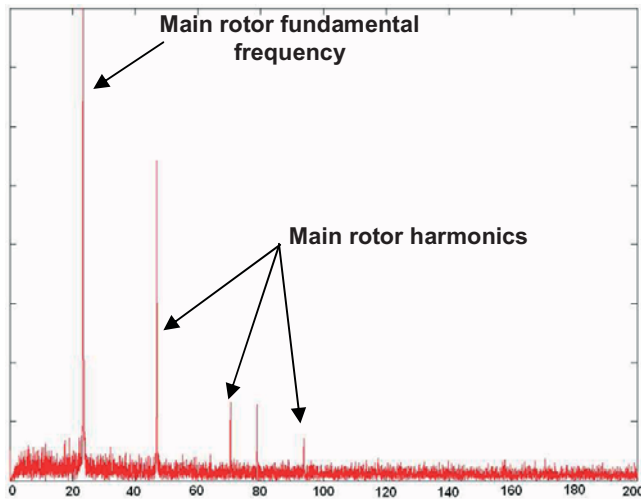
Figure 35: Main rotor frequencies

Acoustic results will be deeply analysed by DSNA but some measurements from the microphones can already be shown. In the next figure (Figure 35), a Fast Fourier Transform reveals the fundamental frequency and harmonics of the main rotor captured by the first microphone. As expected, fundamental frequency of a four bladed rotor turning at around 352rev/min is well measured and equal to 23.46 Hz.

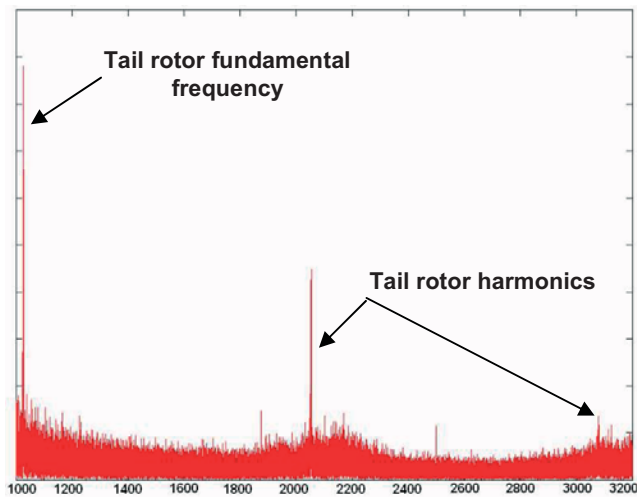
Figure 36: Tail rotor frequencies

During this stabilised flight case, the tail rotor turned at around 4734rev/min. Figure 36 shows the fundamental frequency and harmonics of this 13 bladed tail rotor. In these conditions, its first harmonic is equal to 1025.7 Hz.

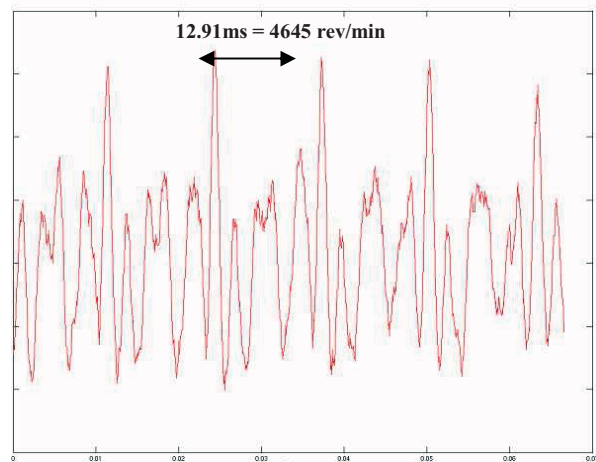
Figure 37: Strain observed on gauge

In this example, the time between two peaks is around 12.91 ms, corresponding to a rotor RPM of about 4645. This phenomenon was observed in all flight cases independently of the loads applied on the rotor. This led us to the conclusion that this rather high level of dynamic loads is certainly due to the passage of the blade in front of the tail rotor drive. The tail rotor drive careenage is a rather large metal piece placed in the Fenestron duct as it can be seen in figure 38. It probably creates locally a very disturbed airflow which causes blade flapping and then, alternated strains.
