## DETECTING PLANETARY GEAR BORE CRACK

Wenyi Wang, [wenyi.wang@dst.defence.gov.au](mailto:wenyi.wang@dst.defence.gov.au), Defence Science and Technology Group (Australia)

### Abstract

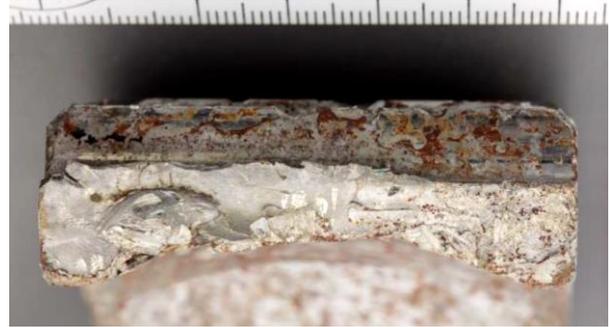
*Figure 1. H225 Super Puma planet gear bore crack propagation [2, Fig. 31] – Photo from AIBN/QinetiQ*

Common planet gear faults include tooth cracks and spalls, which have been studied extensively over the last 40 years. In this paper, our focus is on planet gear bore cracking, which is an unusual type of fault and has reportedly only occurred on the two failures of the Super Puma helicopter. As an example of the planet gear bore crack propagation, the 2016 H225 planet gear failure case is shown in *Figure 1*, which shows that the crack [2] was initially formed on left side of the picture from a spall on the bearing outer raceway.

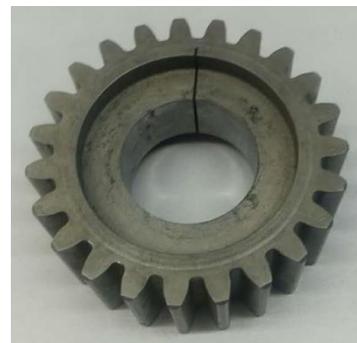
*Figure 3. Test planet gear with an EDM notch (Courtesy of UNSW)*

*Figure 3* shows a diagram with dimensions and a picture of the notched test planet gear. The gear has an electric discharge machined (EDM) notch through the outer race ring of the planet bearing and into the rim of the planet gear. This type of planet gear-bearing, often found in industrial machinery, is different from those in most helicopter main gearboxes as described in the previous section. The thickness of the gear rim is 3.5 mm (i.e.  $9.5 - 6$ ) and we had two sizes (1 mm and 1.5 mm) of EDM notches into the rim.
