**HC-Mk1 (CHINOOK) HEATED ROTOR BLADE ICING TEST
PART II
ANALYSIS OF ATMOSPHERIC CONDITIONS, AIRCRAFT AND SYSTEMS
CHARACTERISTICS**

TENTH EUROPEAN ROTORCRAFT FORUM

AUGUST 28 – 31, 1984 – THE HAGUE, THE NETHERLANDS

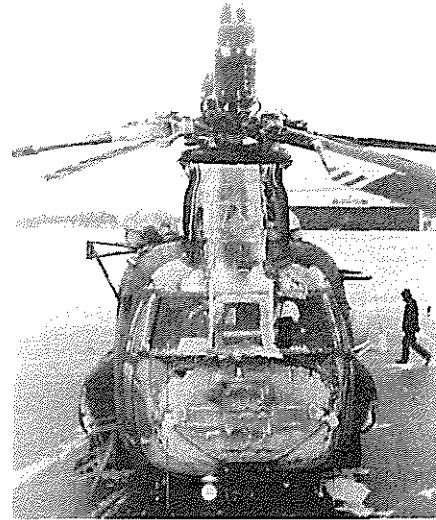
FIGURE 4 PICTURE OF HC-Mk1 AFTER FLIGHT IN FREEZING RAIN

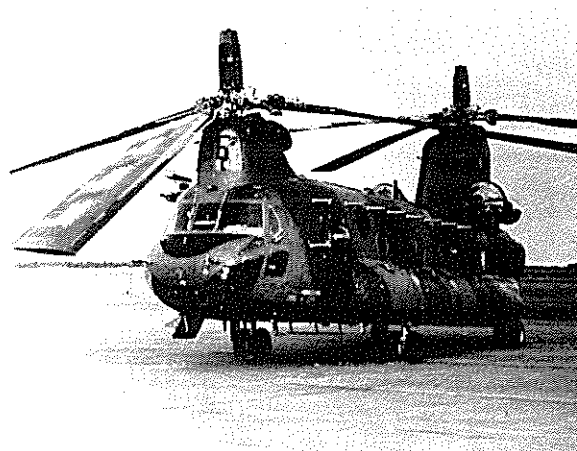
FIGURES 7 AND 8

When the icing conditions 'ran out' in the designated trials area(s) and/or the aircraft's endurance was reached, the aircraft returned to base at a height above the freezing level whenever climatic and air traffic control patterns permitted. On landing, a detailed examination of the extent of residual ice accretions on the engine intakes, the rotor heads, blades and the airframe was made. All ice accretions were logged and most were recorded on video and stills cameras. Figures 7 and 8 show typical ice accretions following an icing flight.

ROTOR HEAD ACCRETION

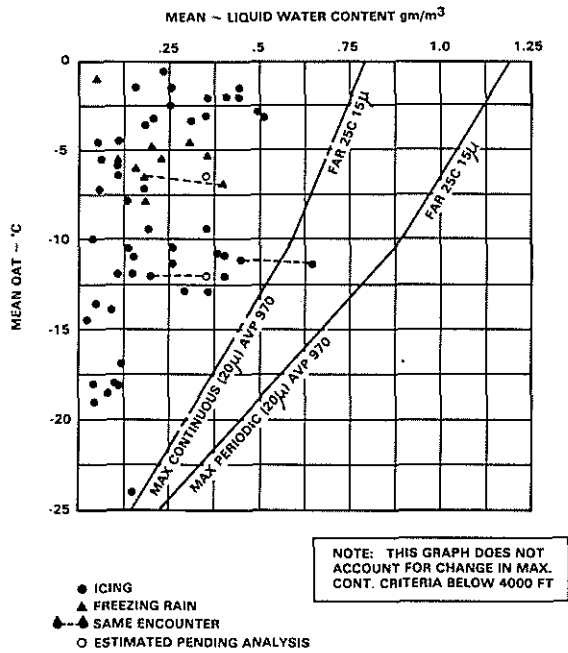
FIGURE 9
SUMMARY OF ICING EXPERIENCE—WINTER 1983/1984 MA020

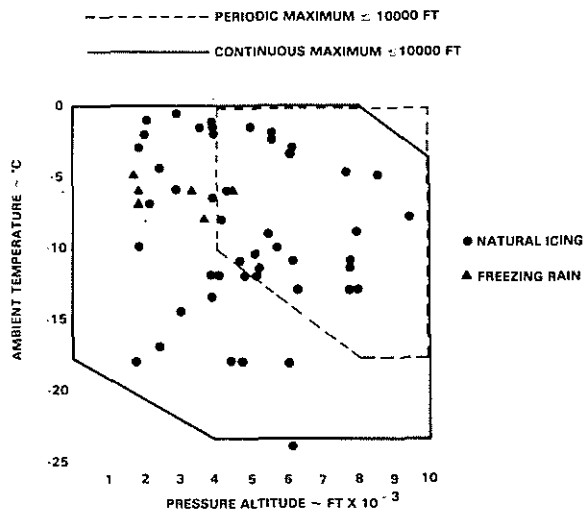
FIGURE 10 RAF ICING TESTS—WINTER 1984/85 ICING EXPERIENCE
OAT VS PRESSURE ALTITUDE

est flight time in icing was $2\text{ hours } 17\text{ minutes}$; in addition, a further 17 flights of one hour's duration or more in icing conditions were experienced. Figure 9 presents the icing conditions encountered in terms of LWC and OAT. Mean LWC's up to 0.5 gm/m^3 were quite common down to -12°C . Two other notable test points were at -11.5°C , with a mean LWC of 0.64 gm/m^3 and 0.15 gm/m^3 at -24°C (approximately 115% and 85% of the continuous maximum values of AvP 970, respectively). The extent of the icing experience in relation to FAR AC 29-2 altitude requirement is shown in Figure 10.

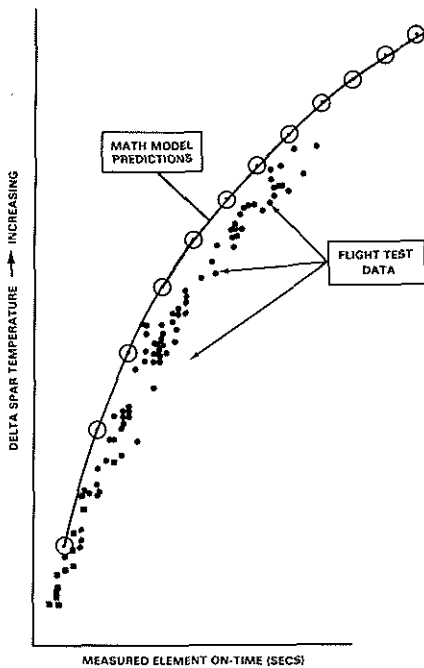
Figure 19 shows the correlation obtained between math model data and flight data. The math model data consistently gave a conservative temperature margin, which was used as a built-in factor of safety.

FIGURE 19 MATH MODEL TO FLIGHT TEST BLADE TEMPERATURE DATA COMPARISON

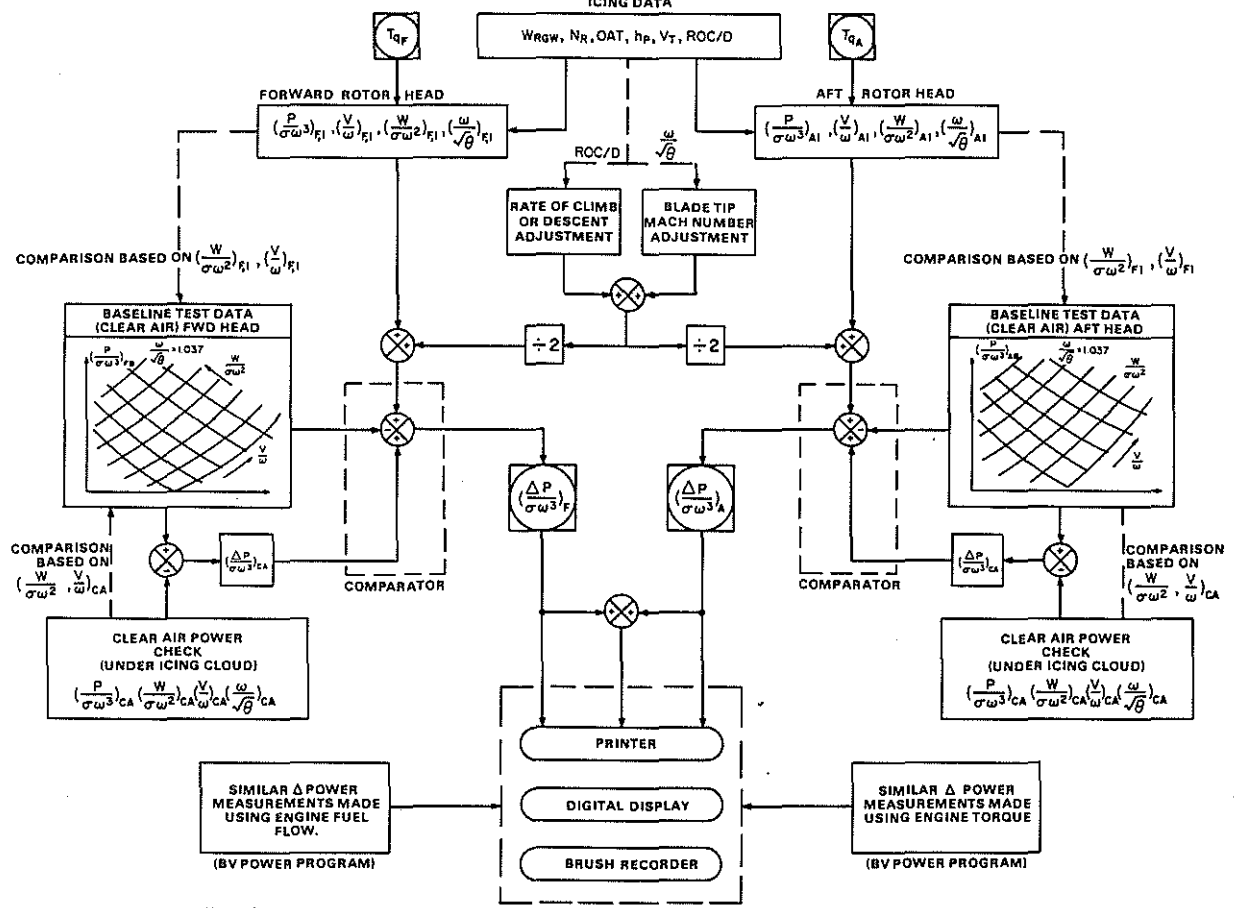
FIGURE A1 DELTA POWER PERFORMANCE ANALYSIS—ROTOR TORQUE

Baseline Power Derivation and Storage (Figure A1 of Appendix)

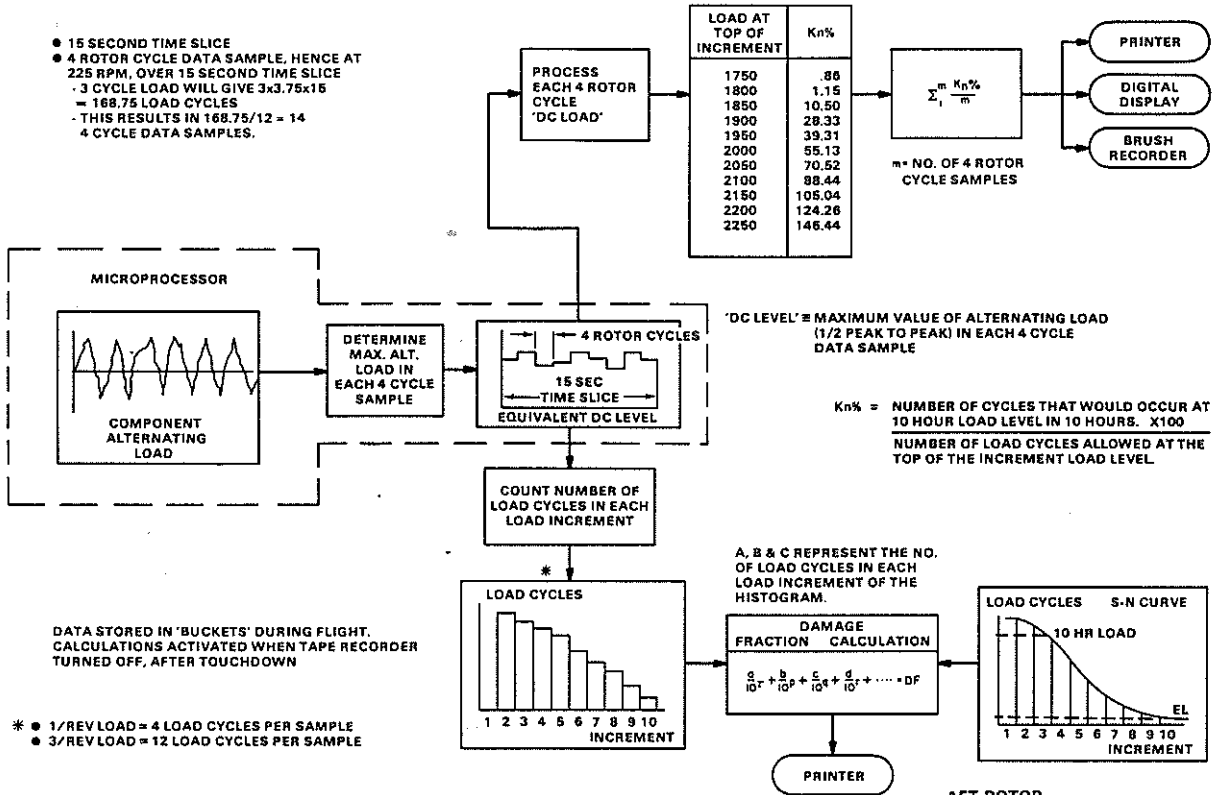
FIGURE A3 COMPONENT FATIGUE DAMAGE CALCULATIONS
