THE STARFLEX® FLYING ALL OVER THE WORLD AND ALWAYS IN EVOLUTION

Jean Marc Besson and Yoan Marino
EUROCOPTER Aéroport International Marseille Provence 13725 Marignane Cedex

This paper gives an overview of the Eurocopter composite hub called Starflex®. The material is E glass fibre associated to an epoxy resin. This type of hub is flying since 1974 and has been able to support a lot of evolutions and versions of Dauphin and Ecureuil families. It is presented the way to manage the composite material all over the years, the evolution of the certification process, the main difficulty encountered in service and the solution applied. A new Starflex® with a new resin epoxy and integrating all the improvements will be delivered to our customers before end of this year. For this new version the static and fatigue substantiation principles are given.

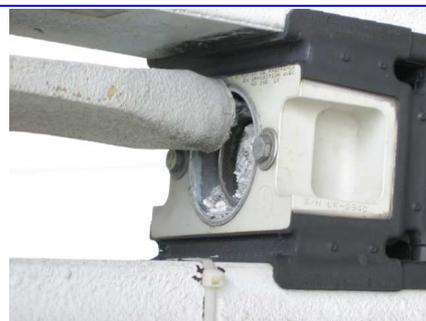
These incidents occurred in 2005. It was quite surprising that it has appeared after an important number of flight hours. The first one occurred on an Ecureuil: the tip arm was presented an important deformation (figure 13). The second one happened a few months after on a DAUPHIN: the tip arm has been broken and the pilot has been able to land (figure 14).

Figure 14: DAUPHIN tip arm failure

Flight tests, laboratory tests, and investigations have been done and have shown that under certain circumstances the composite temperature could locally exceed the glass transition temperature. This effect is mainly due to the warm up induced by the ball bearing dynamic movement and the friction coefficient associated. It is explained in case of high external temperature associated to high speed conditions and also by the ball bearing dispersion (gap, wear, friction coefficient...). Before these incidents, such level of temperature increase was not expected.

Design modifications have been done but the most important improvement was to drill holes in the main rotor damper in order to cool the confined area of the tip. A visual interval inspection has been put. Another improvement is done through the new Starflex® version presented in paragraph 6.

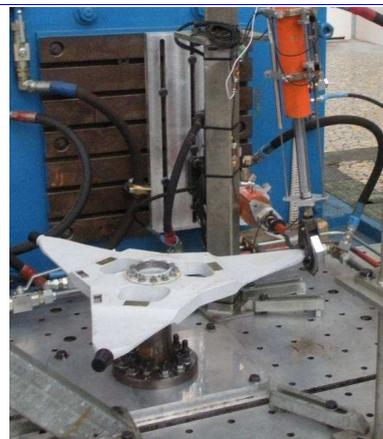
Figure 15: Starflex® arm test bench

- impacts of 25 joules on the edge,
- fatigue tests to create a first delamination (more severe than the minimum manufacturing quality); see test bench on figure 15,
- static test until failure and ultimate margin substantiation taking into account the ageing and temperature effects by the coefficients issued from samples.

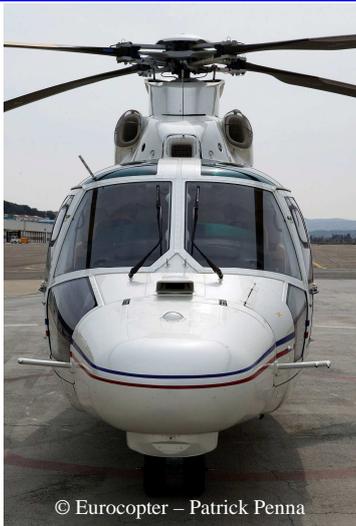
Figure 16: Starflex® on the Dauphin
