CRASHWORTHINESS OF TRUNCATED COMPOSITE CONES UNDER SIDE LOADS

David C. Fleming* and Anthony J. Vizzini†

Center for Rotorcraft Education and Research
Composites Research Laboratory
Department of Aerospace Engineering
University of Maryland
College Park, MD 20742, USA

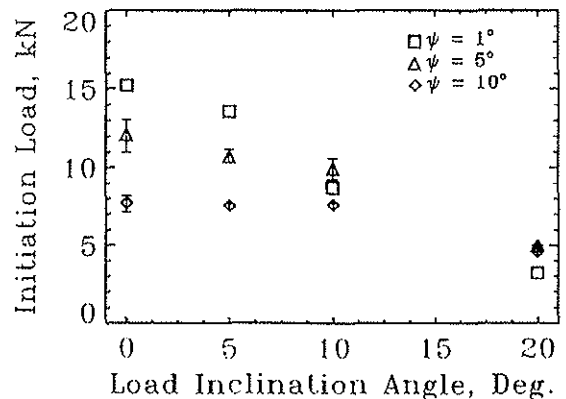
For the axially loaded specimens the smallest taper angle specimen had the greatest initiation load. By 10° load inclination angle, though, the 5° taper specimens initiated at a higher load than the 1° taper specimen. At 20° load inclination angle, both the 5°

Figure 6 Initiation load versus load inclination angle

and the 10° taper specimens had a greater initiation load than the corresponding 1° taper specimen. Also note that the load initiation value for the 5° load angle and the 10° load angle 1° taper specimens are each within 15% of the initiation load for the axially loaded 5° taper and the 10° taper specimens respectively, indicating a correlation between the angle which the side of the specimen makes with the contact surface and damage initiation.

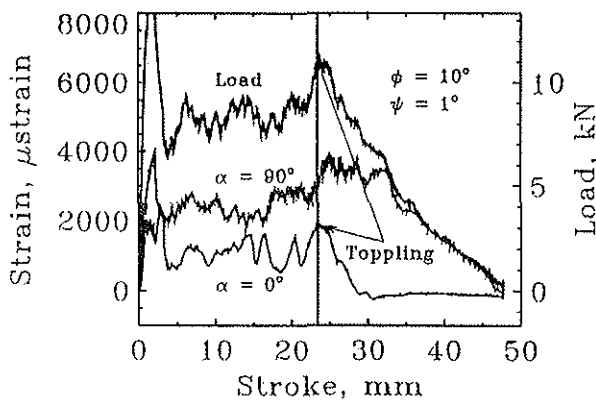
Toppling can be seen in the load-stroke and strain-stroke curves. For example, in Figure 9 a 1° taper angle specimen at a 10° load inclination angle undergoes both sustained crushing and toppling. After displaying the typical crushing response, the load curve drops steeply as toppling begins to dominate the behavior of the specimen. The sharp spikes

The strain gage data in conjunction with the load-stroke curve show the point of toppling initiation. As the specimen begins to topple, pressure is relieved from the ends on the sides opposite the sites of maximum damage. As the toppling progresses, these sites, on the bottom surface at α equal to 0° and the top surface at α equal to 180°, lose contact with the crushing platens. Thus the strain drops to near zero on the α equal to 0° and 180° sides. The point at which the strain begins to drop monotonically to zero is the point of toppling initiation. This is shown in Figure 9 at the point when the stroke

is approximately 23.4 mm. Note that after toppling initiates, the specimen still exhibits some crushing behavior. The strain gage at α equal to 90° indicates an increase at that location after toppling has started. Eventually, the strain at this location decreases to zero as the entire specimen topples. Strain gage data can thus be used to determine whether toppling behavior is present in a specimen and at what stroke it initiates. The crushing response of specimens can then be evaluated independently of toppling response by considering the regions before and after toppling initiation separately.

Figure 9 Load and strain versus stroke for a 1° taper specimen loaded at $\phi=10^\circ$

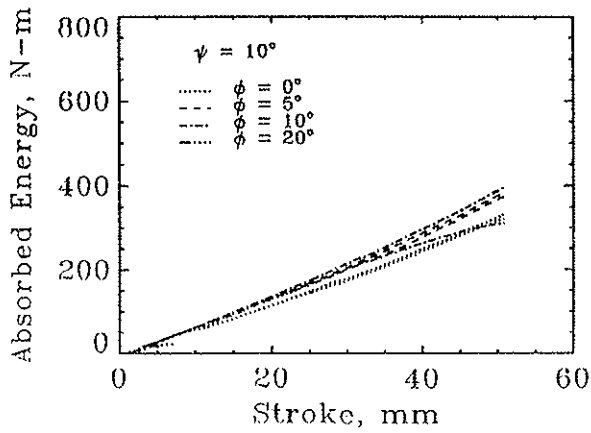
The cumulative amount of energy absorbed by a specimen at a given point in the test is obtained by numerically integrating the load versus stroke response up to that point. A linear interpolation is assumed between successive data points. Energy versus stroke is presented in Figures 13 through 15 for each taper angle. The quadratic nature of the energy-stroke curves is evident within the sustained crushing regions. The effect is especially pronounced in the 10° taper case. The quadratic nature is due to the linear nature of the load versus stroke curves. The occurrence of toppling is indicated in these curves by the tangent slope approaching zero.

Figure 13 Energy versus stroke for 1° taper specimens

Figure 14 Energy versus stroke for 5° taper specimens

Figure 15 Energy versus stroke for 10° taper specimens

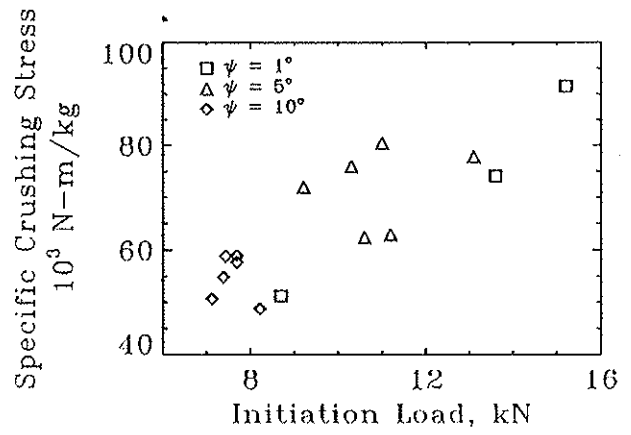
Figure 20 shows the specific crushing stress plotted against the initiation load for all of the specimens. Generally, specimens which initiate at a relatively high load tend to also exhibit higher specific crushing stress. Low values of the initiation load are indicative of a load concentration at a preferred location on the cross section. This concentration reduces in energy absorption because the damage to the structure is localized.

Figure 20 Specific crushing stress versus damage initiation load

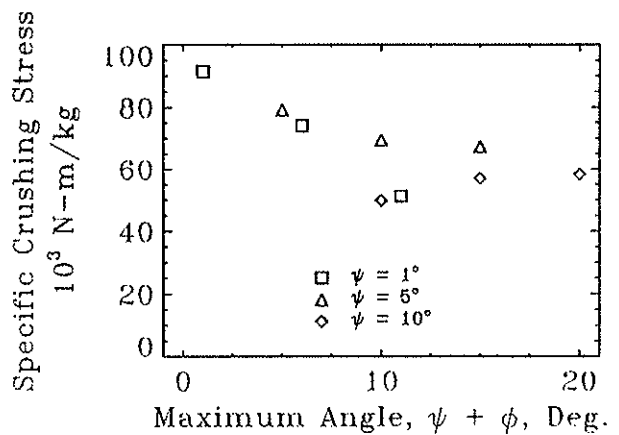
Figure 21 Specific crushing stress versus the minimum angle difference

Figure 22 Specific crushing stress versus the maximum angle difference

The maximum value is given by the sum of the load inclination angle and the taper angle. These two newly defined angles indicate the degree of misalignment between the load and the cone. In Figures 21 and 22, the specific crushing energy is plotted

against the absolute difference and the sum of the inclination angle and the taper angle. In general the trend is towards a decrease in performance as either of these two parameters increase. Thus as the load becomes more misaligned, the overall performance decreases.

Two possible parameters of interest are the minimum and maximum incident angle made by the load and any edge of the tapered specimen. The minimum is given by the absolute difference between the load inclination angle and the taper angle.
