NINTH EUROPEAN ROTORCRAFT AND POWERED LIFT AIRCRAFT FORUM

Paper No. 100

**AEROSPATIALE'S EXPERIENCE ON HELICOPTER FLIGHT
IN ICING CONDITIONS**

Société Nationale Industrielle Aérospatiale

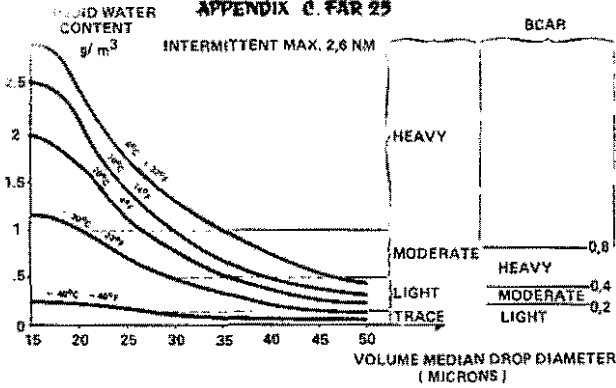
Fig. 5 : F.A.R. 25- INTERMITTENT MAX.CONDITIONS

Figures 4 and 5 present the Appendix C to FAR Part 25, «Liquid Water Content as a function of temperature and drop size». For illustration, the four degrees of icing severity defined by Lockheed, California, for the U.S. Army and the three degrees of icing severity defined by BCAR are provided on these figures.

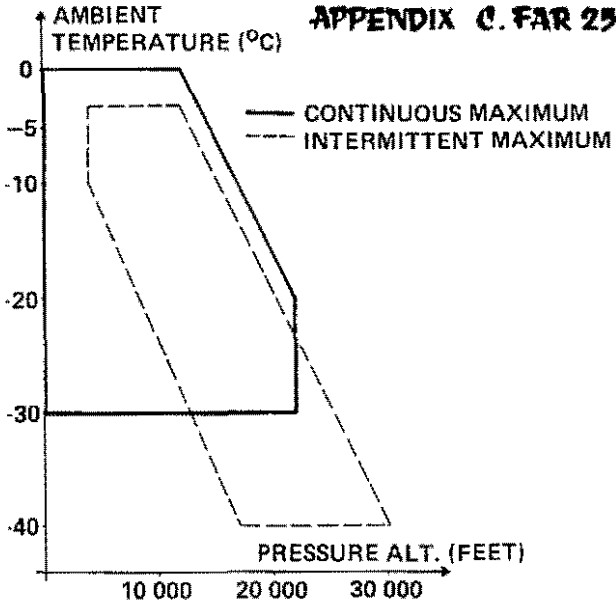
Fig. 6 : F.A.R. 25- APPENDIX «C»

The altitude and temperature envelope is also defined for the two types of icing (Figure 6). It can be seen that it extends considerably beyond the flight envelope of present day helicopters.

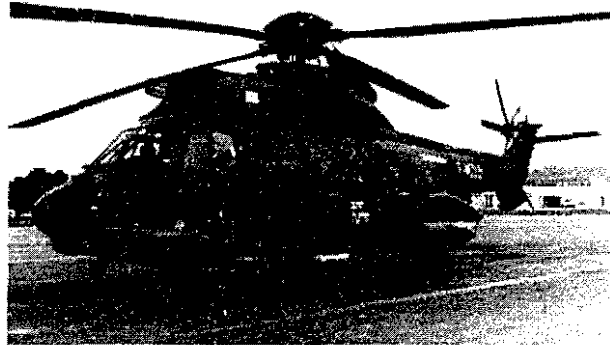
Fig. 8 : GENERAL VIEW OF SUPER PUMA No. 2005 USED FOR THE ICING TESTS

- Restrainer fairings
 - Ice detector (providing icing severity)
 - Weather radar
- The basic aircraft is normally fitted with protection against unexpected icing and environmental conditions as follows : (Figure 8)

Engine air intake screens
Electrically anti-iced pitot heads
Electrically anti-iced cockpit windshields
Lightning protection for rotors, fuel tanks and fuel tank vents.

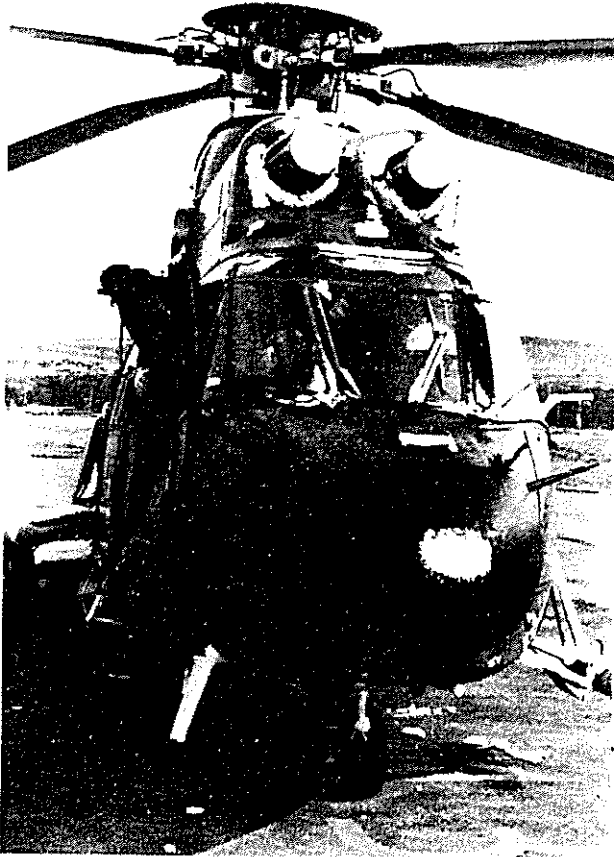
Fig. 21 : ICING AT ABOUT -12° C ON AS 332

Main rotor deicing proves effective for all the icing conditions encountered. After the flights, when the ground temperature was negative, the extent of the various buildups (Figures 21 and 22) was measured and checks were made particularly to ensure that there were no traces of refreezing on the main rotor blades. Apart from the cyclic torque variations associated with the deicing cycle, no significant change in the mean torque value was observed in flight during the longest periods in icing conditions (1 hr 50 mn).

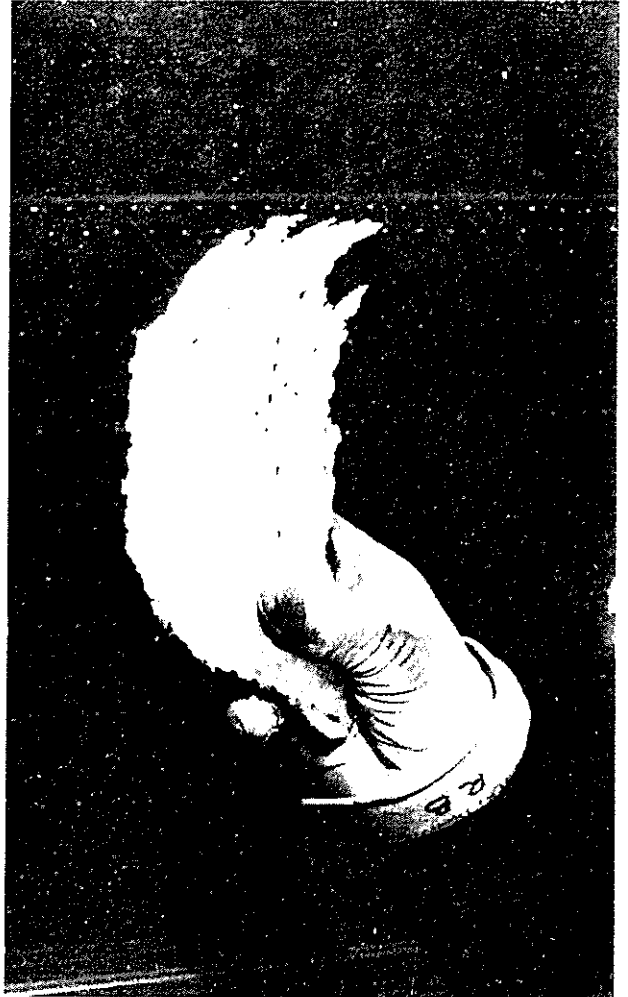
Fig. 23 : ICE BUILDUP ON AS 332 ENGINE AIR INTAKE

The engine fitted with its air intake was tested in an icing wind tunnel under FAR 25 conditions, and then in flight. Figure 23 shows that the buildup occurring in flight on the side wall of the air intake screens remains porous and cannot cause complete blockage of the air intake.

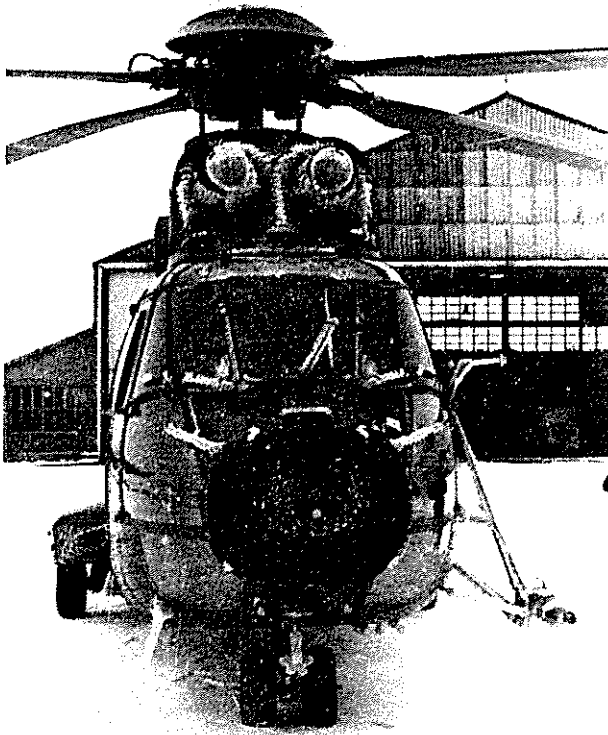
Fig. 22 : ICING BETWEEN -3° C AND -6° C ON AS 332

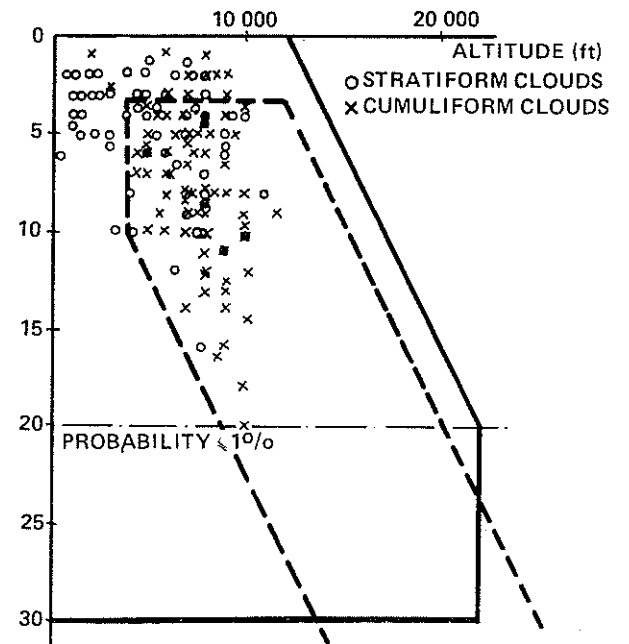
Fig. 24 : ICING CONDITIONS ENCOUNTERED
