**SOLUTIONS TO HELICOPTER BLADE EROSION  
~ IMPROVING AIRCRAFT AVAILABILITY AND REDUCING COSTS**

**Pat Collins**, Science Gateway, Helicopters Operating Centre, Defence Equipment & Support, Bristol, UK  
**Chris Moore**, Materials Engineer, AgustaWestland, Yeovil, UK

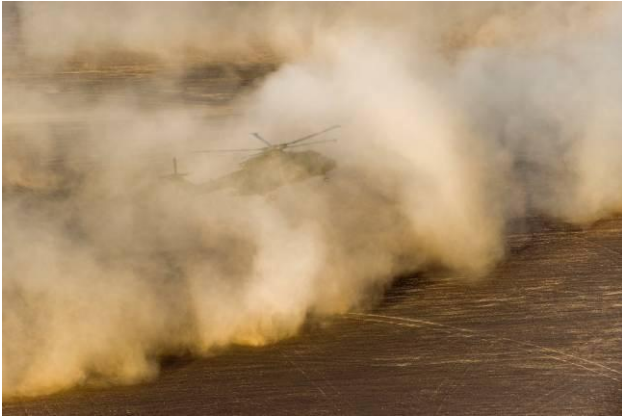
Figure 1: Merlin helicopter engulfed in dust cloud (image courtesy of [www.defenceimagery.mod.uk](http://www.defenceimagery.mod.uk))

downwash from the helicopter rotor blades causing a large cloud which can completely envelop the platform, as illustrated in figure 1. The nature of the dust cloud can vary significantly depending upon the size of the particulates.

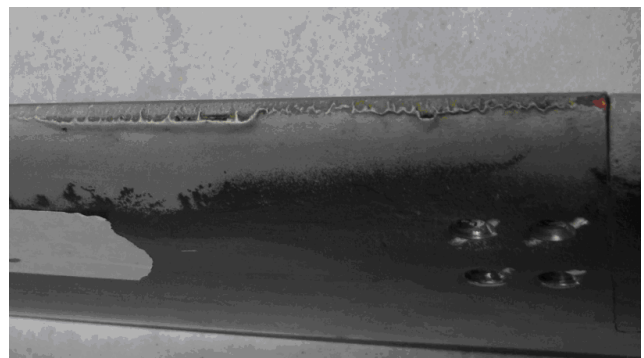
Figure 2: Tail rotor blade showing severe erosion and perforation of the leading edge. (image courtesy of AgustaWestland)

In many cases the damage caused to the rotor blades tends to be limited to a polishing effect of the erosion shield where it becomes difficult to quantify the residual thickness. In extreme cases the erosion shield is reduced to a very thin foil which without detailed inspection can fail without warning to the operator, see figure 2, leading to damage to the substrate and immediate unserviceability.

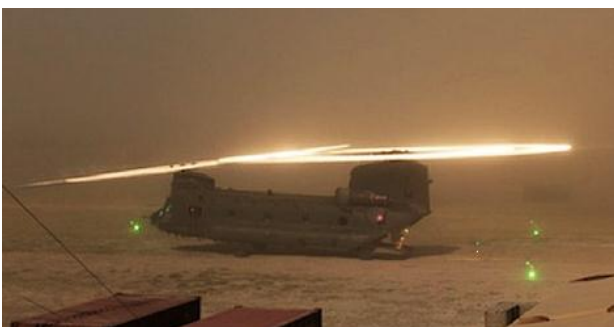
Figure 4: Chinook helicopter demonstrating scintillation (image courtesy of Michael Yon, [www.michaelyon-online.com](http://www.michaelyon-online.com))

Scintillation (also sometimes referred to as the “Kopp-Etchells effect”) is a term used to describe the light generated around rotor blades as they are engulfed in dust, see figure 4. The primary cause of the phenomena is the oxidation of material from the leading edge erosion shield of the blade following impact from sand and dust particles. The brightness of the light generated is dependant upon the material used for the erosion shield with titanium demonstrating the highest intensity although similar effects can be seen with other materials<sup>2</sup>.

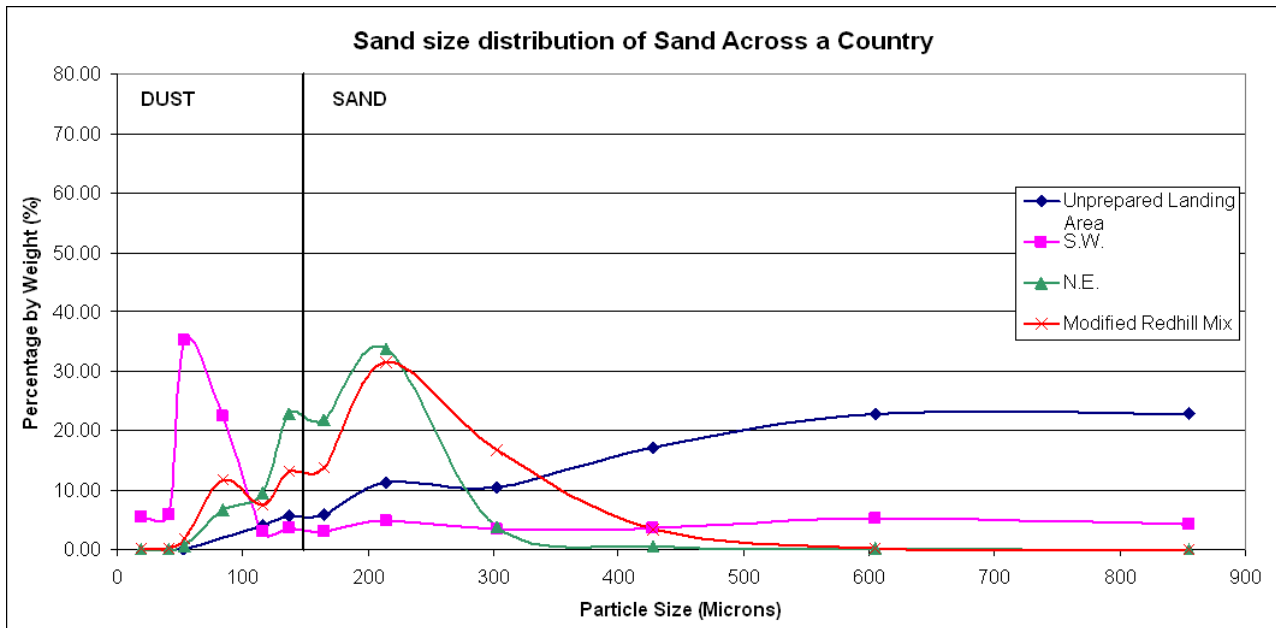
Figure 5: Sand size distribution (image courtesy of AgustaWestland)

The initial finding from analysing the samples is the wide ranging variety of particles present. The sample from an unprepared landing strip showed a low proportion of small particles present and a large number of small stones measuring in excess of 1000µm, these larger stones were irregular in size with jagged edges. The fine sample consisted of dust, with an average grain size of approximately 54µm. The UK MOD define this dust as ‘temporarily airborne dust’ and can remain in suspension in the atmosphere for extended periods of time by the natural turbulence of the air. Coarse samples contain similar size sand as that associated with the British coast, represented by the Modified Redhill mix in figure 5. Upon further investigation the sand consisted of smoothed particles with an average diameter of 200µm. Particles of such dimensions are classified as instantaneously airborne dust by the UK MOD and as a result of their mass are most commonly raised by artificial means.

Investigation of the sand particles; excluding those greater than 850µm illustrates that the sample taken from the unprepared landing strip consists of particles covering a wide range of dimensions, as visible in figure 5. This sample can be broadly characterised as containing two separate groups of particles, one being largely composed of coarse dust/sand and the other of small stones.

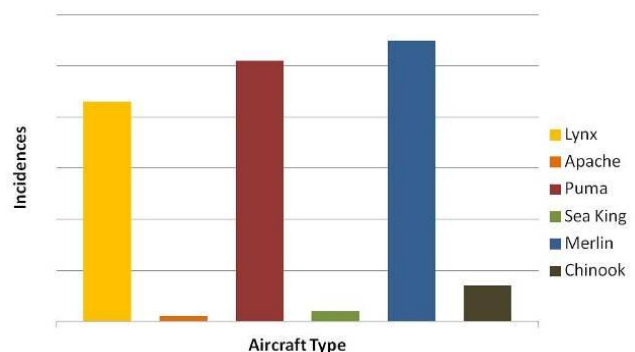
Figure 7: Reported Main Rotor Blade Erosion Incidents between August 2009 and August 2010 (image courtesy of AgustaWestland)

Overall the findings show a large difference in erosion incidents reported between the different aircraft types as shown in figure 7. Support Helicopters such as the Lynx, Puma and Merlin were found to suffer significant damage that could be attributed to erosion. This is likely to be as a result of the large number of landings these aircraft make often on unprepared landing strips. This link with the number of landings is supported by analysing the level of erosion on the Apache blades which, despite operating alongside the Merlin, rarely landed on unprepared surfaces. Apache is often employed to provide surveillance meaning it is not generally required to operate away from main operating bases and subsequently is not frequently exposed to high levels of erodent.

An anomaly in the data is the level of erosion incidents recorded for the Chinook fleet which, whilst operating in a similar role to the Merlin carrying stores & troops around the battle field, has levels of erosion significantly lower than that of the Merlin fleet. The low level of erosion experienced by the Chinook fleet is attributed to the increased level of maintenance applied to the rotor blades whilst on operations. Typically the Chinook blades were carefully inspected and repairs carried out to the blade tape after every flight, incurring a high

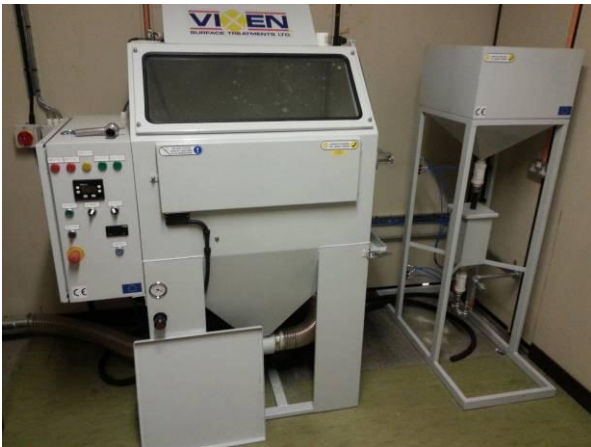
Figure 9: The blade erosion rig developed for this programme in situ in the materials laboratory at AgustaWestland, Yeovil. (image courtesy of AgustaWestland)

Following a competitive tendering process a contract was placed with Vixen Surface Treatments Ltd. The test rig consists of a modified sand blasting cabinet with separate filtration to avoid issues associated with silicosis and a hopper providing a metered supply of erodent into the main chamber. Figure 9 shows the test rig installed in the materials laboratory at AgustaWestland's Yeovil facility. The erodent is supplied from the hopper via an adjustable feed valve onto a vibratory feeder and a split funnel before being introduced to the high velocity air flow via a venture nozzle arrangement. Upon entering the air stream the erodent is accelerated into the erosion chamber where it impinges with the specimen. Waste air and fine sand is vented

whilst large particles drop out of suspension ensuring there is no possibility of air re-circulating. A novel feature of the test rig is the rotating sample carrier which can be seen in figure 10. This provides the capability to impinge the samples in a highly dynamic environment and provides the opportunity to test a number of samples simultaneously. The samples are 50mm x 50mm carbon fibre “stubs” approximately 2mm thick coated with standard blade paint on the test face. A range of candidate erosion protection materials (paints, coatings, tape, etc.) have been applied to these samples in preparation for testing. By use of a “standard” control sample with well understood performance characteristics it will be possible to conduct comparative tests against the candidate materials with a clear understanding of what will constitute a good result.

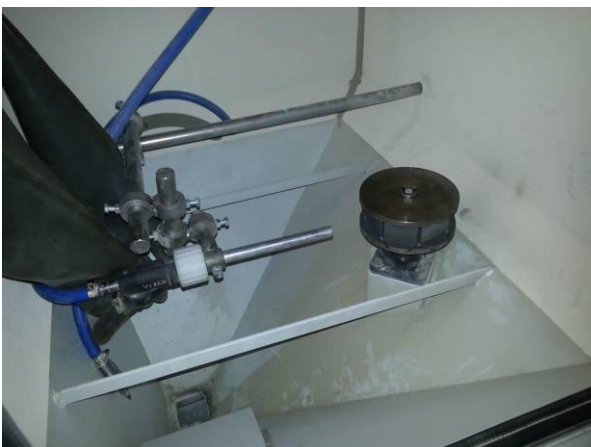
Figure 10: Internal view of Blade Erosion rig showing rotating sample carrier and ejector nozzle. (image courtesy of AgustaWestland)
