THE ROYAL AIR FORCE CHINOOK HELICOPTER SNOW AND ICING FLIGHT ENVELOPE

Mark Roots, Tony Dyer, Mike Curnow, Malcolm Tier
Rotary Wing Aircraft Department
Aircraft Test and Evaluation
DERA Boscombe Down
Salisbury, Wiltshire SP4 0JF
UNITED KINGDOM

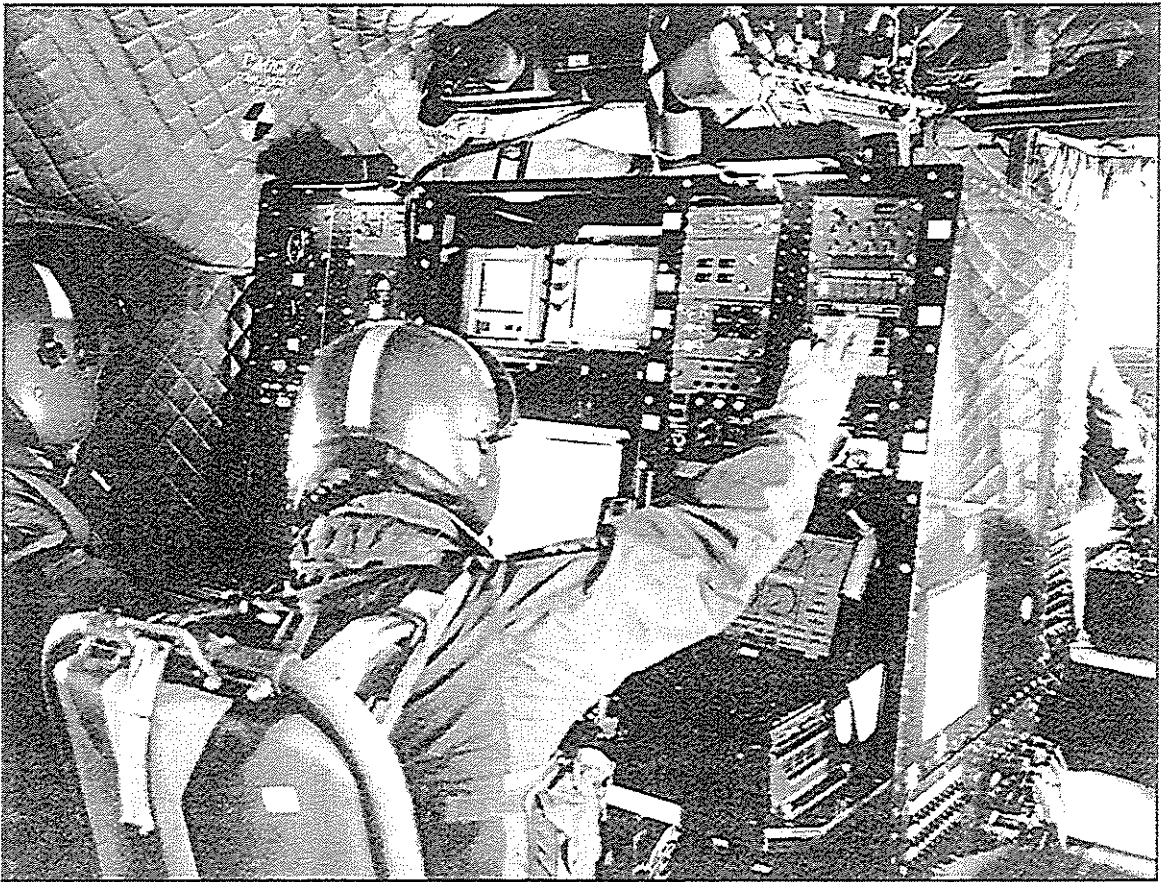
Figure 1: Flight Test Engineer's Station.

A general view of the flight test engineers station in the aircraft is shown in Figure 1. All the controls for the instrumentation and test equipment were located on the panels for ease of operation by the flight test engineers. Data displays were provided to the flight test engineers on the two colour LCD computer screens. Three video monitors enabled the ice accretion in and around the engines to be monitored.

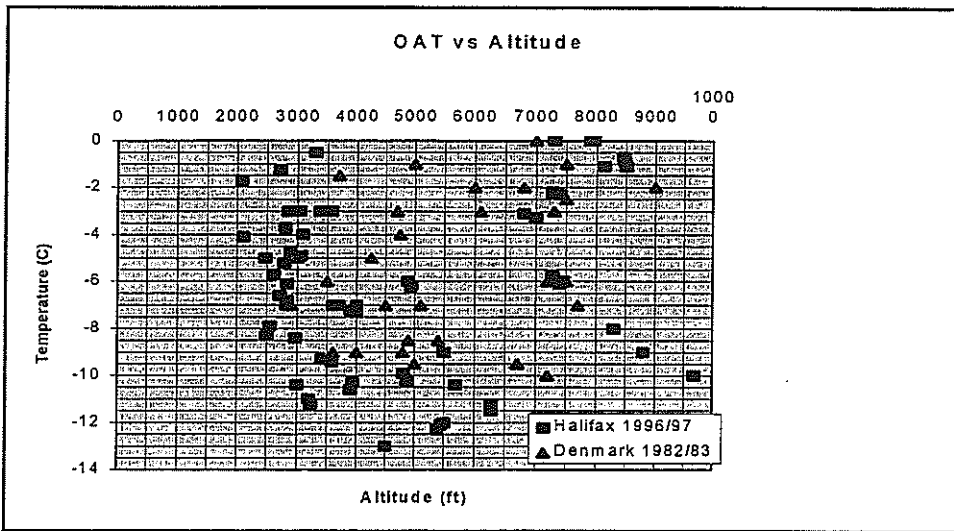
Figure 3: OAT vs Altitude Planning Chart

Figures 3 and 4 show the conditions that were experienced in Canada. Figure 5 presents the icing experience in terms of the time in icing versus outside air temperature for four altitude bands. The majority of the icing (67%) was encountered below a pressure altitude of 4000 ft, 15% was accumulated between 4000 ft and 6000 ft, 12% between 6000 ft and 8000 ft and only 6% was accumulated above 8000 ft.

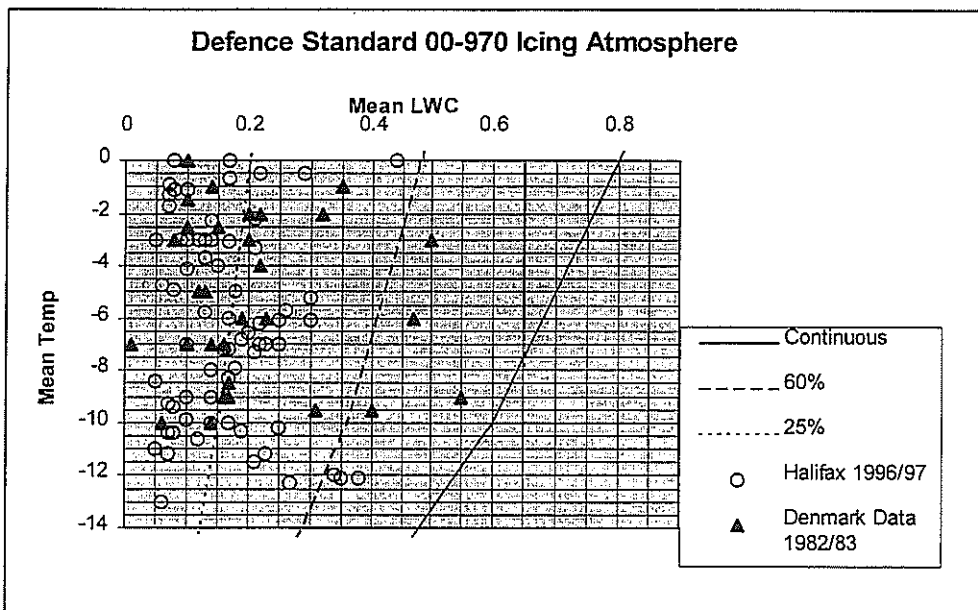
Figure 4: OAT vs LWC Chart

The time spent in icing, however, gives little indication of the value of the icing experience. Figure 4 shows that most of the icing encounters were in cloud with low liquid water content, typically 0.05 to 0.25 g/m³. The highest mean values of LWC recorded were 0.44 g/m³ at an OAT of 0°C for 5 minutes and 0.38 g/m³ at a temperature of -12.1° C for 10 minutes, however, the latter condition had to be vacated due to asymmetric shedding of the ice from the rotors. All the encounters at LWC values above 0.25 g/m³ and temperatures below -10°C were vacated due to high CGI activity and/or asymmetric shedding. The test conditions, where the aircraft was forced out of icing, were experienced at altitudes above 5000 ft; however, insufficient data was obtained at these temperatures (i.e. -10 to -12° C) at lower altitudes to show whether the problems would have been any less severe. It should be noted that satisfactory data was gathered at temperatures down to -11.5°C at altitudes above 5000 ft, however, all this data was at LWC values less than 0.25 g/m³. From previous trials (References 1 & 2) very little testing had been achieved at LWC values above 0.25 g/m³ at temperatures below -10°C, as these conditions have only rarely been encountered during trials. At LWCs above this value and at temperatures below -10° C, the ability of rotary wing aircraft to operate is severely limited without a means to accurately gauge the severity of the icing atmosphere. The severity could be judged by the use of an LWC meter such as those under development during this trial.

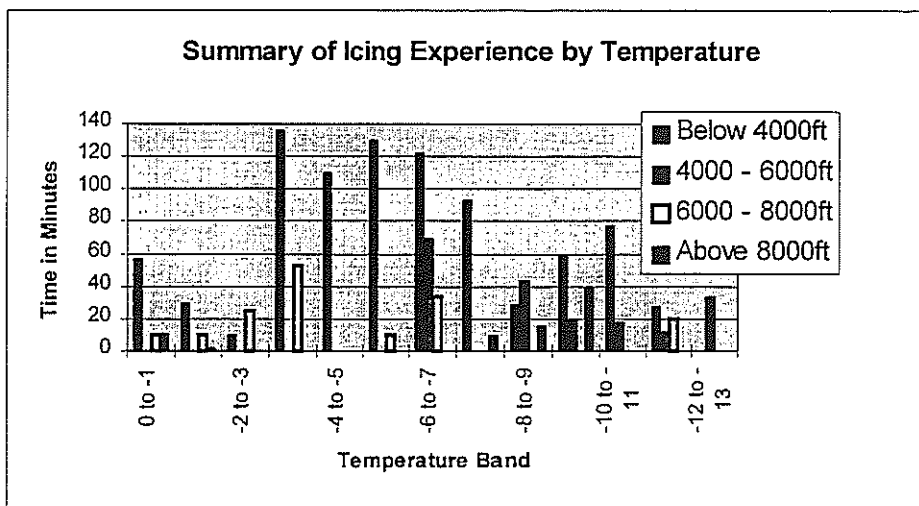
Figure 5: Icing Experience based on temperature and altitude

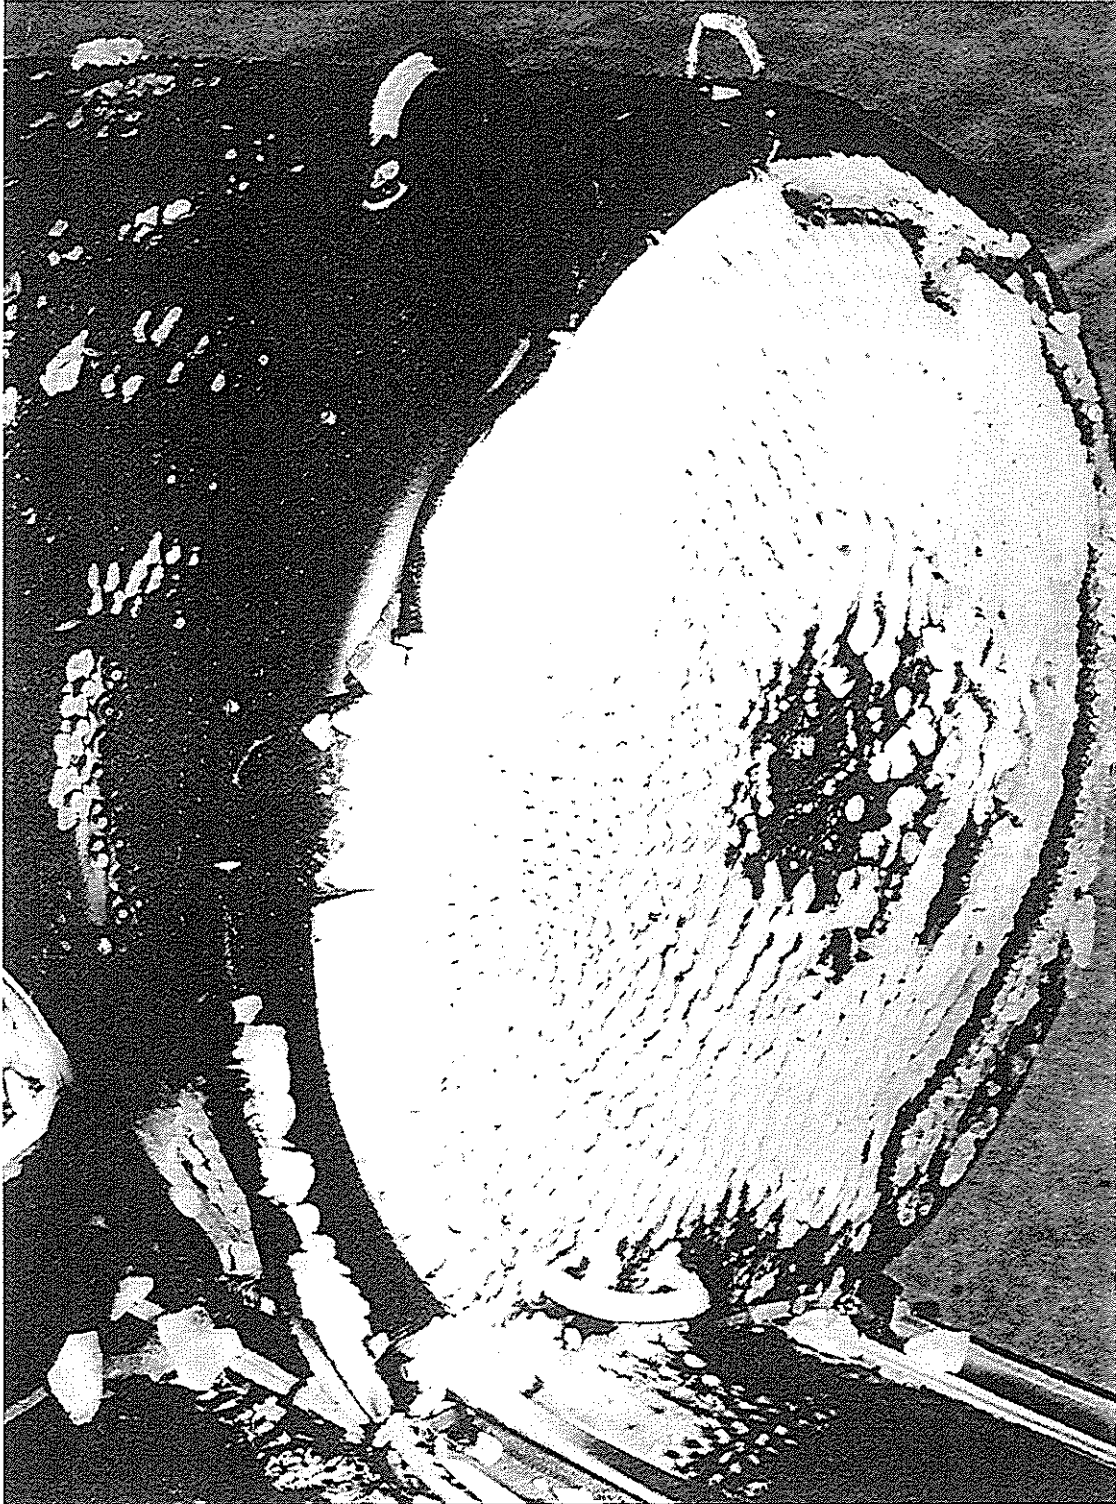
Figure 14: Ice Growth on EAPS Vortex Tubes.

Two standards of Engine Air Particle Separators (EAPS) were tested during the trial. The standard EAPS and the EAPS with an external stone guard (a mesh screen) and/or an internal conical mesh screen. Both standards of EAPS would rapidly accrete ice on entry into icing conditions. On the clean EAPS, the ice would tend to grow on each vortex tube as shown in Figure 14 and whilst it would often appear that the front face of the EAPS was totally blocked, this was never the case. The pressure drop across the standard EAPS did increase with ice accretion, however, the drop was well within the acceptable limits. Typically the pressure drop increased from 12mb (clear air) to between 15 and 20 mb; the maximum pressure drop recorded was 27 mb and this was well below the 100 mb limit. The standard EAPS was considered to be satisfactory for use during icing operations. Fitment of the external stone guards or the internal conical mesh screen had little effect on the capabilities of the EAPS in icing. Although ice was found to accrete and shed slightly more readily on the external mesh guard and the front face became slightly more blocked, these issues were considered insignificant. Neither the external stone guard nor the internal screen caused any increase in pressure drop across the intake nor did they affect the engine performance or handling.
