ULTRASONIC IMPACT DETECTION TECHNIQUES FOR AN EC135 TAILBOOM

A. Szewieczek¹, W. Hillger, D. Schmidt, M. Sinapius
¹artur.szewieczek@dlr.de, DLR (Germany)

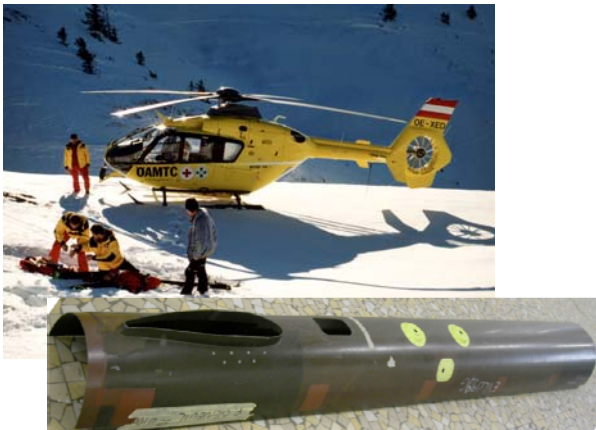
Figure 1: EC135 Tailboom

The curved 3.5 meter sandwich structure of the Tailboom (see Figure 1) consist out of a honey comb core, CFRP and GFRP skin layers with different thickness and an inserted lightning protection. Such complex components are very different

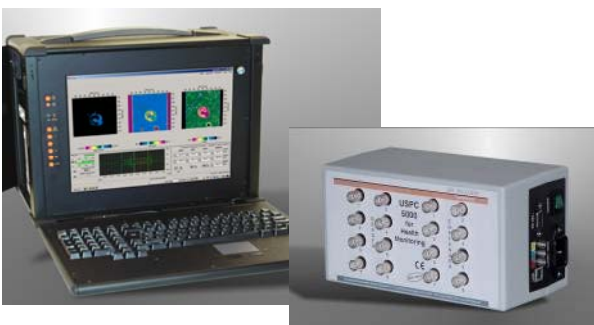
Figure 7: Data acquisition system USPC5000.

An interface box was designed in order to connect the SHM network to the data acquisition system USPC5000 [5]. It allows ultrasonic inspections by an integrated scanner controller as well as data acquisition from discrete sensor networks. The system stores acquired signals in the same data format as the ultrasonic scanning system. This allows data processing and analysis of different measurements by same software without separate alignment.

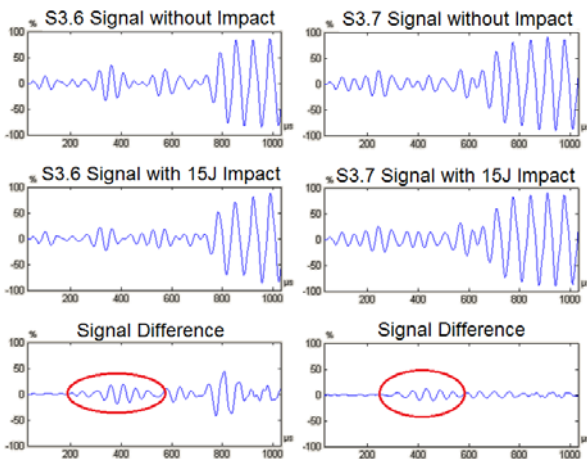
Figure 8: Sensor signals before and after impacting with 15 Joule nearby sensors 3.6 and 3.7.

Figure 8 shows the corresponding sensor signals before and after impacting and the signal difference between both structure conditions. An new signal component caused by the impact can be observed in both plots between 300 and 500 microseconds after excitation (red mark).

The addition amplitude in the difference signal of sensor S3.6 between 600 and 900 microseconds after excitation is cause by a phase shift of the signal after impacting. Such effects can be identified by enhanced signal analysis. A challenge for an automatic impact detection algorithm can be the consideration of such phase shifts additional to amplitude analysis.
