FLIGHT TESTING OF PIONEER BRIDGES AS HELICOPTER SLUNG LOADS USING A CH-53G

Hanno Brenner

Deutsches Zentrum für Luft- und Raumfahrt e.V. (DLR)
Institute of Flight Systems
Braunschweig, Germany
E-Mail: Hanno.Brenner@dlr.de

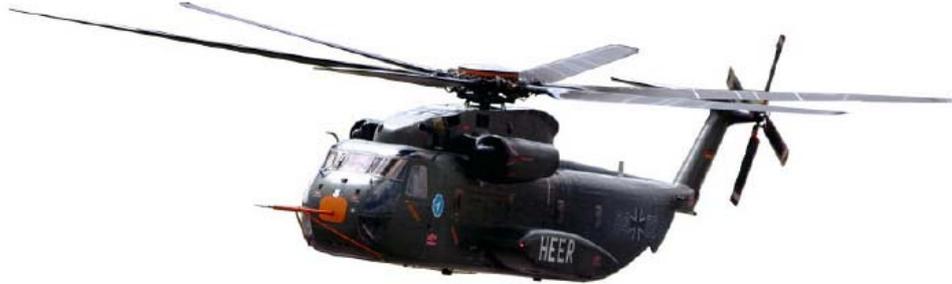
Table 2: Specifications of the WTD-61 Sikorsky CH-53G testbed [2]

weights		performance	
max. gross weight	19,050 kg (42,000 lbs)	engines	2 x T-64-GE-7
max. external load	7,255 kg (16,000 lbs)	cont. power	2 x 2,409 kW
number of load hooks	1	max. speed at SL	315 km/h (170 kts)
		cruise speed at SL	278 km/h (150 kts)
main rotor		tail rotor	
number of blades	6	number of blades	4
type	articulated	diameter	4.88 m (16 ft)
diameter	22.02 m (72 ft)	rated frequency	82.8 rad/s
rated frequency	19.4 rad/s

The CH-53G is operated by two pilots (test and safety pilot) as well as a flight test engineer and a load master. The aircraft provides conventional mechanical helicopter controls that are augmented by two parallel and independent hydraulic servo systems. Collective control is cross fed to the lateral cyclic as well as the tail rotor controls in order to compensate for roll and yaw moments produced by collective pitch changes. The electronic Automatic Flight Control System (AFCS) includes command augmentation of longitudinal cyclic control, rate damping about all axes, attitude and heading stabilization, and turn coordination at indicated airspeeds above 60 knots (q.v. table 2). Helicopter related parameters were recorded on tape at 120 Hz and transmitted simultaneously to a telemetry station for online monitoring. Air data were measured by means of a nose boom.

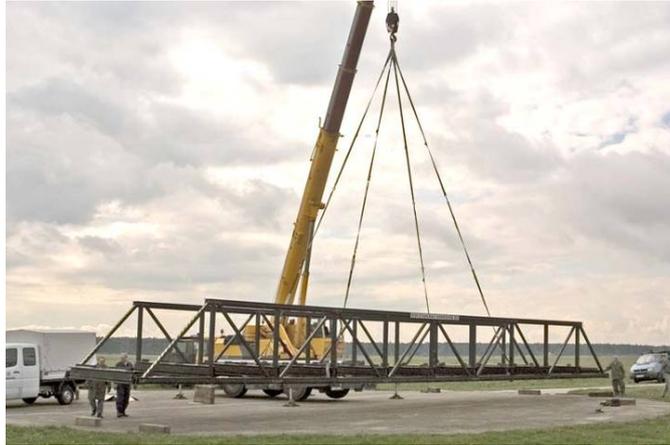
Figure 4: Ground tests at bridge 1

Ground tests applied for the phases 1, 2, and 8. The attention in phases 1 and 8 turned to the ground handling concerning the proper (dis-)assembly of the bridges and the documentation of necessary precautions that must be taken, i.e. selection of solid subsoil and cleaning up the hover zone for obvious safety reasons, respectively. The installation of the suspension harness in phase 2 was tested with the aid of a crane (q.v. figure 4). The attachment points of the straps at the bridge structure were chosen concerning the optimal relation between minimum spread angle and tilt-stability of the load. The suspension harness was built up of several straps being towed together. This assembly was approved and certified, and was tested for practical realization and applicability.

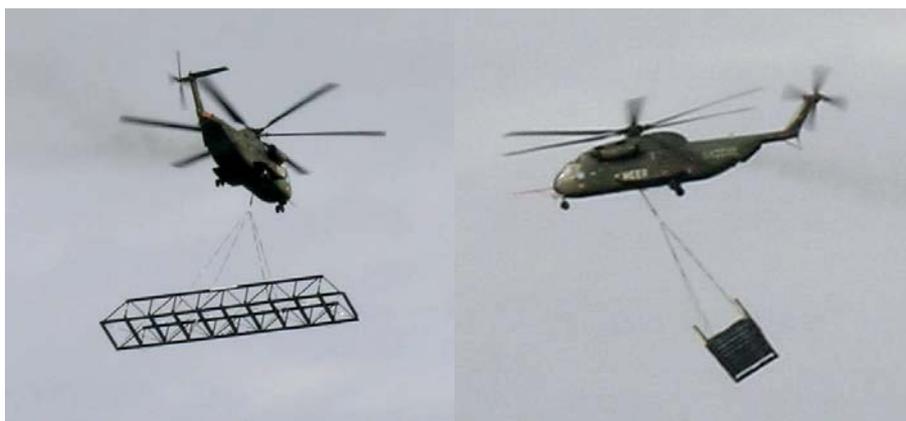
Figure 9: Bridge 1 at 50 KIAS forward flight

The phase was interrupted at 55 KIAS forward flight again, when the alternating pitch motion in helicopter pitch recurred. The helicopter pitch accounted for about -10 degrees. The straps of the suspension harness vibrated heavily. Hence, the flight envelope was limited to 55 KIAS (q.v. figure 9).

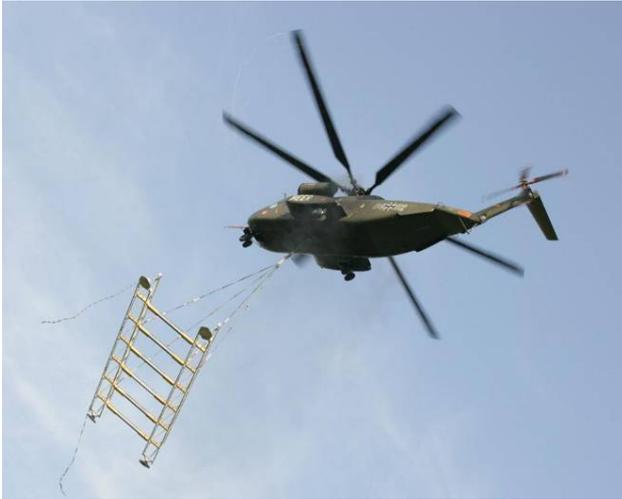
Figure 10: Bridge 3 in manoeuvre flight

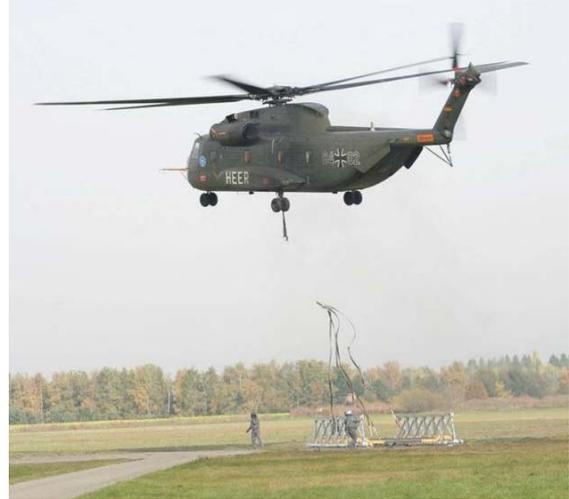
Figure 11: Bridge 3 - precise positioning

Bridge 3 Similar to bridge 2 the third bridge was translational positioned. The aerodynamic activity of the load due to the rotor downwash complicated the turning control by the ground personnel due to hindered handling. The problems which occurred due to time delays between reporting the load displacement and controlling in a corrective manner were even amplified compared the other loads. Because the load master was not able to see through the fully closed CRP-bridge in contrast to the framework structures, a loss of orientation and a lack of survey of the positioning area occurred. Thus, reporting the load displacement was mostly tardy and imprecisely. The desired position accuracy was not achieved.

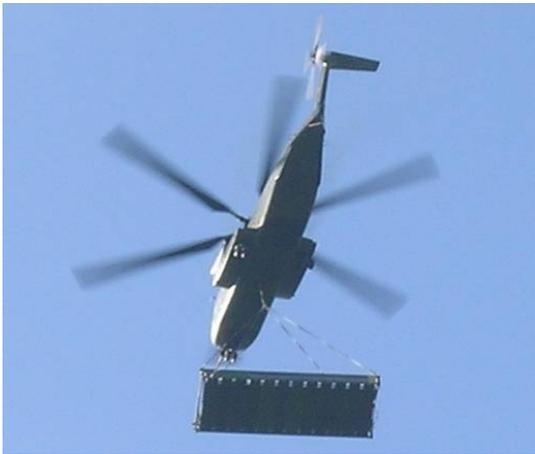
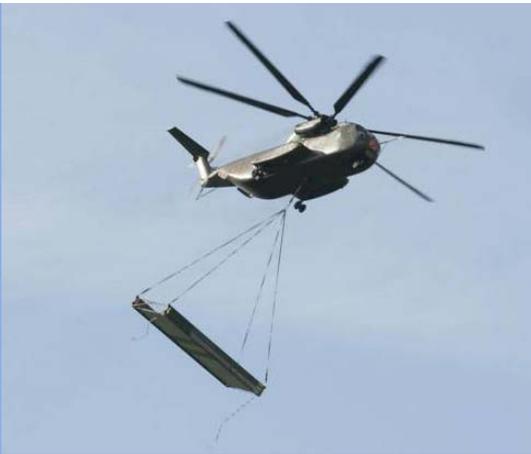
Figure 12: Bridge 2 at 40 KIAS

Bridge 3 The load oscillated about the yaw axis by ± 20 degrees at 40 KIAS with a stationary deflection of about 30 degrees backwards. This did not influence the helicopter dynamics. At 60 KIAS forward flight, the alternating pitch motion in helicopter pitch recurred (q.v. figure 6). Like before this phenomenon represented an envelope limiting factor. However, the load remained stable in yaw. Helicopter pitch accounted for about -5 degrees (figure 12). The flight envelope was therefore limited to 60 KIAS.
