## MARKER LAYER TECHNOLOGY: ADVANCED CRACK DETECTION IN ELASTOMERIC BEARINGS

By James R. Halladay and Haris Halilovic  
LORD Corporation  
2455 Robison Road West, Erie, PA 16509  
USA

### Abstract

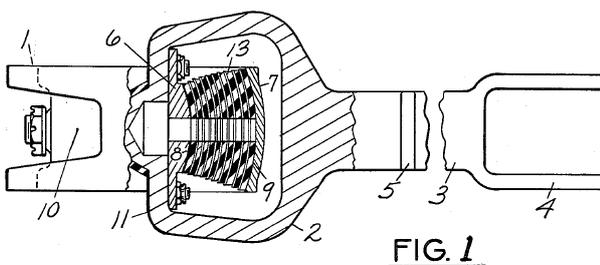
**FIG. 1**

Figure 1: Early Patent for an Elastomeric Bearing

Elastomeric bearings, also known as High Capacity Laminate or HCL bearings, are used in helicopter rotor applications to accommodate loads and motions. These “laminated” or “compressive load carrying” bearings were invented at LORD Corporation in the 1960’s<sup>[1,2]</sup> (Fig. 1) and commercialized for use as helicopter rotor bearings in the 1970’s<sup>[3,4,5]</sup>.

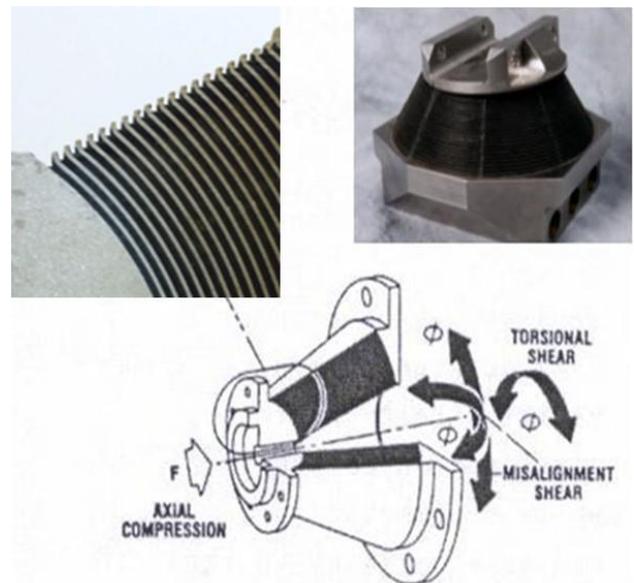
The bearings consist of thin elastomeric layers sandwiched between rigid shims. The elastomer layers allow for shear motions while the shims make the part stiff in compression. Elastomeric bearings are thus able to support extremely high axial compressive loads while accommodating large motions in torsion and cocking directions (Fig. 2).

Figure 2: Elastomeric Bearings Accommodate Loads and Motions

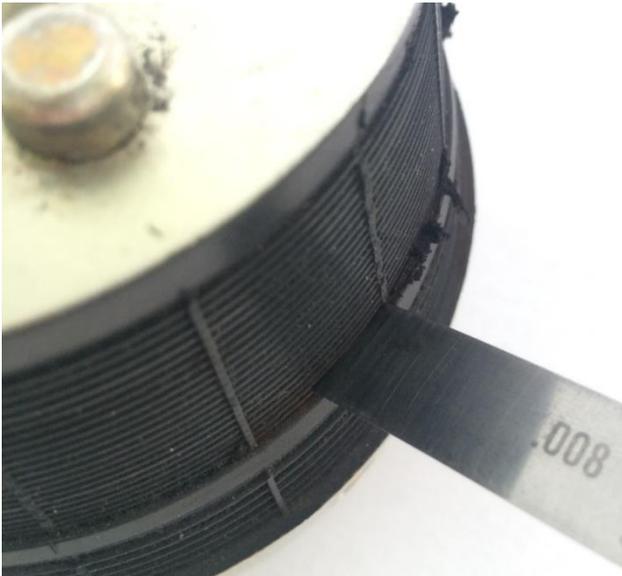
Fatigue degradation in HCL bearings normally begins at the exposed elastomer surface on the outer diameter and progresses into the rubber layers towards the center. These bearings are typically replaced “on condition”, that is, once elastomer fatigue degradation has reached a prescribed depth, a bearing is considered to have reached the end of its useful life. Since the earliest development of elastomeric bearings, determination of the extent of cracking while in service has presented a major challenge. The elastomeric layers are quite thin (typically from 0.5 mm to 2.5 mm), making it quite difficult to measure the depth to which a crack has progressed. For some parts, crack depth is determined by inserting a feeler gage into the crack to measure depth (Fig. 3).

Figure 3: Traditional Crack Depth Inspection Using a Feeler Gage

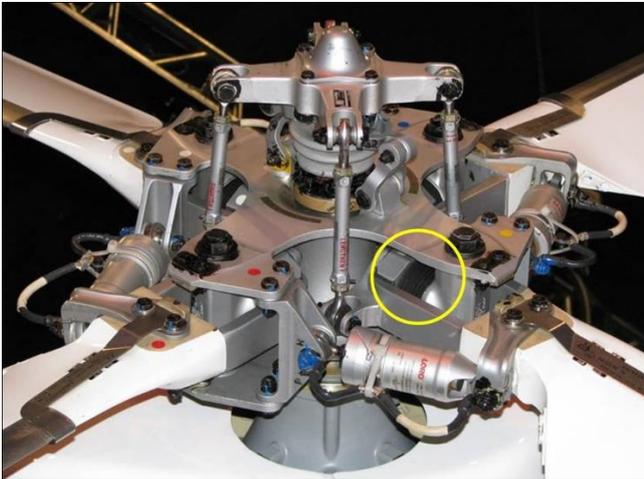
Figure 4: Elastomeric Bearing as Installed on a Helicopter Rotor

This measurement method is further complicated because of how the parts are used and where they are located on the aircraft. The bearings in service are loaded in compression and the thin elastomeric layers are often spherical making it difficult to insert a feeler gage. Additionally, the parts are generally located in areas that are difficult to access (Fig. 4 and Fig 5).

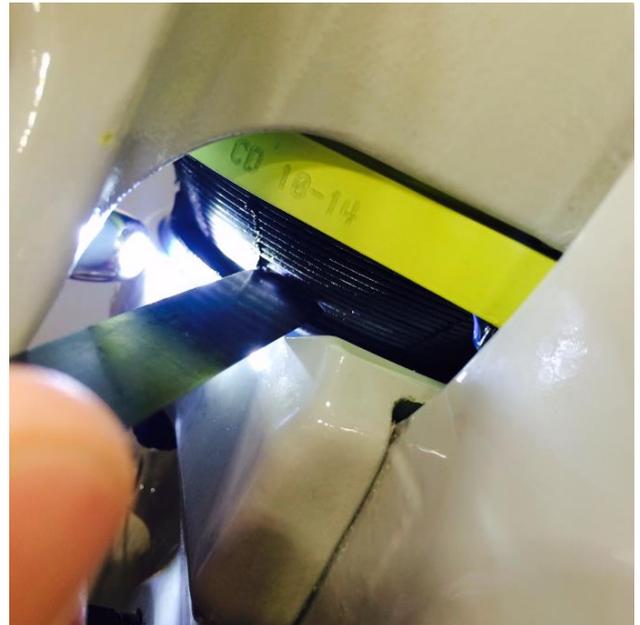
Figure 5: Elastomeric Bearing as Installed on a Helicopter Rotor (Inspection via Feeler Gage)

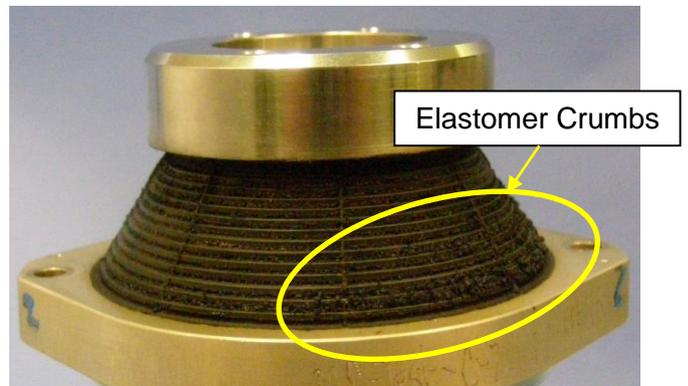
As normal fatigue degradation progresses, particles of the cracked rubber are carried to the surface of the part where they can be visually observed. The high compression loads force the rubber crumbs to the surface where the pressures are lower. These crumbs remain on the surface of the part throughout various helicopter operating conditions (Fig. 6).

Figure 6: Examples of Crumbs on the Surface of an Elastomeric Bearing Removed from Service

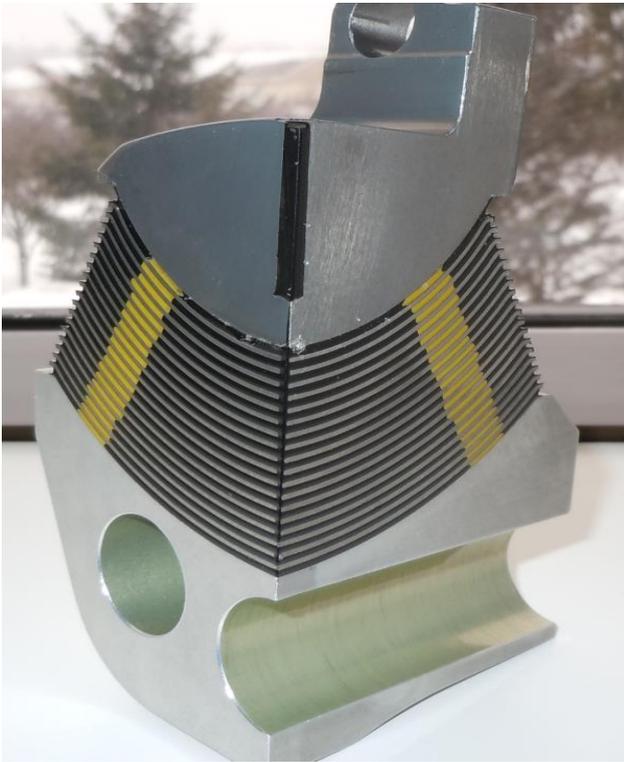
Figure 7: Quarter Section of a Bearing Shows Colored Marker Layer Embedded at a Predetermined Depth

The marker layer technology is a LORD Corporation innovation by which two or more visually distinct elastomers are embedded within the individual layers of an elastomeric bearing. By embedding visually contrasting rubber at predetermined depths, the crack depth in an elastomeric bearing can be monitored by observing the color of the elastomer crumbs as they appear

at the surface. The appearance of contrasting rubber crumbs on the surface from the marker layer is an indication that the bearing is approaching the end of its service life (Fig. 7 and 8). Marker layer provides a proactive maintenance flag so that the removal of the bearing can be scheduled without affecting the flight operations (i.e. 100 hours prior to the bearing removal).

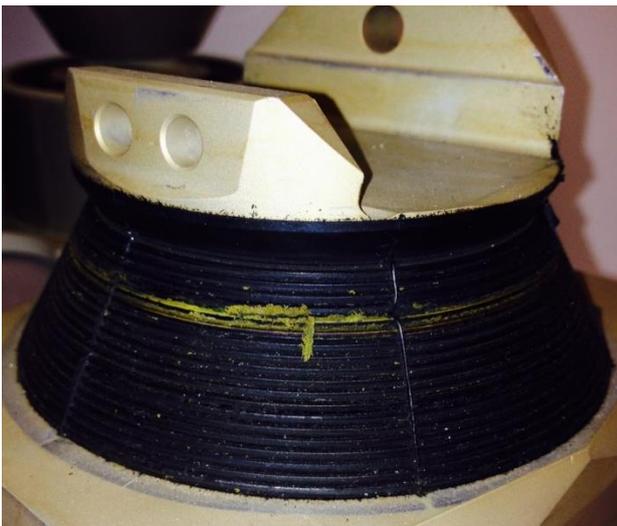
Figure 8: Example of Colored Crumbing at the Surface

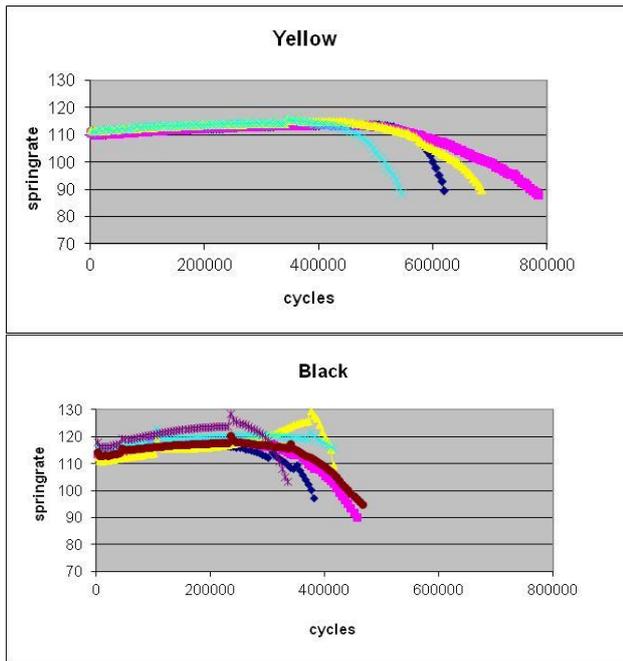
Initial development and validation of the marker layer compound utilized fracture mechanics. Fracture mechanics deals with crack growth from intrinsic flaws and can be used to characterize the rate at which strain energy is released as a crack grows. This strain energy release rate is termed "tearing energy" (abbreviated as  $G$ ), and it can be used to characterize the behavior of different materials intended for use in dynamic applications. The fracture mechanics based Fatigue Crack Propagation (FCP) test<sup>[8, 9, 10]</sup> which utilizes a "pure shear" test specimen, was used to characterize the crack growth behavior of black and colored rubber compounds. Additional characterization was performed using thin layer fatigue specimen, which was fatigued in shear under high compression loads (Fig. 9).

Figure 9: Resistance of Black and Yellow Stocks in Thin Layer Fatigue

Once laboratory data showed that the Marker Layer formulations were as good as or better than the black formulations, parts were made and subjected to fatigue testing. Testing demonstrated that the addition of marker layer materials maintains both the reliability and identical performance characteristics of a standard elastomeric bearing.

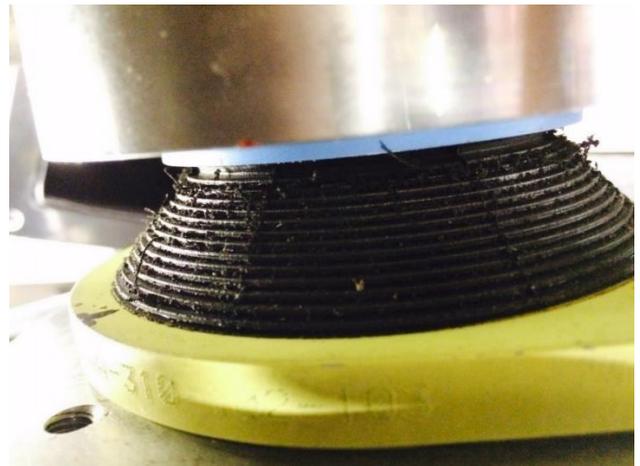
Figure 10: Black Crumbs Provide no Indication of Crack Depth

Inspection of a bearing containing the marker layer compound is easy. Black crumbs on a black background are difficult to distinguish (Figure 10) and give no indication of crack depth while the yellow crumbs are highly distinguishable against the black background (Fig. 11). Due to the nature of crack propagation in HCL bearings, the elastomer crumbs stay on the surface throughout the helicopter operating environment. The yellow crumbs visible on the surface serve as an inspection enhancement.

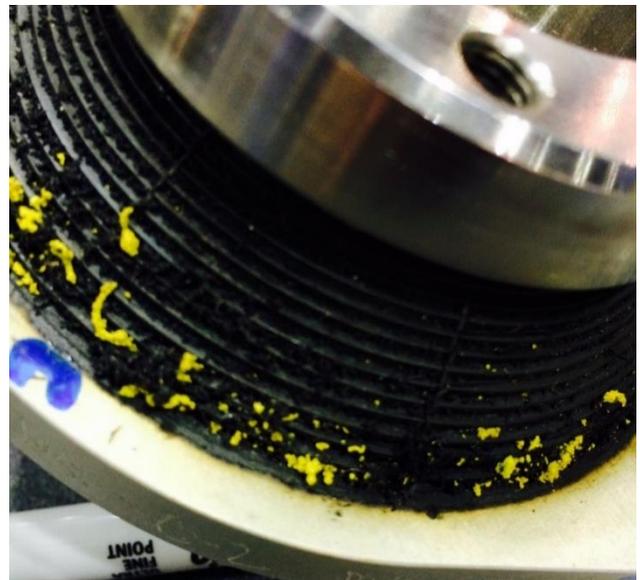
Figure 11: Yellow crumbs are Easily Distinguishable

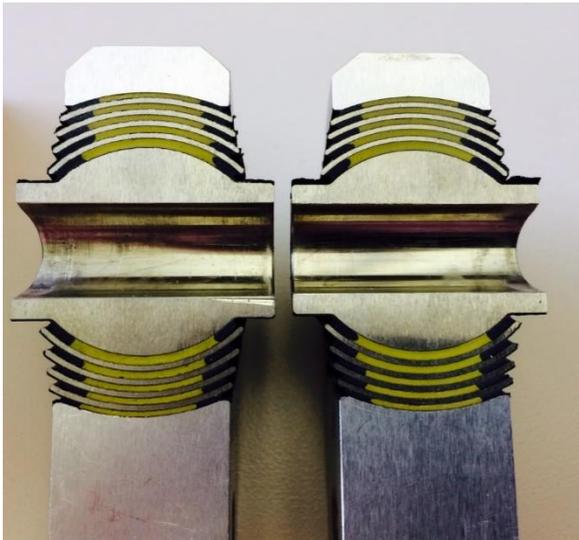
Figure 12: Rod-End Bearing Cross-Section with Embedded Marker Layer

Currently, the main focus of this discussion has been on spherical thrust bearings, but other elastomeric parts such as rod-ends and tube-forms, can also be fabricated using the marker layer technology (Fig. 12 and 13).

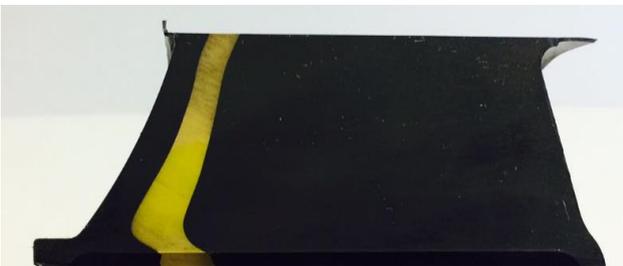
Figure 13: Tube-Form Cross-Section with Embedded Marker Layer

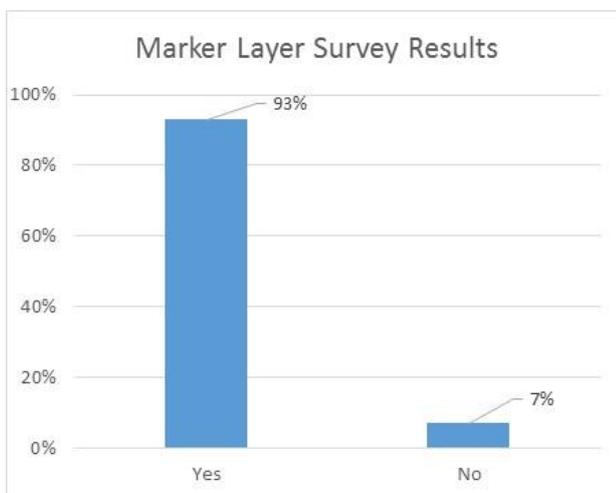
In a survey of sixty (60) maintenance technicians and helicopter operators, the question was asked, “Do you see this technology as a benefit to preflight and post-flight inspection processes?” Ninety-three percent responded with “Yes” (Fig. 14).

Figure 14: Marker Layer Survey Results
