The EC135 Drive Train Analysis and Improvement of the Fatigue Strength

ECD-0159-07-PUB

Key words: EC135, Fatigue strength, Drive train, Main gear box

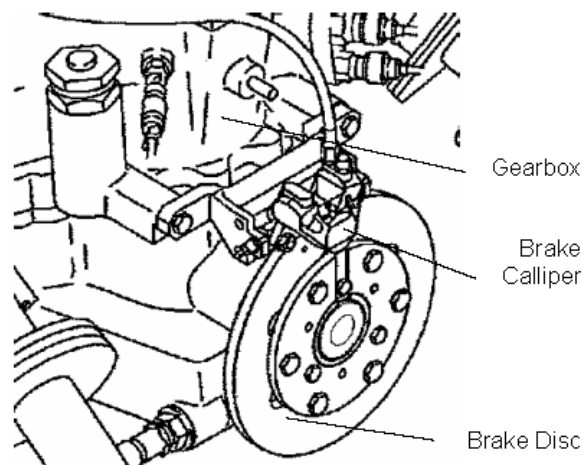
Figure 12: Connection of Brake Disc and Calliper on the Main Gearbox of the Helicopter EC135

The customers of EC 135 often complained a rattling behaviour of the rotor brake system. This was caused by some tolerances which were selected too high and was aggravated in some cases by deformation of the rotor brake disc. In some cases hot spots were observed on the disc and in very few cases cracks appeared in the disc as seen in Figure 13. Eurocopter did deeper investigations on this phenomenon to avoid such kind of hot spots, while the usage of the rotor brake was not recommended for some time.

New manufactured brake discs with very high tolerance requirements (flat and parallel faces) were introduced to avoid possible starting points of such hot spot areas and thus disc cracks. In parallel the weight reduction holes were deleted to allow a more uniform radial heat transfer distribution across the disc circumference. As third the disc adapter was also changed from an assembly consisting of two parts to an integrated, not assembled part. By these three means, all complaints of the customers stopped and the unlimited use of the rotor brake system is possible. Actually Eurocopter collects all in service feedback to demonstrate the performance of the system.

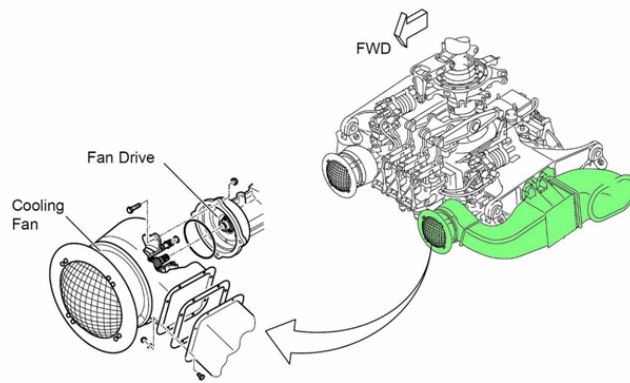
a) Location of the Fan Drive Shaft

The fan drive shaft connects the MGB with the fan as shown in Figure 14 a). The fan cools the oil of the MGB and the engine 1 or 2 depending on the installed side. As for all accessory drives for EC135 the drive shaft is designed as a mechanical fuse: In case of seizure or sudden stoppage of the fan, the shaft will shear and the fan will be decoupled from the MGB to prevent the MGB from further damage. On the other side, due to this design the shaft has a very small diameter which may also shear unintendedly (see an example in Figure 14 b)). This happened several times during the early serial phase of the EC135. Also rather heavy wear and seizing in the splined connection was found.

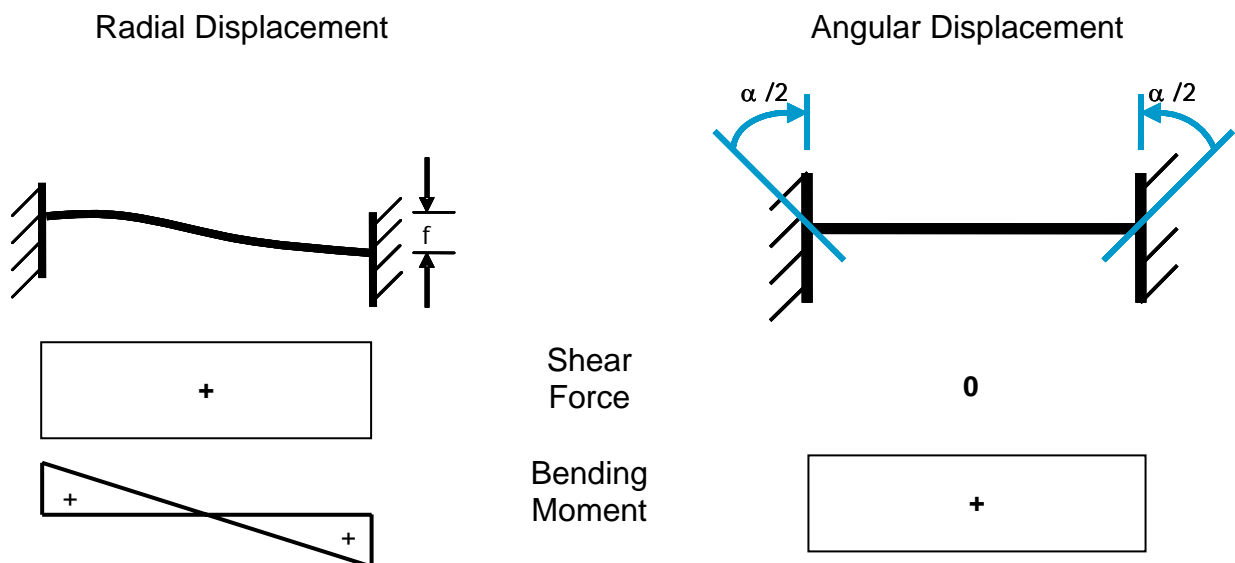
Figure 15: Shear Force and Bending Moment due to forced Radial or Angular Displacement

The transmitted load is limited by the fan and is much too low to create the failure, so the stress due to misalignments was investigated. Depending on the type of misalignment - radial or angular displacement - additional dynamic stresses are created inside the shaft, coming from the bending moment (for radial displacement) or from the shear forces (for angular displacement), see Figure 15. As the rotational speed of the shaft is 12.665 RPM the applied load cycles reach a very high number in a short period of flight time.

In both cases a relatively low deviation in position can result in a too high stress inside the fan drive shaft. It was calculated, that for an radial displacement of $f = 0,004 \text{ mm}$ a shear stress of about $\tau = 200 \text{ N/mm}^2$ and for an angular displacement of $\alpha = 0,23^\circ$ a bending stress of $\sigma = 500 \text{ N/mm}^2$ is reached.
