S-61N FREE WHEEL UNIT MALFUNCTIONING

F. LOUWERS AND F. SCHAPER

KLM HELIKOPTERS B.V. SCHIPHOL AIRPORT EAST, THE NETHERLANDS

FIFTEENTH EUROPEAN ROTORCRAFT FORUM

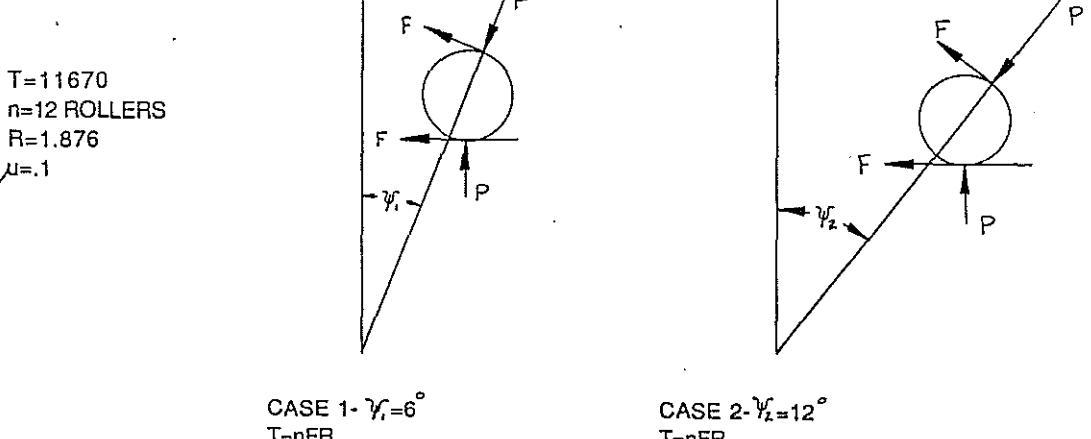
T≕nFR F=11670/(12)(1.876)=518# F=Ptan(V/2) P=518/tan3=9880# Fmax=uP=.1(9880)=988# 518#<988# DRIVE

- ROLLER EXITS DRIVE POSITION
- CAGE CARRIES ALL OTHER ROLLERS
- DRIVE IS LOST
- MAY REENGAGE
- MAY CAUSE ENGINE SHUT DOWN
