EH101: LIGHTNING PROTECTION OF COMPOSITE MATERIALS:
RESULTS OF PRELIMINARY TESTS ON CFC PANELS

L.Luini, G.Meschi
Costruzioni Aeronautiche G.Agusta
Cascina Costa, Italy

A.Bertazzi
CESI
Milano, Italy

September 8-11, 1987
ARLES, FRANCE

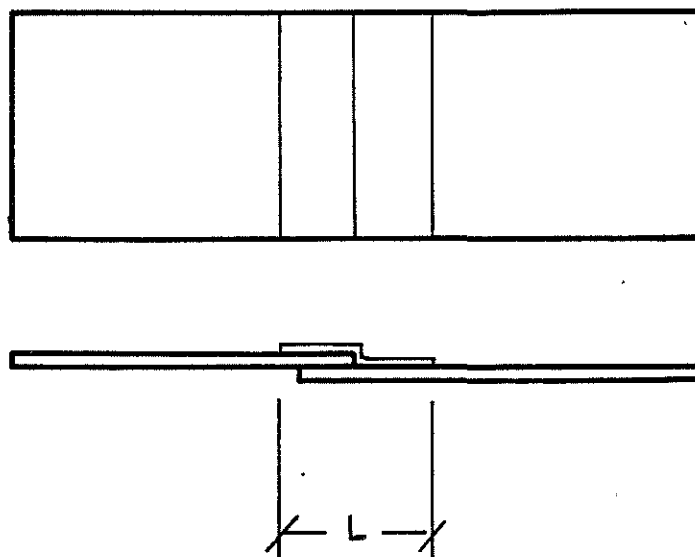
The panels with glued joint are protected with aluminized fabric; the joint is also covered with flame sprayed aluminum for a length of 60 mm or 80 mm or 100 mm as indicated in fig. 9.

Fig. 9. Detail of the flame sprayed aluminum on the joint of the glued panels.

L=extension of the flame sprayed zone: L=60, 80, 100 mm.
