# EXPERIENCE OF VIRTUAL SIMULATION OF AIRCRAFT ACCIDENTS RELATED TO STRENGTH PROBLEMS

Yuri Aleksandrin, Vladimir Grigoryev, [vgrigoryev@mi-helicopter.ru](mailto:vgrigoryev@mi-helicopter.ru),  
Mil Moscow Helicopter Plant (Russia)

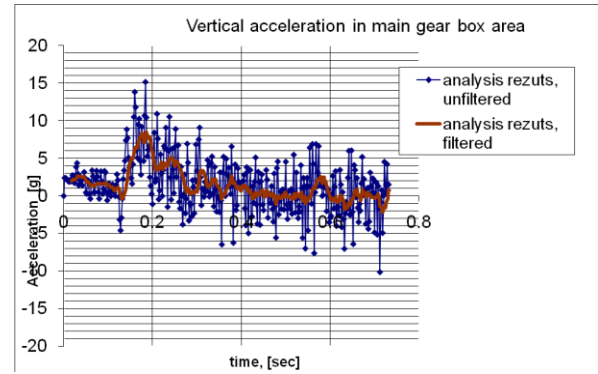
A final phase of crush of FA was simulated – namely – collision of aircraft with earth and partially destroying of the structure (tail beam detachment). Predicted load factor (Figure 5) in area of mounted flight recorder sensor and pictures of destroyed structure were quite close to reality.

Figure 5. Vertical acceleration of main gear box, [g]

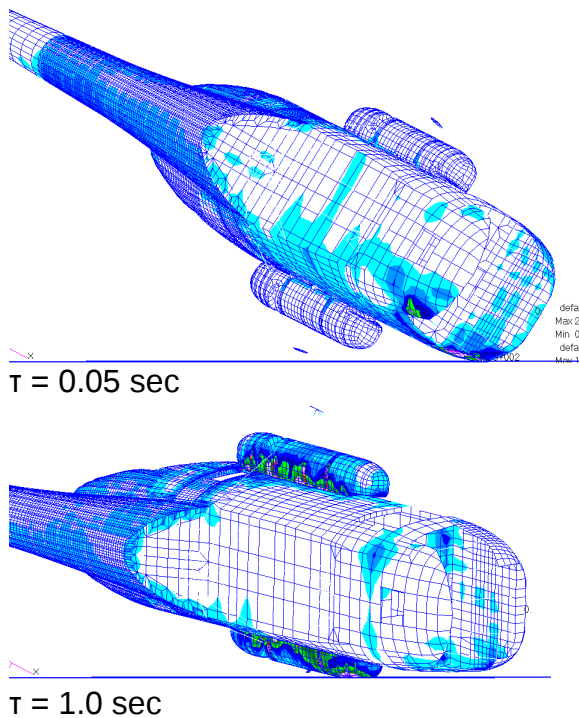
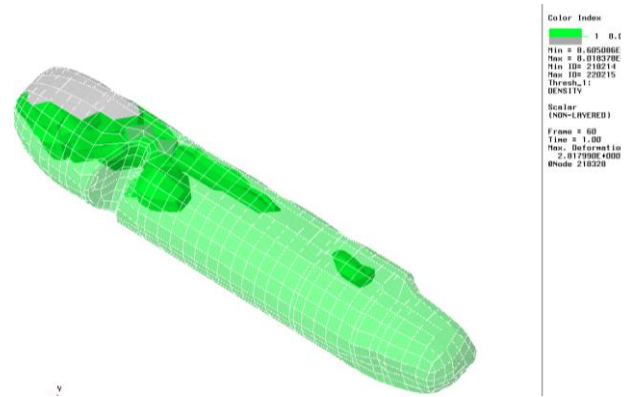
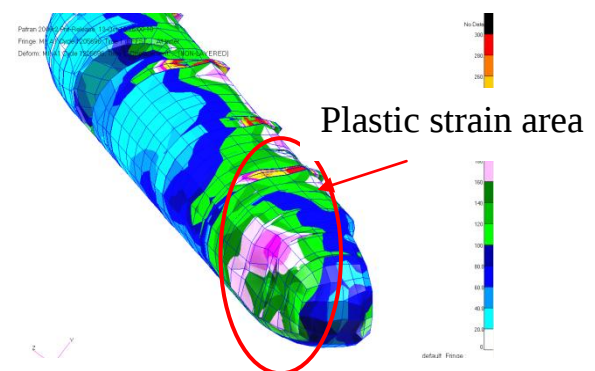
Using Msc.DYTRAN (and Msc.Patran – pre-post tools), such crash situation was simulated, when aircraft slides in side direction and then rollover to main gear box took place. Two phase fluid behavior was simulated inside fuel tanks, physical, geometry and structure (contact) kinds of nonlinearity were taken into account. It was shown by analysis, what plastic deformation during such rollover does not lead to damages with spillage remarkable amount of fuel.

It can be see very close agreement between simulations and real FA pictures.

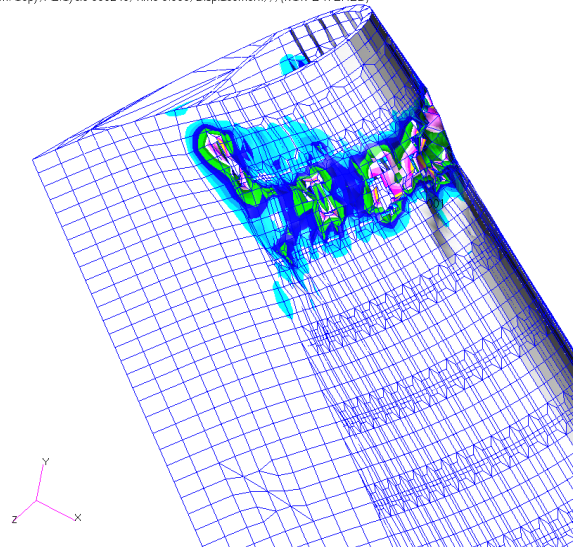
Figure 13. Deformed state and plastic strain of fin skin ( $\tau = 0.67$  sec)

It was discovered what main cause of structure damage was tail rotor disbalance, forced with detachment of part of tail rotor blade. The followed process can be characterized as having short overload (release of elastic energy), excitation of

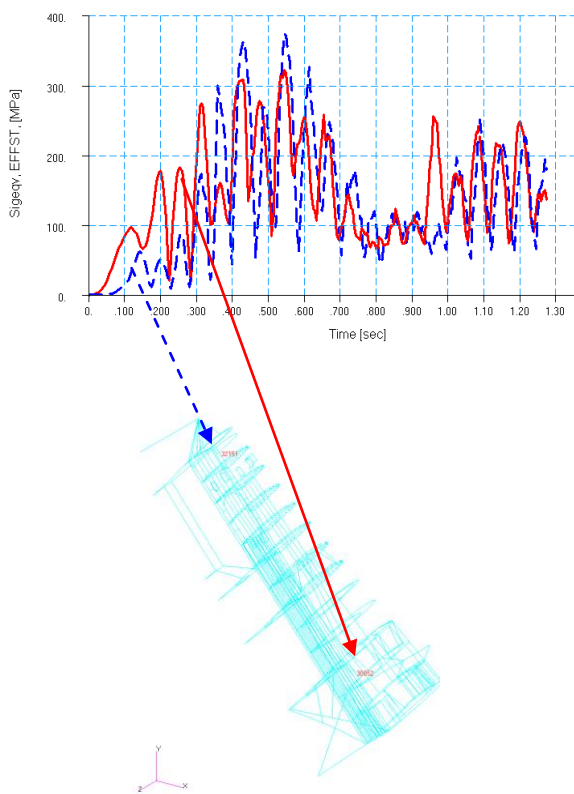
Figure 14. Time history of equivalent stresses in fin spar caps (sections rib3 – rib4, rib13 – rib14).

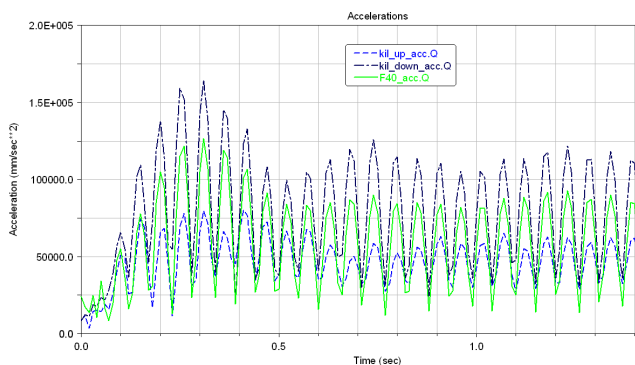
Figure 15. Accelerations in tail and boom structure of aircraft (kil\_up\_acc – tail gear box, kil\_down\_acc – intermediate gear box, F40\_acc – flight recorder mount in boom)

These analysis results were quite close to those recorded in the real structure, both in magnitude of accelerations and damage pattern.

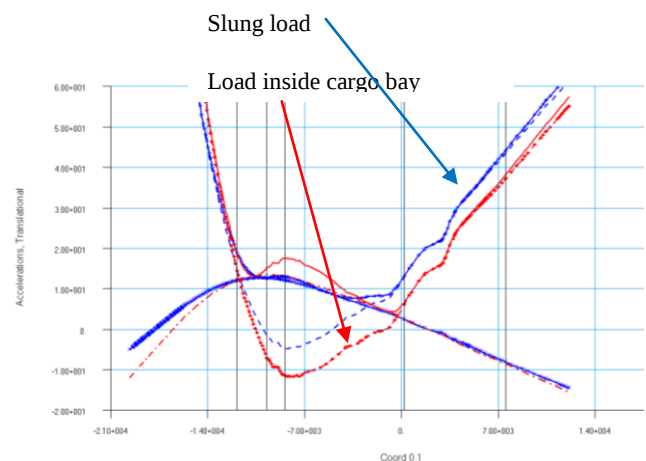
Analysis showed, what having load factor sensor near GC of aircraft, data received had not enough sufficiency for estimation of vibration state changing. It was due to sensor position nearly in vibration mode shape zeroes, with excitation on main rotor rotation frequency.

Figure 18. Vertical acceleration distribution along length of fuselage, in case of slung load configuration, and in load inside. Excitation frequency – 2.2 Hz.

It was pointed out, what in case, when several acceleration sensors were disposed in critical points of aircraft structure (for example near crosswise skin joints), it become possible to predict arising of dangerous fatigue cracks (Figure18, 19).

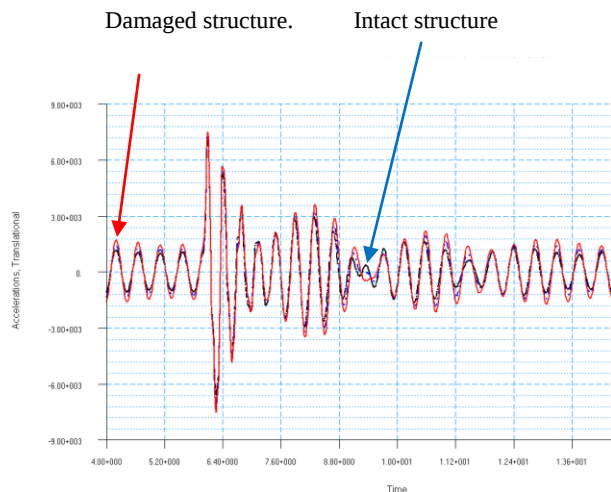
Fractography analysis shows, what fatigue damages were present in the skin at the area of frame #33. Fatigue crack growth to a state of critical length was taken place due to coincidence the number of adverse factors:

Figure 19. Vertical acceleration time history during maneuver performing. Intact and damaged structure, near #33 frame, [mm/sec<sup>2</sup>].
