TWENTYFIFTH EUROPEAN ROTOCRAFT FORUM

Paper n° M9

**DAMAGE RECOGNITION IN GEAR BOXES FOR
HEALTH AND USAGE MONITORING**

S.Emmerling
EUROCOPTER DEUTSCHLAND GmbH, München, Germany

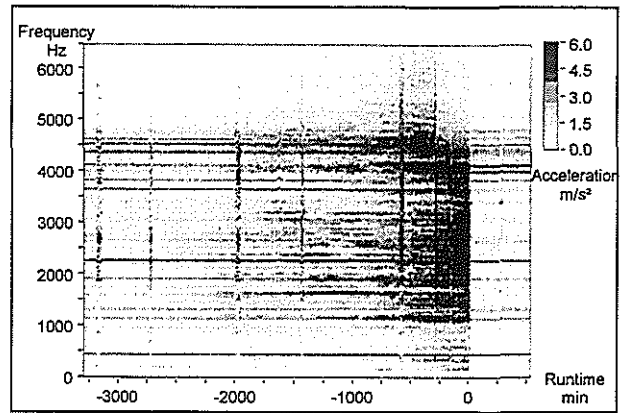
Figure 9: High Frequency Amplitude Spectrum of Step 0 in Table 2

As the high frequency spectrum up to 6 kHz in Figure 9 comprises all gear meshing frequencies this chart contains many peaks clearly distinctive from the beginning on. The defect of the bearing can be noticed mainly by the increase of the parts between the gear meshing frequencies.

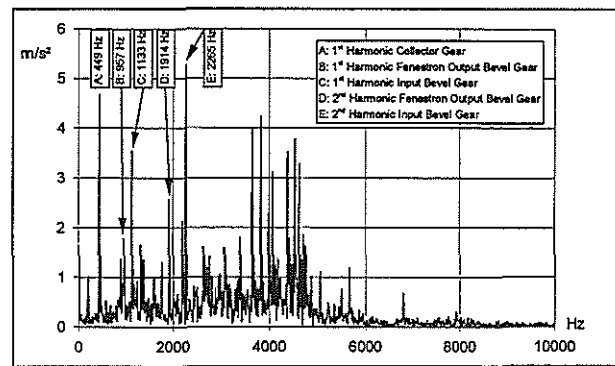
Figure 10: Amplitude versus Frequency at -6540 min of Step 0 in Table 2

More expressive is the comparison of two graphs showing the frequency spectrum for -6540 and -2580 minutes run time of the test (Figure 10 and Figure 11). Some of the most characteristic 1st and 2nd harmonics of gear meshing frequencies are marked in Figure 10. In Figure 11 the overall level of amplitudes and also the peaks have increased considerably. All three graphic representations of the high frequency spectrum show that above 5000 Hz there are no more exploitable information.

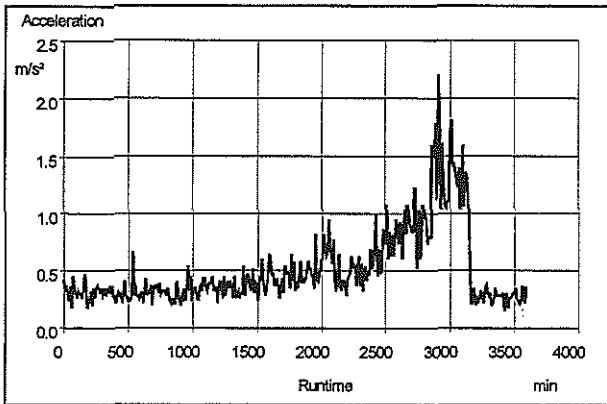
Figure 13: Amplitudes of the Shock Sequence Frequency of the No 13 Outer Bearing Race versus Time

Looking at the specific frequency of the shock sequence of the outer bearing race versus time in Figure 13 gives a good indicator for the establishment of a test interruption criterion.

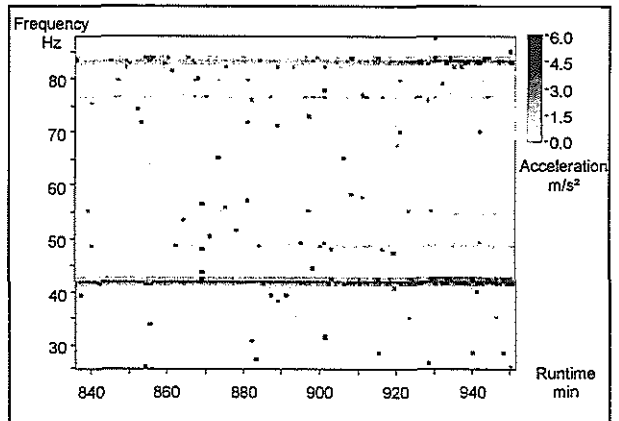
Figure 16: Envelope Spectrum of Step 1 in Table 2

- Figure 15 shows the low frequency spectrum with the significant increase of the 8th harmonic of the rotating frequency of the fenestron output shaft 41.5 Hz. Also for the 4th harmonic an amplitude increase can be detected.
- In the envelope spectrum of Figure 16 the shaft frequency and the trend of its 2nd harmonic also point at an anomaly of this component.
- Figure 17 depicts the pronounced increase of the acceleration values of the rotation frequency of the fenestron output shaft gained from the demodulated envelope.
