„Safe in the Sky“ Continuing Airworthiness Process at Eurocopter Deutschland

Eurocopter Deutschland GmbH, 81663 Munich, Germany

By means of a practical example, describing the rupture of a balance weight of a flight control lever of the tail rotor on an EC145 helicopter, the different process steps are shown and explained in detail. These steps start with the incident, along the occurrence reporting by the operator to the OEM, further to the different analysis and investigation steps which are subsequently leading to the definition of protective and corrective measures and finally to an information to all operators in order to accomplish actions for the affected helicopter fleet.

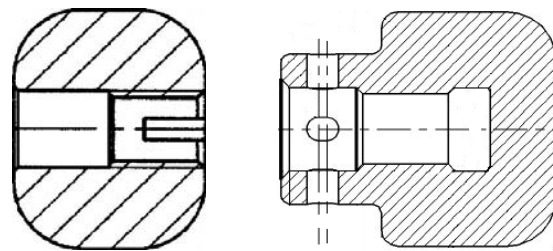
The basic design of the BK117 control lever was taken over, but modified in a way for the EC145 to further improve the pedal force characteristic. To achieve this target, the resulting lever arm for the propeller moment weights on the control lever was increased by re-design of its outer shape. Figure 8 shows both design variants. With the new design the propeller moment weight is mounted on a more outboard position which enlarges the moment of inertia. The modified propeller moment weight has now no feed-through hole, but a blind bore. To reduce the degree of modification in terms of manufacturing, the basic design of the control lever was kept. Only the borehole for the split pin was moved to the inboard position. Subsequently the production of both control lever variants was possible with the same forged

Figure 8. Initial (left-hand) and modified (right-hand) propeller moment weight design (material: tungsten)

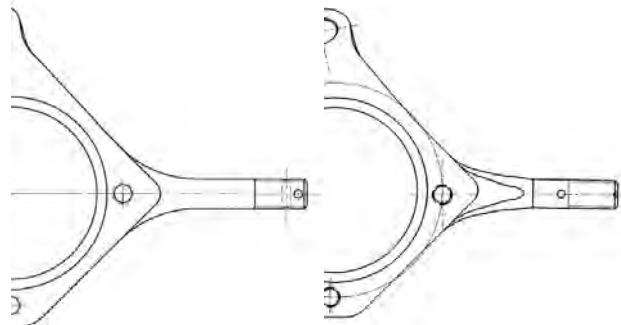
Figure 9. Initial (left-hand) and modified (right-hand) control lever design (material: titanium)
