EH101 - MAIN ROTOR HEAD COMPONENTS EVALUATION OF THE DAMAGE TOLERANCE CAPABILITY

M. Biasini - Stress Engineer - Rotor Dept.
U. Mariani - Senior Stress Engineer - Fatigue Dept.
F. Oggioni - Senior Stress Engineer - Rotor Dept.

AGUSTA s.p.a.
C. Costa - Italy

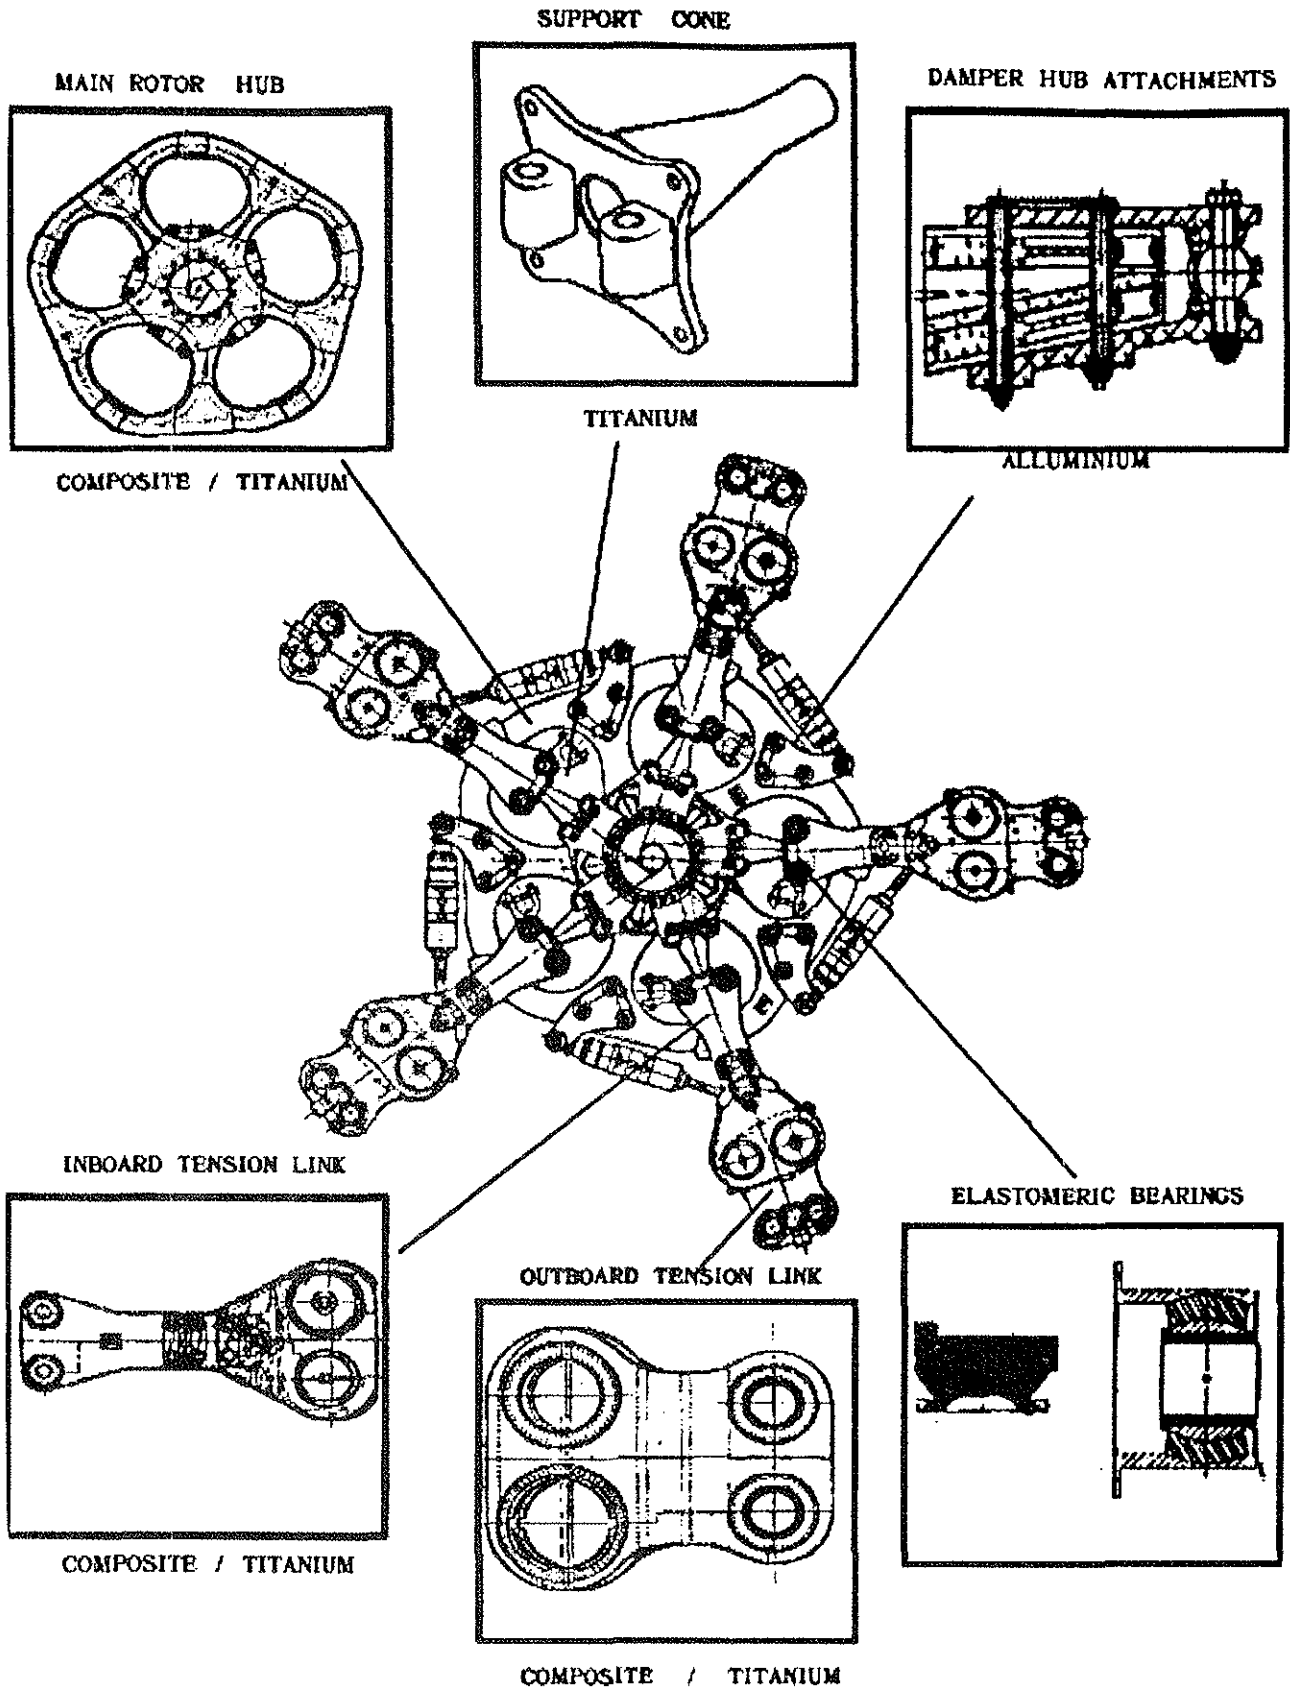
The figure 1 shows the EH101 Main Rotor Head with the components verified for Damage Tolerance capabilities.

Figure 1 - EH101 Main Rotor Head - Components verified for Damage Tolerance capabilities.

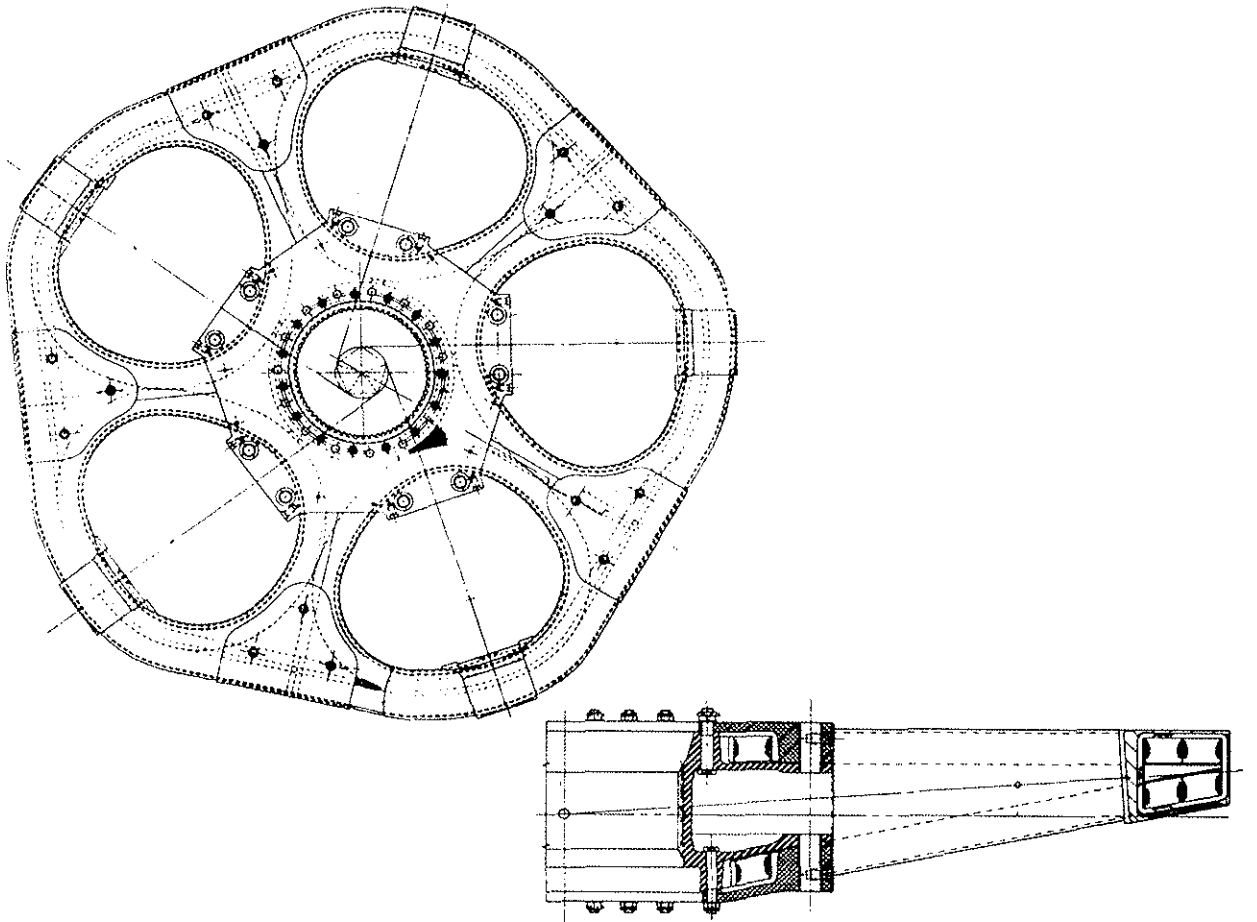
The M.R. Hub, figure 2, assures connection of the 5 blades and transfer the loads to the mast through a splined coupling. It is a hybrid metal-composite structure made by a titanium splined coupling and 10 small plus 2 large carbon fibre-epoxy loop windings enclosed by an external wrapped glass-epoxy box. The hub is a 125°C autoclave cured component.

Figure 2 - Main Rotor Hub

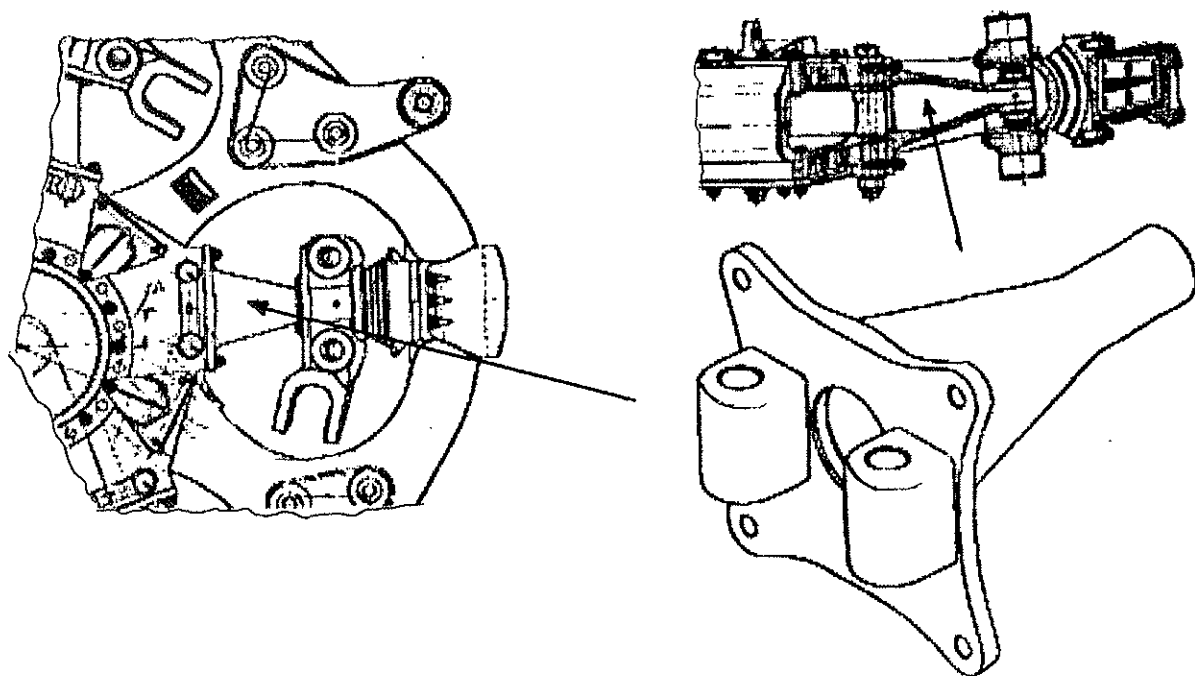
The M.R. Support Cone connects the Pitch Change Arm to the Rotor Hub. It is made by Titanium with a vulcanised Elastomeric Centering Bearing, which allows the pitch movement of the blade, figure 9. The Support Cone is connected to the Hub core via two Special Bolts and four Stud Bolts.

Figure 9 - M.R. Support Cone

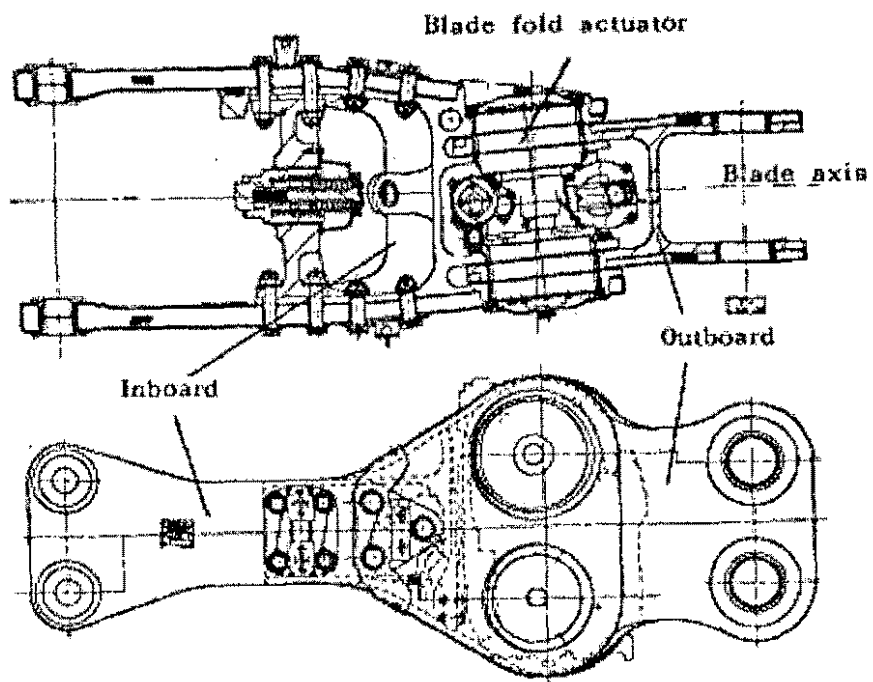
Figure 11 shows the two components.

Figure 11 - M.R. Inboard and Outboard Tension Links

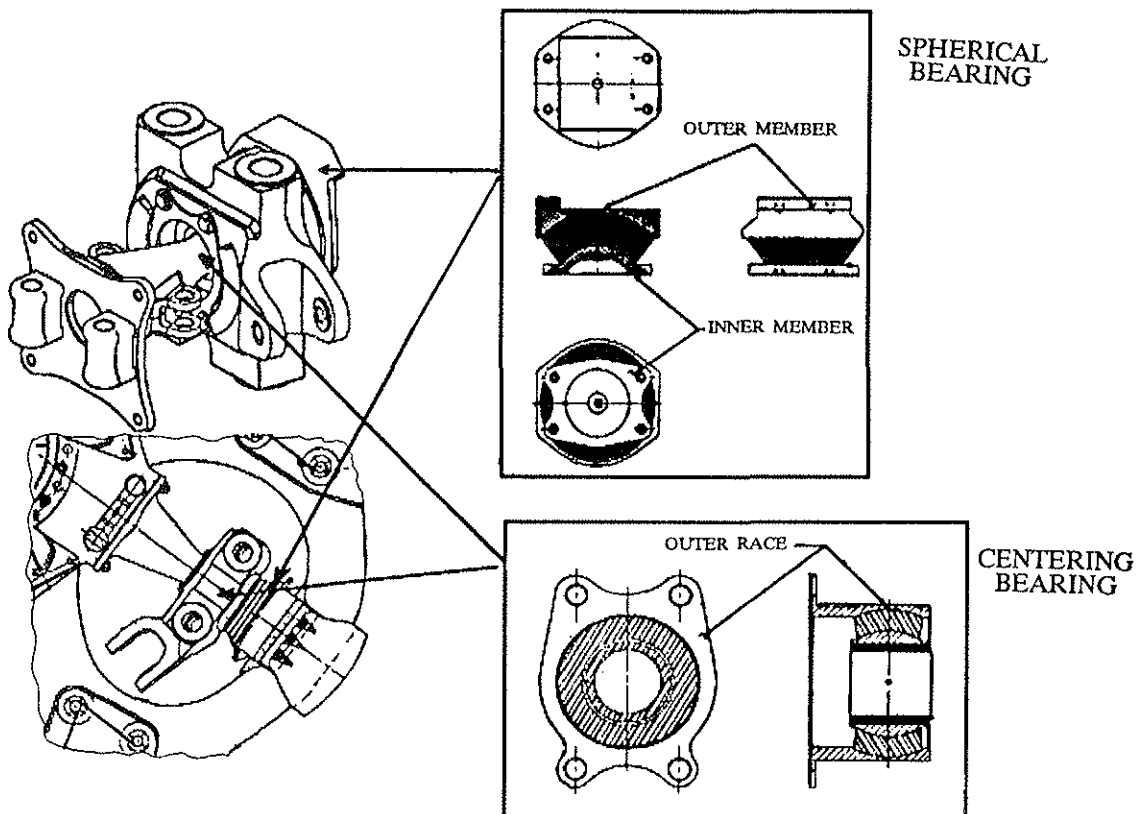
Two types of Elastomeric Bearings, figure 13, are installed on the M.R. Head, providing the drag, pitch and flap hinges of articulation and transmitting the blade shear loads, Centering Bearing, and centrifugal force, Spherical Bearing, to the Hub. The Spherical Bearing transmits part of the blade shear loads due to its radial stiffness and it can provide a redundant loading path for the flight completion in case of failure of the Centering Bearing, as proved by test.

Figure 13 - M.R. Hub Centering and Spherical Bearings
