Crashworthiness of rotorcraft on water, an experimental test campaign

Abstract

The present paper describes the preparation and results of two water impact test performed at CIRA. The activities were included in the research project CAST, devoted to improve crashworthiness of rotorcraft on water. First test was executed on a Westland WG30 sub-floor section, the second was the water impact of a complete full scale WG30 fuselage. For both tests, impact velocity was 8 m/s with flat attitude. Test specimens were fitted with ballast masses to recreate realistic load conditions, and equipped with pressure transducers and accelerometers to obtain objective quantitative data representing the severity of the loading, to which the structure was exposed. Moreover tests results were needed to assess numerical simulations performed by other partners of the project. Pre-test numerical simulation results produced by DLR together with advice from Westland led to the final test configuration of the component. This avoided unrealistic failure of the test specimen in question. The test specification for the full scale test was provided by Westland

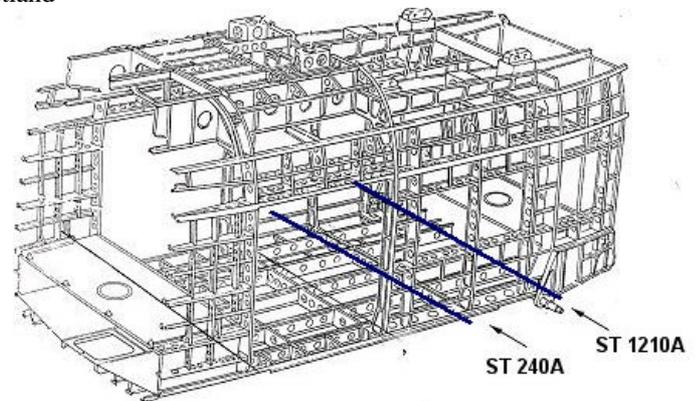
Fig. 1 Subfloor section

The component tested was a section of a WG30 under-floor structure. Specifically, it was the section included between Fuselage Station 1210A and 240A, as shown in Fig. 1. The overall dimensions of the section were 2170 mm width and 970 mm length. The test specimen also included floor panels.

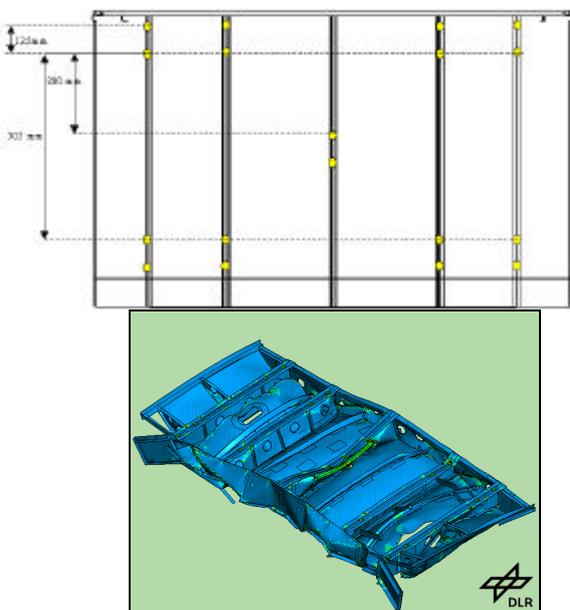
Fig. 3 Eighteen hosting point lay-out and simulation results

As shown in Fig. 2, the eight point arrangement would have caused an unrealistic bending failure of the structure. The pre-test simulation on the new configuration led to the final test set-up. Fig. 3 shows the simulation result with the eighteen-point configuration.

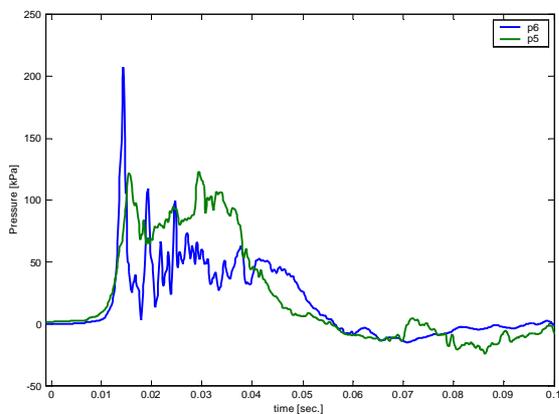
Fig. 7 Pressure time histories at location 6 and 5

Higher pressure values were reached at stiffer locations, which also corresponded to shorter pulse duration. In the following figure, time histories of transducer p6, which was mounted at a reinforced location corresponding to the sub-floor central keel beam, and p5, which was mounted on the panel's centre, are compared.

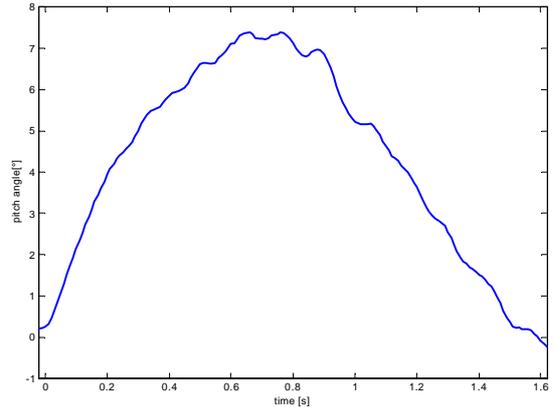
Fig. 13 Pitch angle time history

The measured impact velocity was 7.95 m/s. At impact with water the fuselage assumed a positive pitch attitude which can be considered to be caused by the tail rotor mass. The following picture depicts the time history of the pitch angle as evaluated from the high speed camera.

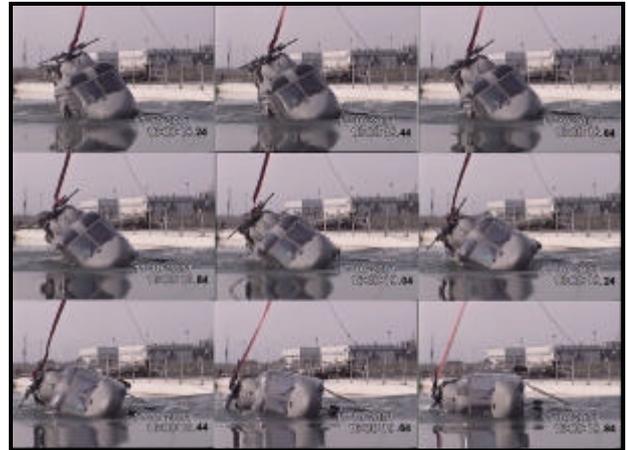
Fig. 14 Impact sequence

Two seconds after first impact, the test specimen rolled on the side because of the high upstanding engine and transmission masses. In the following picture, the impact sequence is shown as recorded by a slow speed camera.

After impacting on water, the rotorcraft rolled on the side because of the high upstanding masses of rotors and transmission. This is a common feature of rotorcraft, as mentioned in numerous accident investigation reports, and is related to cabin evacuation issues. In fact, in a number of helicopter accidents involving water, fatalities were caused by the impossibility of escaping from the drowning fuselage.

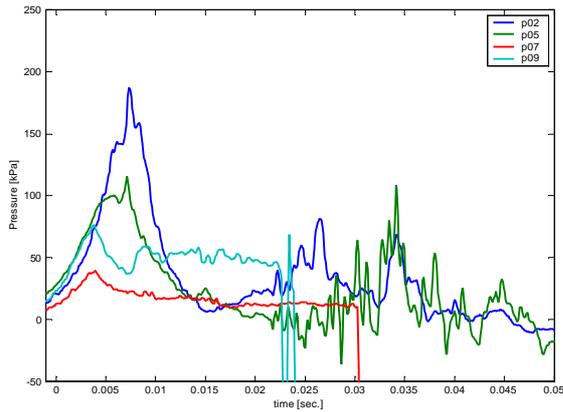
Fig. 15 Pressure time histories

The pressures on the belly skin were in the range from 50 to 130 kPa as it can be noticed from time histories of transducers located on the longitudinal centreline of the belly skin. The highest values were collected by transducer p02, which is located at F.S. 2457 F on a very stiff location between the front fuel tank and cabin. The lowest values on the contrary were reached at F.S. 450 F, which is located at the door frame on the same station the highest deformations were observed.

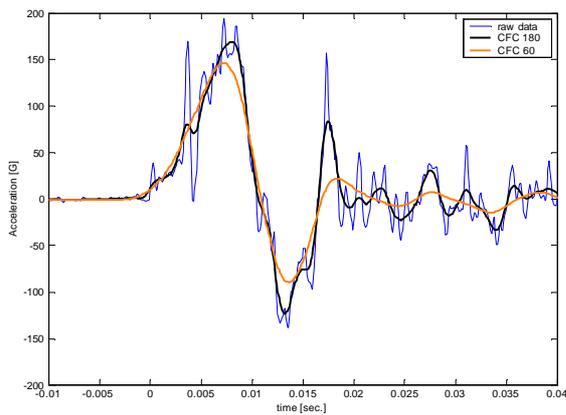
Fig. 16 Seat track acceleration time history at different filtering conditions

The acceleration data presented in this paper have been obtained by filtering raw data through a SAE CFC180 filter. Even if SAE J211 suggests to use a CFC60 filter for analysing structural data, in this case a wider band filter has been chosen for the reason that a CFC60 would have resulted in a significant under-estimation of the loading magnitude. In Fig. 16, the acceleration time history acc13 located on the seat track on the central keel beam FS 450F is shown unfiltered and filtered with a CFC60 and a CFC180 filter.

As it can be noticed, the use a CFC60 filter causes an underestimation of 30G in the main pulse, about 50G in the rebound, while solicitations subsequent to 15ms are nearly neglected.

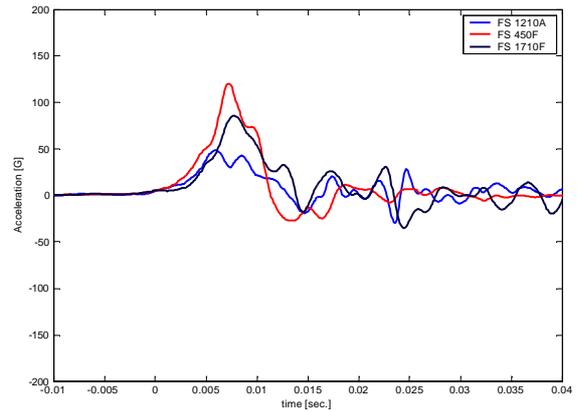
Fig. 17 Seat track acceleration time histories

The accelerations measured on the seat track were in the range between 50G and 160G. The highest values were reached at FS 450F, where the largest deformations were observed. In the following figure, three accelerometer time histories taken from the seat tracks are shown.

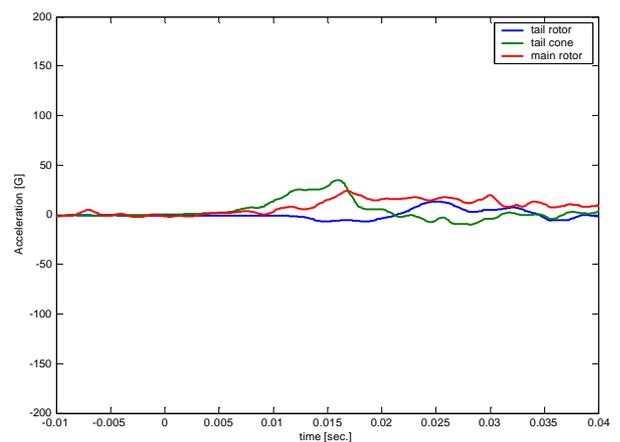
Fig. 18 Rotors and tail cone accelerations

Comparing these values to the accelerations measured on the rotors and tail cone, shown in Fig. 18, it can be noticed that in the second case the acceleration level is considerably lower. This is explained by the fact that the seat track accelerometers were mounted very close to the impact location. In this zone, no mechanism was available in the structure to reduce the load transmitted to the occupants. The upper parts of the structure, on the contrary, could benefit from deformation of side frames and for this reason experienced a lower loading level. In Fig. 19, the compressive load measured by the load cell mounted on the ATD's pelvis is shown. The maximum load exceeded the 6670 N limit prescribed by regulation, confirming that the deceleration environment, to which the occupant was exposed, was significantly high and could cause serious injuries. It must be stressed that the WG30 helicopter is not operative anymore and, being an old design, did not include any energy absorption feature. In addition, no benefit was provided by the landing gears as it would have been the case in an impact on rigid soil.
