THIRTEENTH EUROPEAN ROTORCRAFT FORUM

4.1
Paper No. 55

THE ROLE OF MANUFACTURER IN
THE ACCIDENT INVESTIGATION

AGUSTA - ITALY

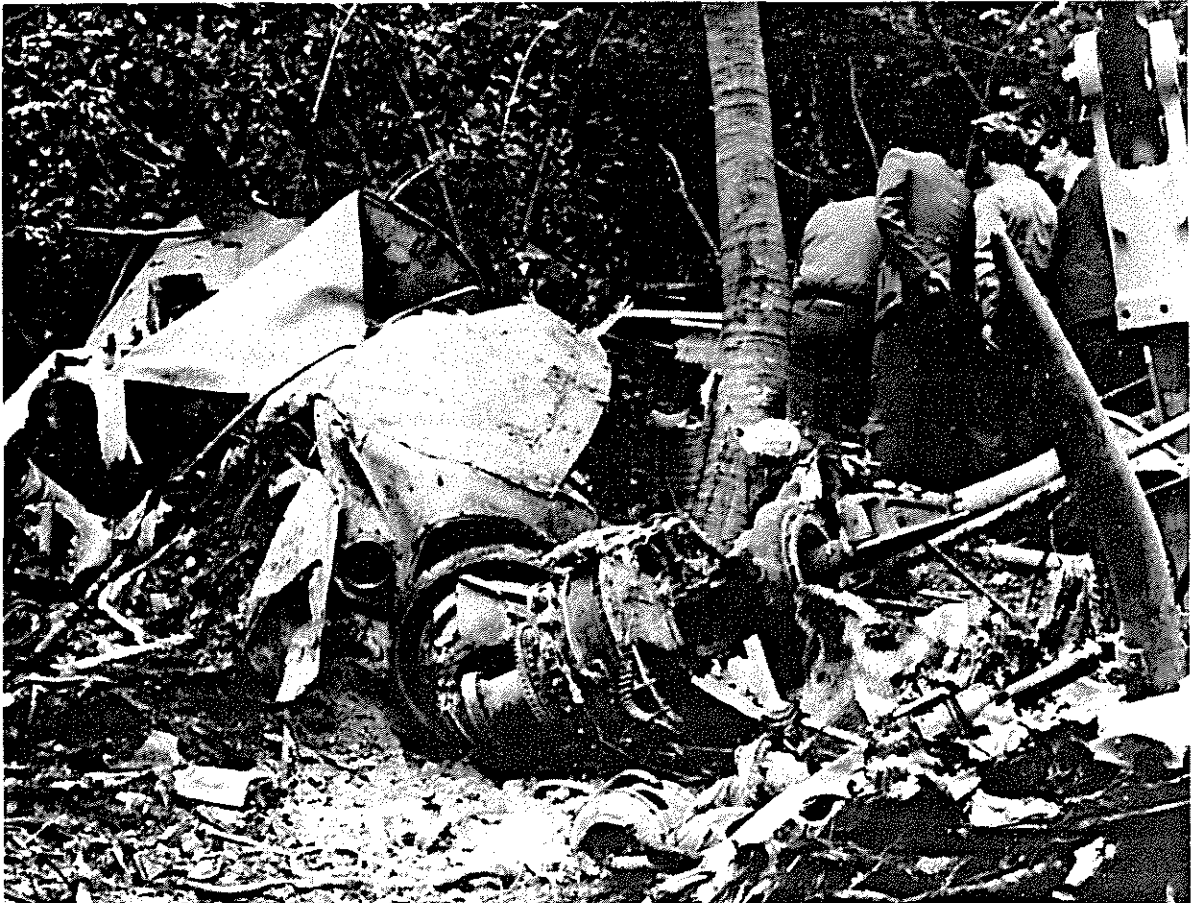
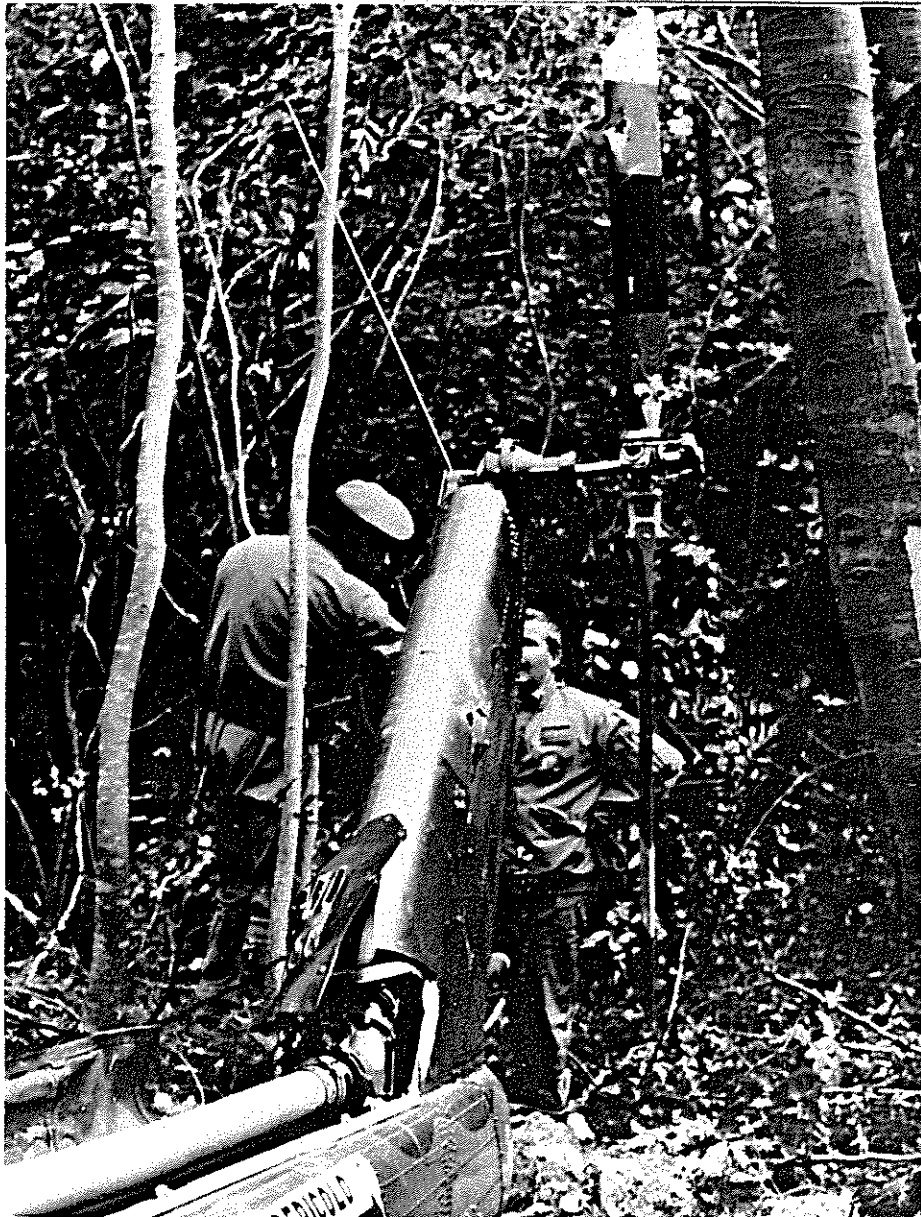
During a training flight at low altitude on a wooded mountainous region with four people on board, the pilot experienced the loss of directional control. One crew member opened the sliding door in flying and confirmed to the pilot the stoppage fo the tail rotor blades. An autorotation descent was initiated, ending in a survival crash landing for the occupants with distruction of the ship by the following fire.

Agusta experts, looking at the type of fracture seen on the tail rotor shaft, focused the attention on the 90° gear box.

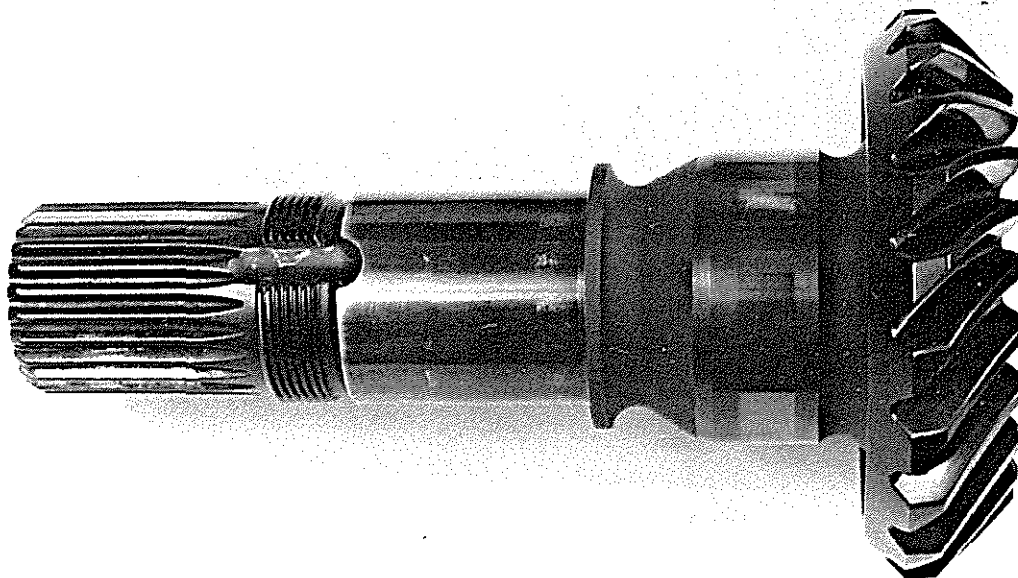
1. Main Gear Box - Tail Rotor Input Pinion

The imprints, see arrow, show that a sudden very high load has been transferred from the gear box to the tail rotor system. This is the case when the tail rotor strike against foreign object. Of course the same know-how is used to show that no sudden stoppage if the tail rotor happened.

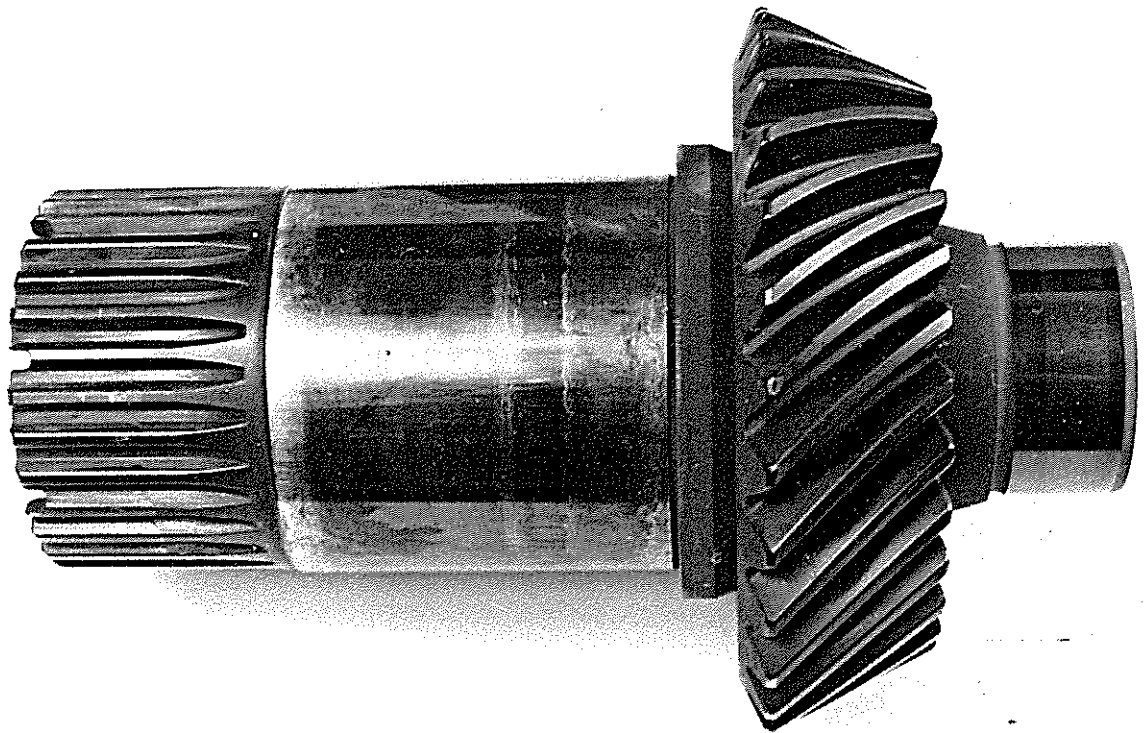
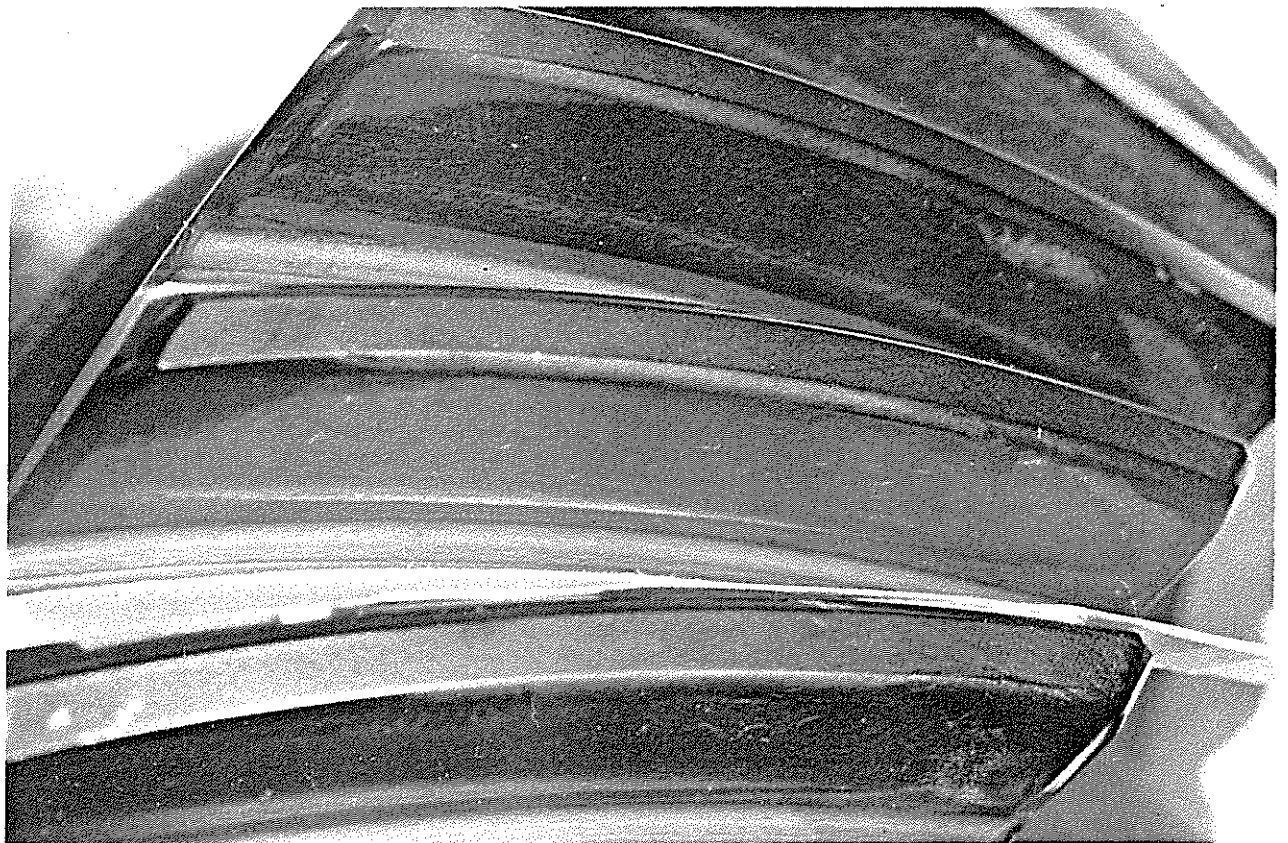
Normal pattern

The patterns indicate, in this case, that an over torque happened. This can be evaluated by the shifting of the tooth pattern due to the higher level of stress on the gear and the housing; it can be seen as an additional pattern located out of the normal working position.

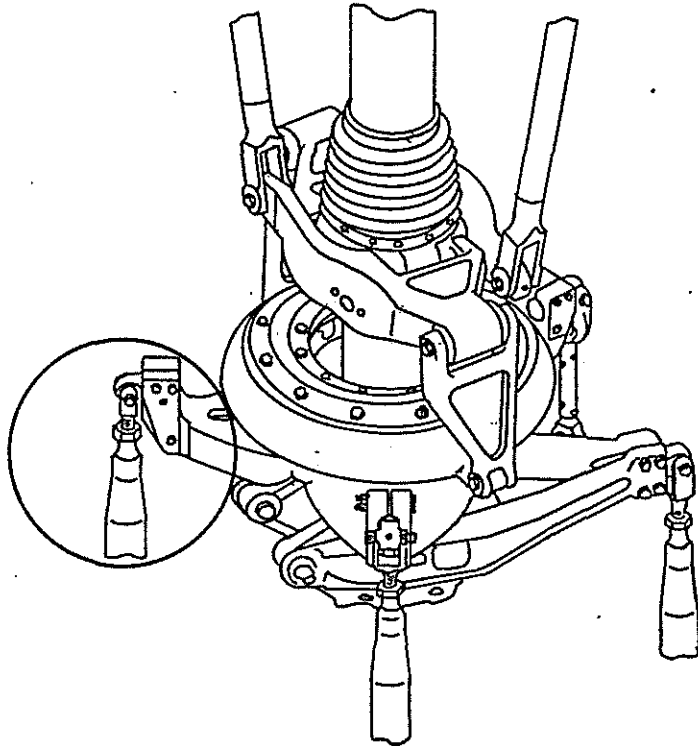
Fig. 12: Swash Plate Assy

We experienced, in factory, during the assembly phase of swash-plate, a very strange failure of the horn-lug as indicated by the arrow, which kept Agusta experts puzzled for a while.

The horns were assembled with the trunnions and torqued according to the specs. without any problems; half a day later we could see clear evidence of failure, with loss of torque and therefore possibility of trunnion separation in flight. I'll tell only the end of the story; we found out that the casting alloy aging naturally, became creep sensitive and the failure was classified as a creep failure for bending stresses. A different casting material removed the problem.

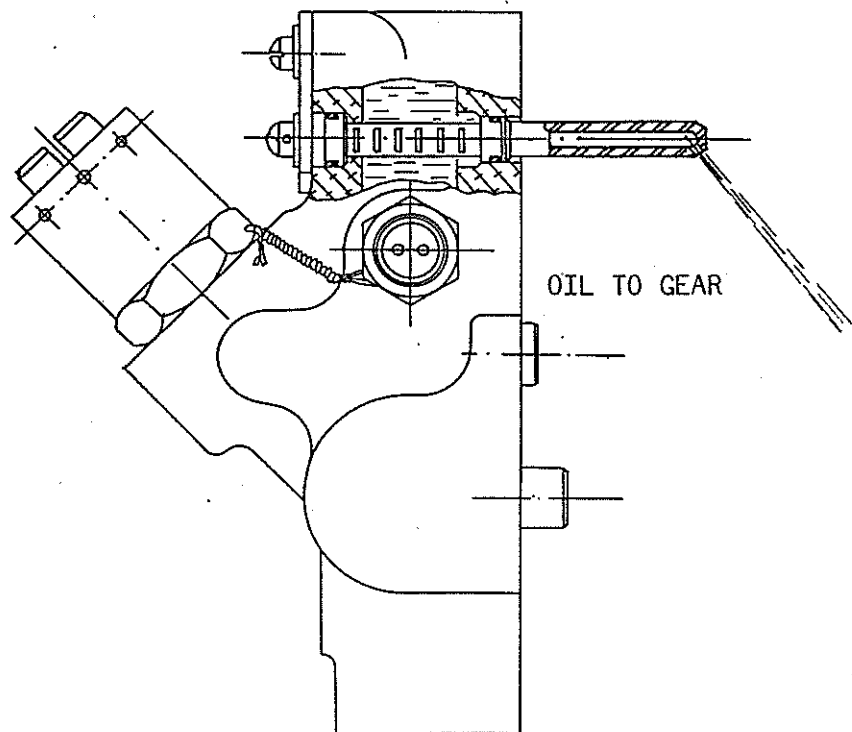
Fig. 15: Typical lubrication system

Main culprit, for us, was a loss of forced lubrication of position n. 1 of main input pinion and bevel gear.

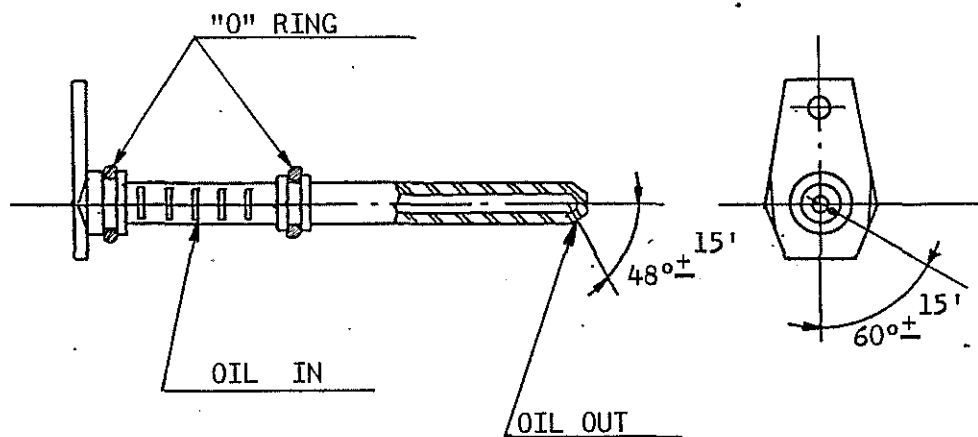
Fig. 16: Oil jet detail - Flow angle requirements

Based with the above firm belief the analysis of oil jet n. 1 revealed a failure.

If You try to remove the jet with the use only of one screwdriver pushing from one side first and the, from the other, You stress for bending the oil jet in the cross section where the resistant area is very low for oil passages. In our case we had a real fracture of the jet with the rotation as explained.
