SECOND EUROPEAN ROTORCRAFT AND POWERED LIFT AIRCRAFT FORUM

BALLISTIC AND IMPACT RESISTANCE
OF COMPOSITE ROTORBLADES

K. Brunsch, P.M. Wackerle

Messerschmitt-Bölkow-Blohm GmbH
Munich, Germany

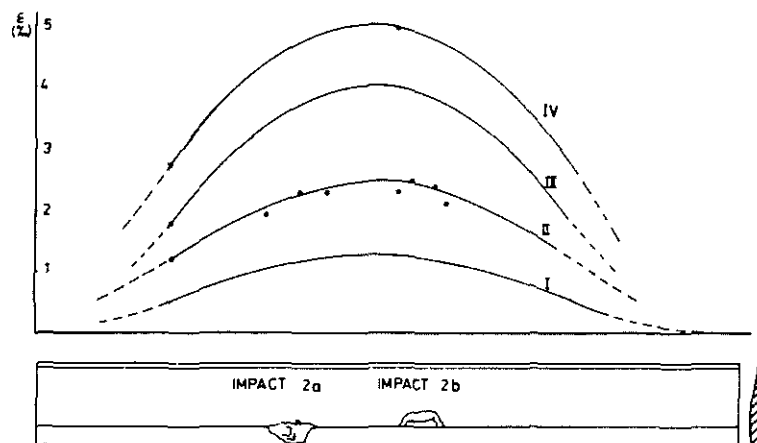
Figure 18 IMPACT TEST, STRAIN DISTRIBUTION

The number 2 specimen was tested for 45.6 million cycles at different loads. The spanwise distribution of alternate flexural deformation is shown in Fig. 18. The test conditions at which the maximum alternating deformation was 0.125, 0.25, 0.4 and 0.5% are referred to conditions 1,2,3 and 4 respectively.

| Condition 1 | 30 million cycles, crack in titanium nose cap starting from 2a impact area |
| Condition 2 | 6.8 to 11.8 million cycles, three additional cracks in titanium and carbon |
| Condition 3 | 0.5 million cycles, cracks in titanium nose cap propagated into unloaded area towards leading edge. Partial debonding of nose cap in 2a area were bullet left blade |
| Condition 4 | .017 million cycles, further cracks in nose cap. Slow growth of delaminated 2b area.

0.5 million cycles, two additional cracks in nose cap. |

.0775 million cycles, failure of the blade skin in the 2b area (figure 19). The most amazing fact is that the 2a area damage showed no growth although loaded to about 0.37% (condition 3) and 0.47% strain (condition 4).

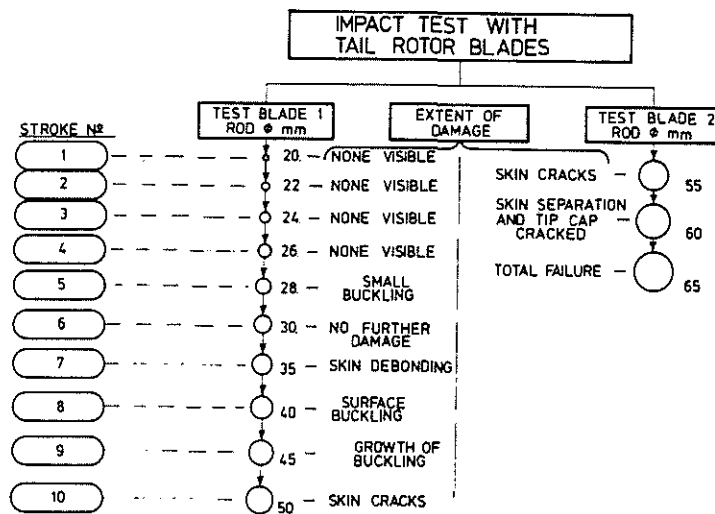
Fig. 31 ROTOR BLADE IMPACT TESTS

The first run with test blade 1 should demonstrate how many strokes the blade can resist with full action capability. This was found up to the point where a safe landing becomes impossible. Test blade 1 resisted a total of 10 strokes, see fig. 31 and after a visual inspection by design- and stress people and by pilots a "safe landing possibility" was attested. During all tests the test blade 1 had no change in its ballance properties. The damage is to be seen in Fig. 32, 33, 34.

With test blade 2 there were three strokes, see Fig. 31. The first on a 55 mm rod initiated the same failure as the test blade 1 had after 10 strokes. The figures 35, 36, 37, 38, 39 are showing the damage increase up to total failure. After the 60 mm rod test an immediate landing seems to be possible although an imbalance initiated by the loss of skin and core parts was detected. A normal landing after the last 65 mm rod impact is impossible because the imbalance initiated by the lost parts will cause secondary failures in tailboom components.
