THE MYTH OF LOSING TAIL ROTOR EFFECTIVENESS

André-Michel Dequin, andre-michel.dequin@airbus.com, Airbus Helicopters (France)

Abstract

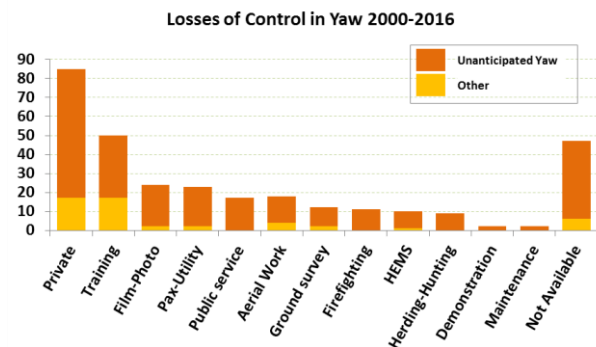
Figure 4: Mission flown when accident occurred

The next plot in Figure 4 presents the missions that were flown when the accident occurred. Private flights come first. This may be linked to the pilot's experience, especially when considering that training is second. Almost half of the training accidents occur during solo flights that only represent 20-25% of syllabi. Accidents with an instructor aboard are however not exceptional, which shows that instructors are not much better prepared to deal with such an event than their student pilots. It is also significant that most of the losses of control that do not look as unanticipated

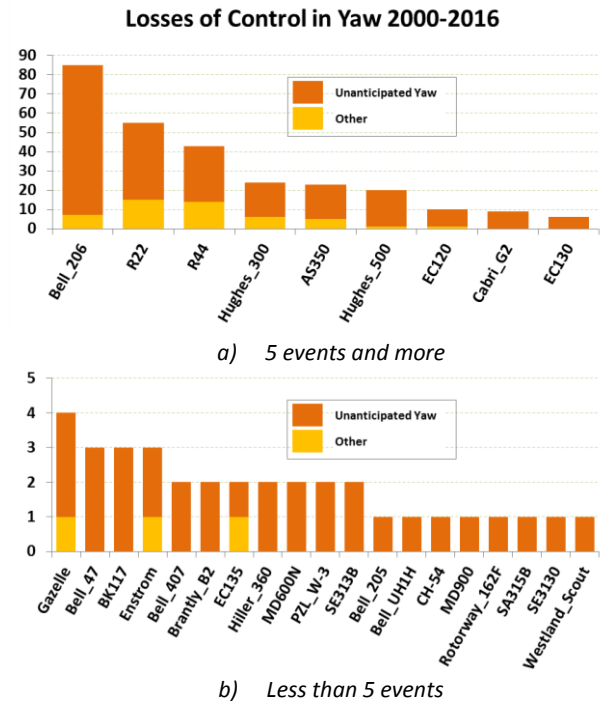
Figure 5: Helicopters involved in the accidents

The helicopter types that were involved in the accidents were grouped by family to allow plotting Figure 5. There is a clear predominance of light helicopters, which is consistent with putting forward private and training flights. There are

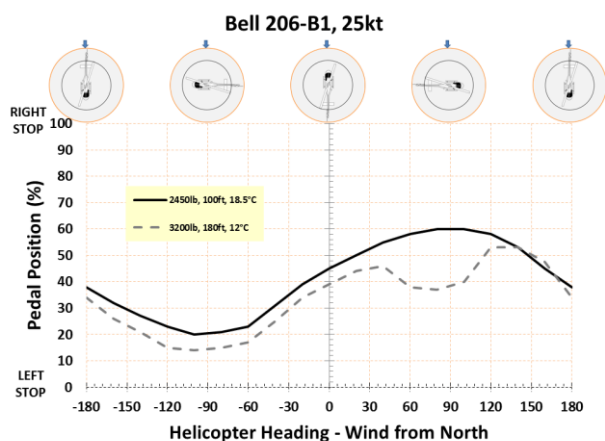
Figure 8: Pedal curves on a Bell 206-B1 with varying collective pitch (data taken from [17])

Another effect is shown in *Figure 8* that is used further in this paper and is quite intuitive. Pedal curves for a unique wind speed and two different weights in almost Sea Level ISA conditions are plotted there. Increasing the weight (more precisely the referred weight, i.e. the weight divided by density, or the collective pitch) asks for more power, therefore more anti-torque, and shifts the pedal curve downwards.

This shift is more obvious on the left side of the figure than on the right side where a strange bump appears, which might be explained by the tail rotor VRS that occurs in 90° heading conditions and induces significant pedal activity, which is only a detail. Keep in mind that an increase of collective mainly makes the trim curve shift downwards.

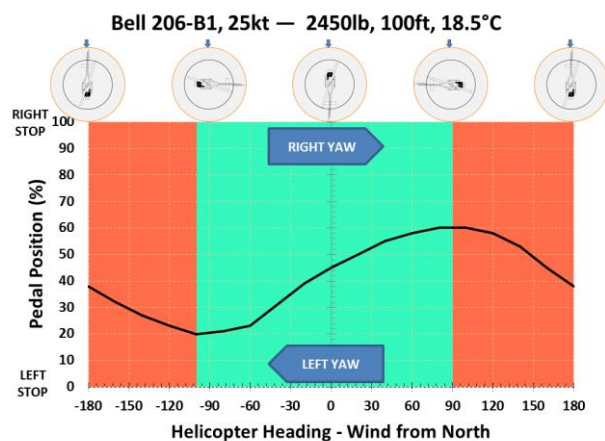
Figure 9: Stable (green) and unstable (red) ranges

In the following of chapter 4, the helicopter is making a hover turn in steady wind conditions. A unique curve is therefore only considered in *Figure 9* and is the basis of this analysis. 25 kt condition has been selected so that a significant pedal change with heading exists.

The helicopter may only be stopped on the black curve (zero yaw rate). When the current point (current pedal position, current heading) is brought below the curve, the pedal is more left than the trim position and the helicopter thus yaws to the left. When it is above that curve, the helicopter yaws rightwards. This is recalled by the two blue arrows in *Figure 9* and following.

The green area corresponds to the stable heading range and the red one to the unstable heading range. Stability and instability is driven by the slope of the pedal curve. The helicopter is stable with a headwind component and unstable with a tailwind component.

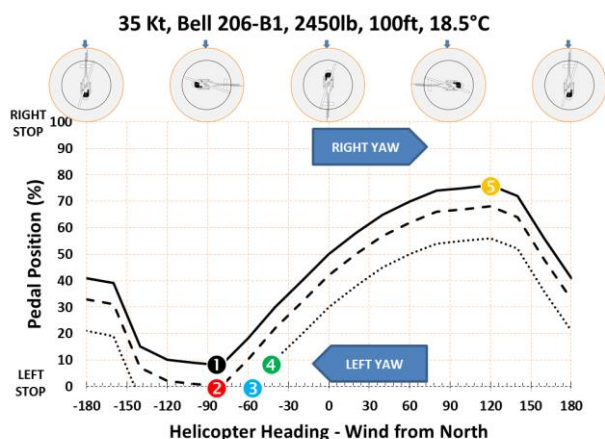
Figure 14: Running out of pedal

Figure 14 allows showing what happens when running out of pedal. The pedal curve is plotted in limit 35 kt wind conditions (full line). From this position the torque is increased by two successive collective inputs, leading first to the dashed line, which minimum exactly corresponds to the left pedal stop, and then to the dotted line, which minimum is out of the pedal range.

The pilot starts in the critical azimuth❶. During the first collective increase he is able to compensate and comes on the left pedal stop in ❷. The following collective increase cannot be longer

counteracted. The pedal curve moves from the dashed line to the dotted line but the pedal position remains on the stop, at 0%. The current point is therefore above the pedal curve and the helicopter yaws right until the dotted line is reached in ③. The current point is now on the pedal curve, in the stable range, and the yaw motion stops there. Running out of pedal does not lead to endless spinning but only makes the helicopter nose come slightly into the wind.
