HELICOPTER SAFETY IN THE OIL AND GAS BUSINESS

Eric Clark¹, Cliff Edwards², Peter Perry³, Grant Campbell⁴, and Mark Stevens⁵

^{1,2,4,5} Shell Aircraft International

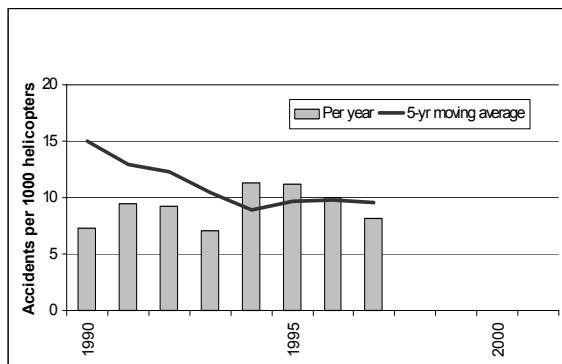
Figure 1: Accidents (Twins) – USA [Ref.2]

- Accident rates for twin turbine helicopters in the USA [Ref.2]
- Accident rates for twin turbine helicopters in the North Sea [Ref. 3]
- Accident rates for all helicopters in the Gulf of Mexico [Ref. 4]

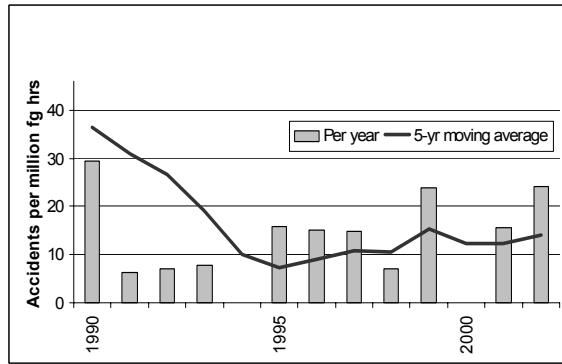
Figure 2: Accidents (Twins) - North Sea [Ref.3]

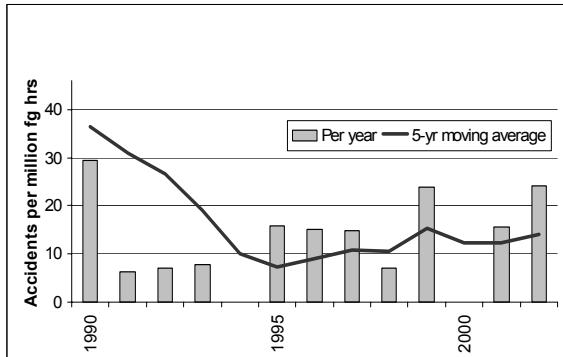
Figure 3: Accidents (all helicopters) - Gulf of Mexico [Ref.4]

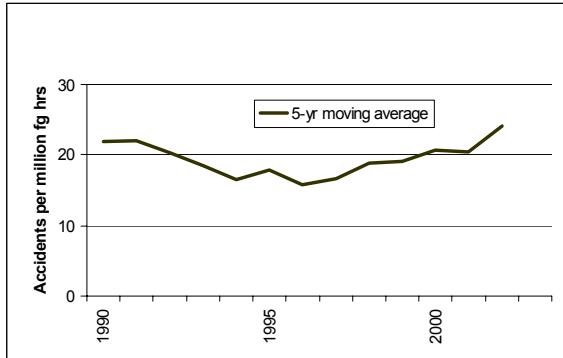
Figure 4: Accidents (Twins) - USA [Ref.5]]

Accident rates for selected twin turbine helicopters typical of those used in the oil industry in the USA [Ref. 5]

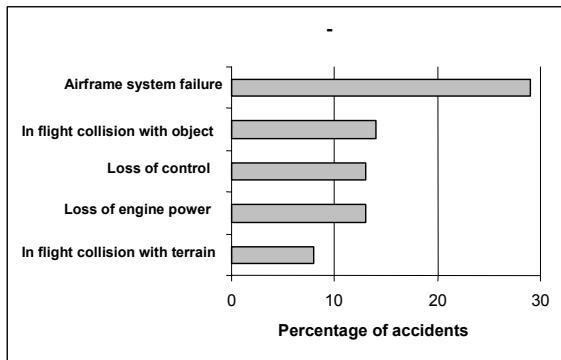
Figure 5: Causes of Accidents USA [Ref.2]

Although References 2, 3 & 4 each used different ways of categorising accidents, system failure (including engine failure), hitting objects, and flying into the ground featured prominently as the main causes and accounted for about 70% of all accidents. The following causes, some of which have design implications, will be analysed and means of mitigation will be considered:

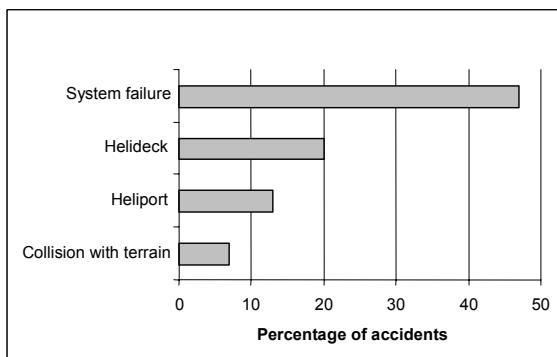
Figure 6: Causes of Accidents – North Sea [Ref.3]

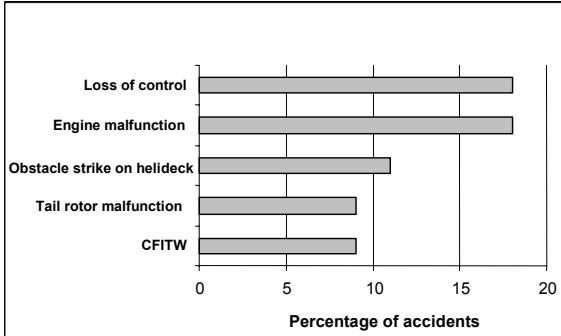
Figure 7: Causes of Accidents – Gulf of Mexico [Ref.4]

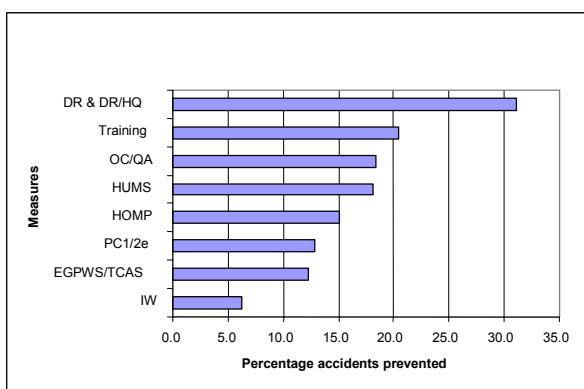
Figure 8: Percentage accidents reported in NASA study prevented by individual mitigation measures

The impact of each mitigation measure acting in isolation, with the others set at zero is shown in the following graphs:

From this analysis, design requirements to the latest amendment combined with enhanced handling qualities, which of course can only be obtained with new types of helicopter, would prove to be the most effective mitigation to prevent accidents. The NASA study covers an earlier period that ends in 1997 whereas the AS332 and S-76 analysis includes a further 6 years up to 2003. The charts indicate that mitigation provided by Training, OC/QA, HUMS and PC1/2E are all lower for the AS332 and S-76 accidents than for the NASA study. This feature may be indicative of improvements that have progressively been introduced over the last 10 years to the AS332/S-76, two helicopters that predominate in offshore operations. The only really significant difference between the two analyses concerns EGPWS/TCAS.

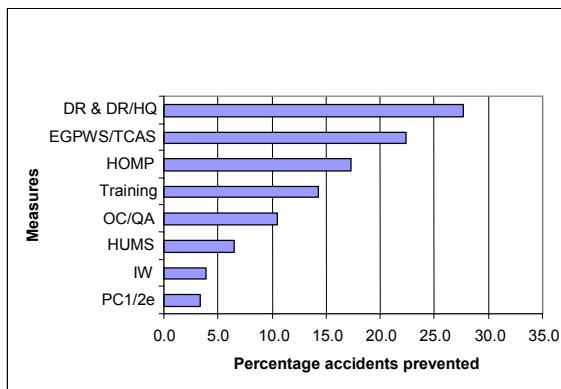
Figure 9: Percentage AS332 and S-76 accidents prevented by individual mitigation measures

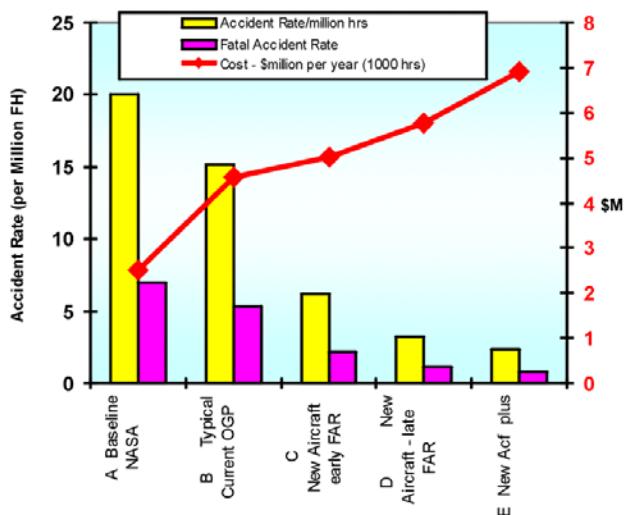
Figure 10: The ALARP Assessment Plot

The ALARP assessment plot shows that in the last decade, in both theory and practice, progress has been made in reducing accident rates through the implementation of some of the mitigation measures. Where there has been more extensive implementation, as in the North Sea, accidents rates have been reduced further. Recent contract rates quoted for old aircraft (Option B) and for new versions of old design (Option C) do not now show the significant difference that existed, say five years ago, and the significant reduction in accident rates clearly justifies the additional cost. However, Option C represents the status quo and is unlikely to enable the OGP to achieve its long-term safety goals. These can only be achieved with the introduction of new design aircraft (Option D). Although Option D shows a premium of up to 15% in terms of annual cost for a medium, 12-seat helicopter, the potential exists to reduce accident rates by 50%. Option E, which looks ahead to the further development of the later versions of the S92, EC225 and AB139, or to the next generation of helicopters, is likely to increase costs by a further 15% - 20% and the mitigation assessment shows an improvement of about 25% in safety. This would indicate that we would be entering the laws of diminishing returns and that the ALARP point, which coincides with the projected safety goal, is Option D.

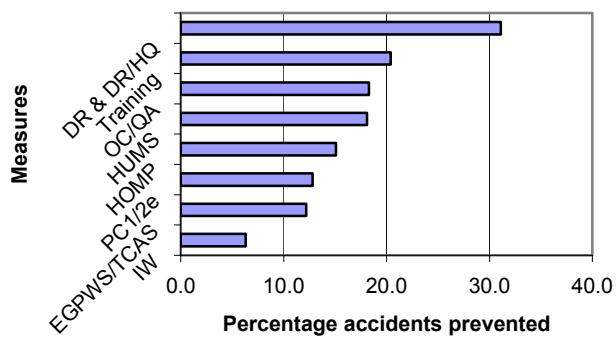
Mitigation	% accidents prevented (individual measure only)
IW	6.3
EGPWS/TCAS	12.2
PC1/2e	12.8
HOMP	15.1
HUMS	18.1
OC/QA	18.3
Training	20.4
DR & DR/HQ	31.1

**Percentage accidents reported in NASA study
prevented by individual mitigation measures**
