Computed Tomography (CT) as a Nondestructive Test Method used for Composite Helicopter Components

Reinhold Oster
MBB, Deutsche Aerospace AG
Helicopter Component Test
Munich, Germany

Abstract

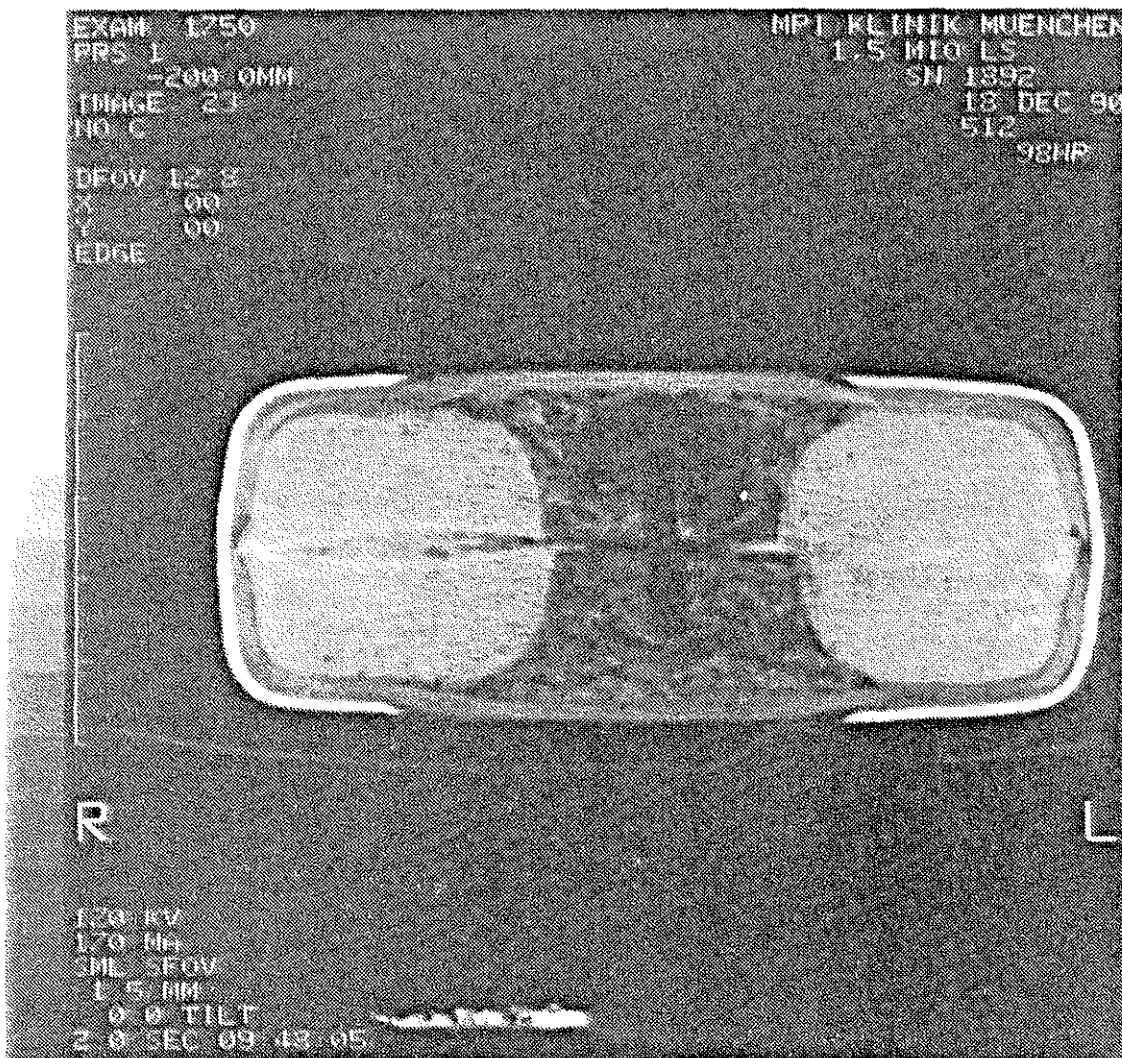
Fig. 3 Tomogram of the rotor-blade neck of the Bo105 helicopter (Bölkow system)

Scan data:

- Upper left: Position, image number, field size algorithm
- Upper right: Location, specimen data
- Lower left: Tube voltage, tube current, slice thickness, scanning time (in this case 2 sec.)
- Lower right: Grey-scale spread (CT units)

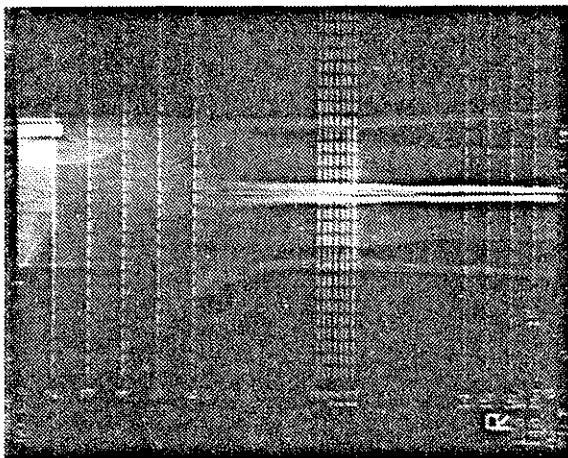
Fig. 17
Shadow image of the transitional area between the rotor twist element and the blade section.
